***Report RL 2008:09e***

**Aircraft accident to OE-KLA in international  
waters south of Trelleborg on  
16 October 2006.**

Case L-31/07

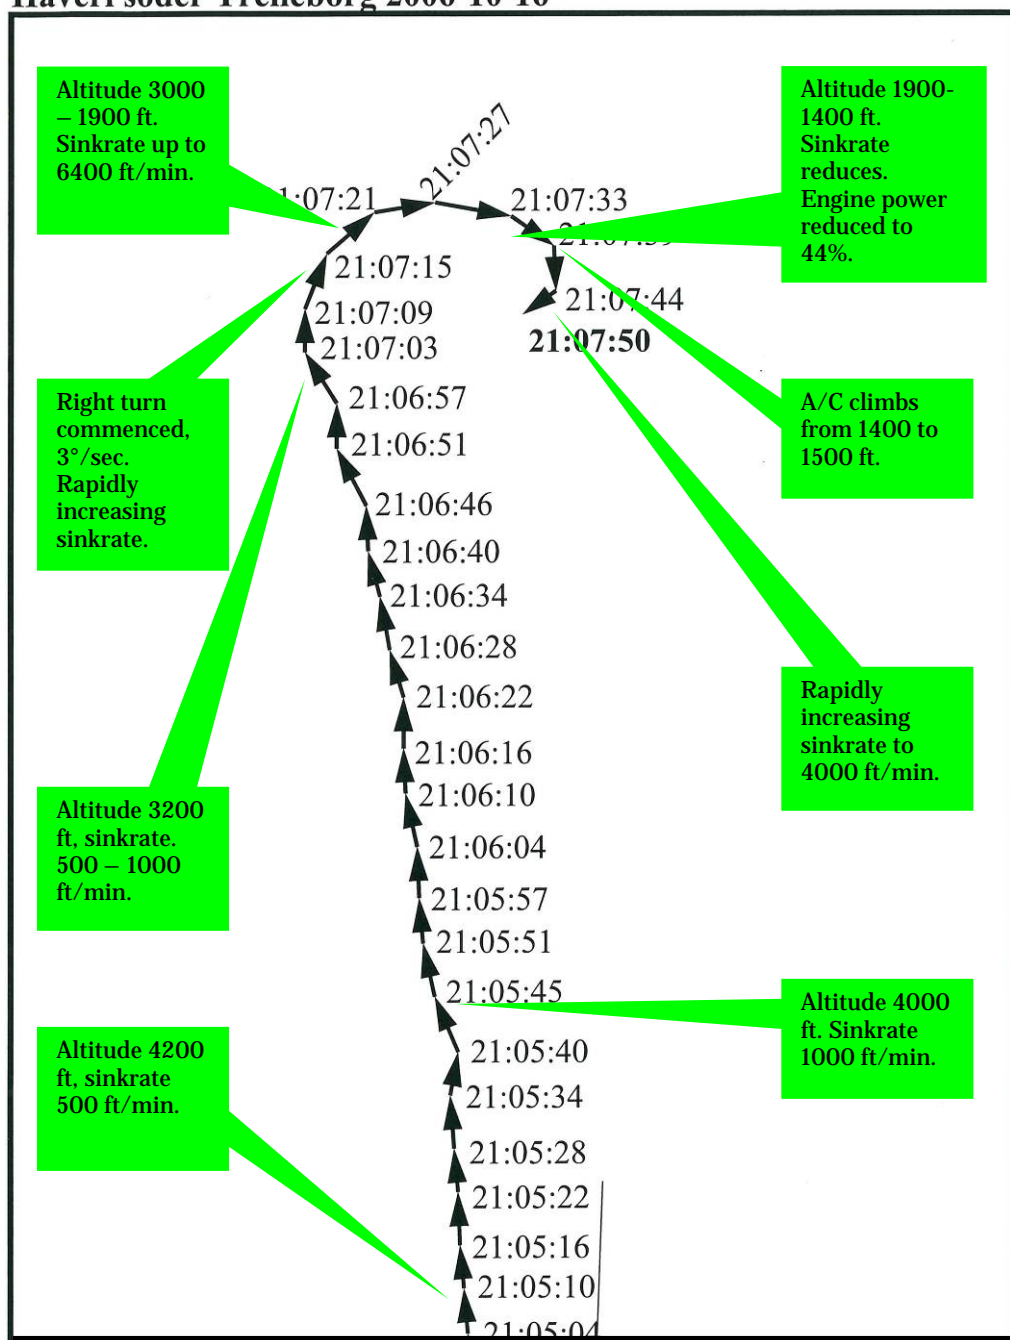
Fig. 2 Detailed graphic of the sequence of events.

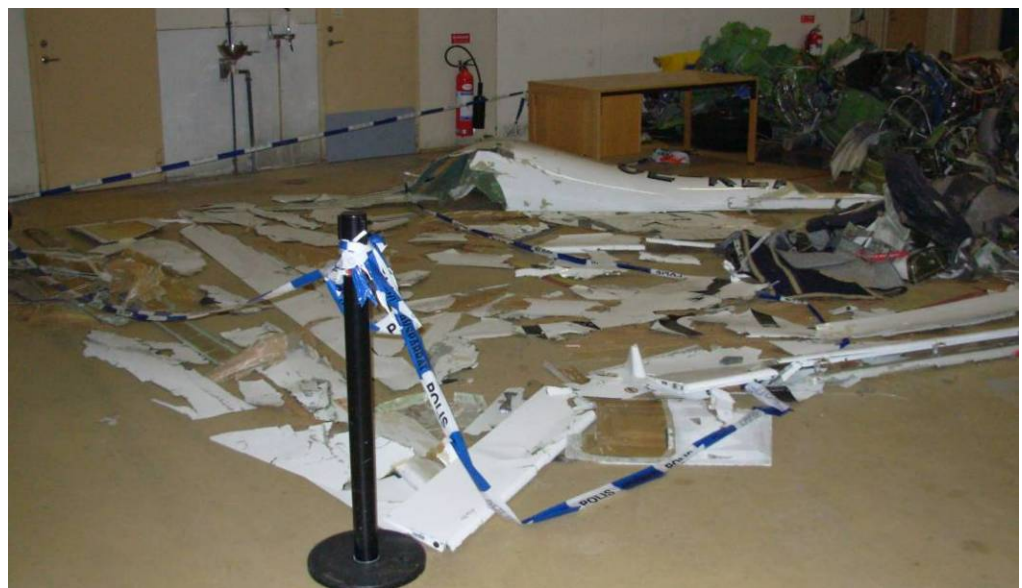
On impact with the water the aircraft disintegrated completely. The illustration at figure 6 below shows the aircraft parts that were brought up from the sea bed and retrieved from the surface. Those parts of the aircraft and its equipment that were not recovered can broadly be summarised as follows:

Fig. 7. The aircraft wreckage. Photograph source: SHK.

The engine and parts of the cabin comprised the largest parts that were recovered. The remaining parts of the aircraft, which were mainly composed of glass fibre/carbon fibre composites, were only found as fragments, most of which were retrieved from the surface. It has not been possible to determine the instrument settings and control positions, since the remains of the instrument panel were severely damaged on impact.

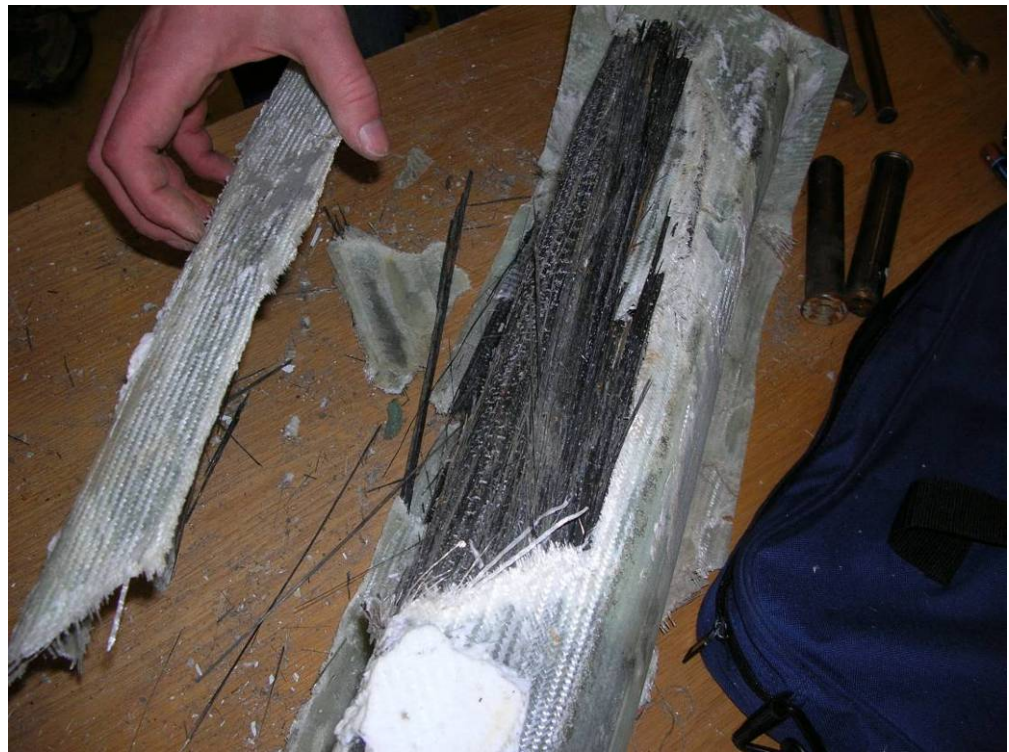
It was concluded that the aircraft completely disintegrated on impact with the water. Both wings had remained attached to the aircraft fuselage, but only the front wing spar was found. Figure 8 below shows an image of the aircraft's front wing spar, with carbon fibre reinforcement on the top of the spar. Both pressure and tearing damage were noted on the spar.

Fig. 8. The front wing spar. Photograph source: SHK.

At the request of SHK certain parts were dismantled from the aircraft wreckage and sent to the manufacturer's laboratory for examination. Nothing in this examination indicated otherwise that the aircraft was complete on impact. It was established that both wings were attached to the fuselage at impact. The damage analysed as being present on the wing spar was probably caused by an almost vertical impact, whereby the wing spar, when the nose hit, was exposed to a forward force, and a fraction of a second later exposed to a backward force when the wing hit the water.

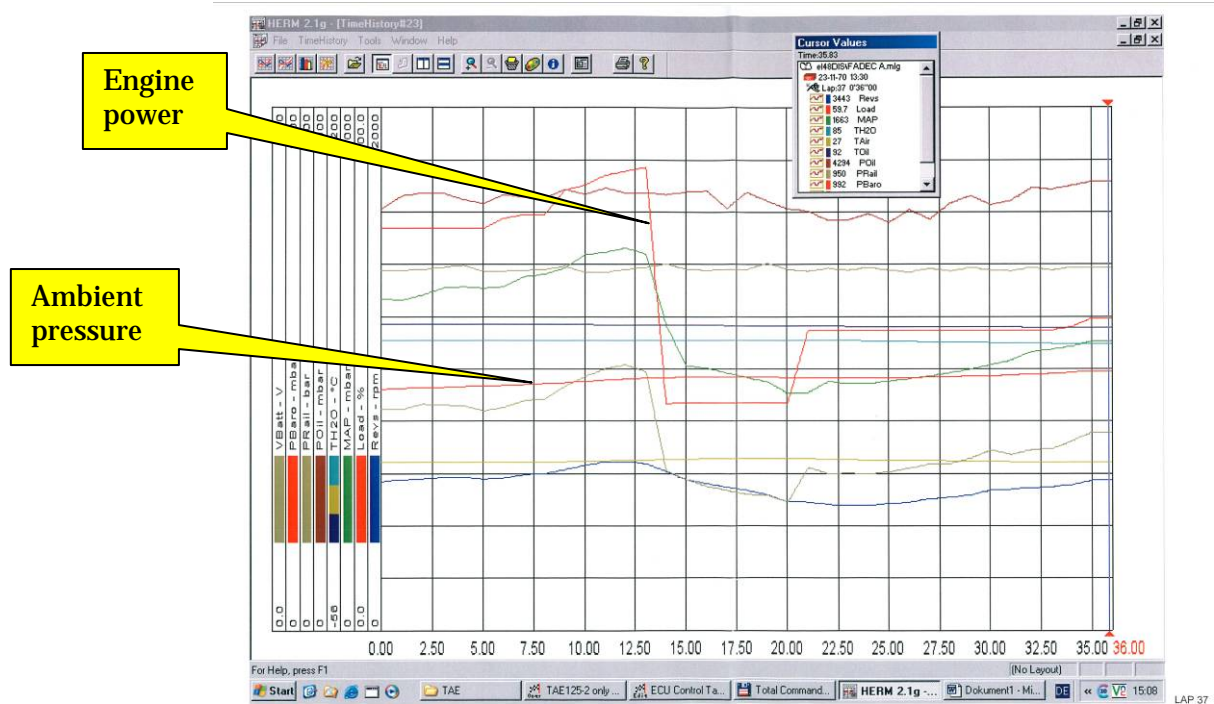
Fig 10. Graphic showing the engine FADEC parameters. Note that increasing ambient air pressure signifies reducing altitude.

Other recorded parameters that were associated with the engine or its systems showed normal, or in the situation relevant, values, without any faults or abnormalities being observed.

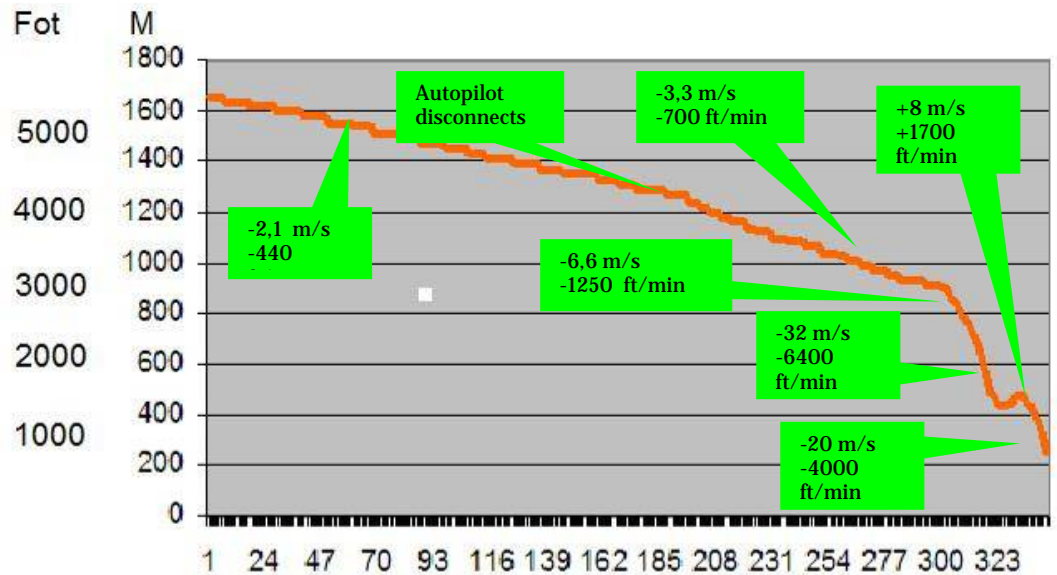
- 6000 feet to about 4400 feet (autopilot disconnects): -500 ft/min
- 4400 feet to about 3200 feet -700 ft/min
- 3200 feet to about 1900 feet -6400 ft/min
- 1400-1500 feet +1700 ft/min
- 1500 feet to impact -4000 ft/min

Fig 11. Graphic showing the vertical movement of the aircraft.  
(Annotations: Fot = Feet, M = Metres, horizontal axis shows seconds)

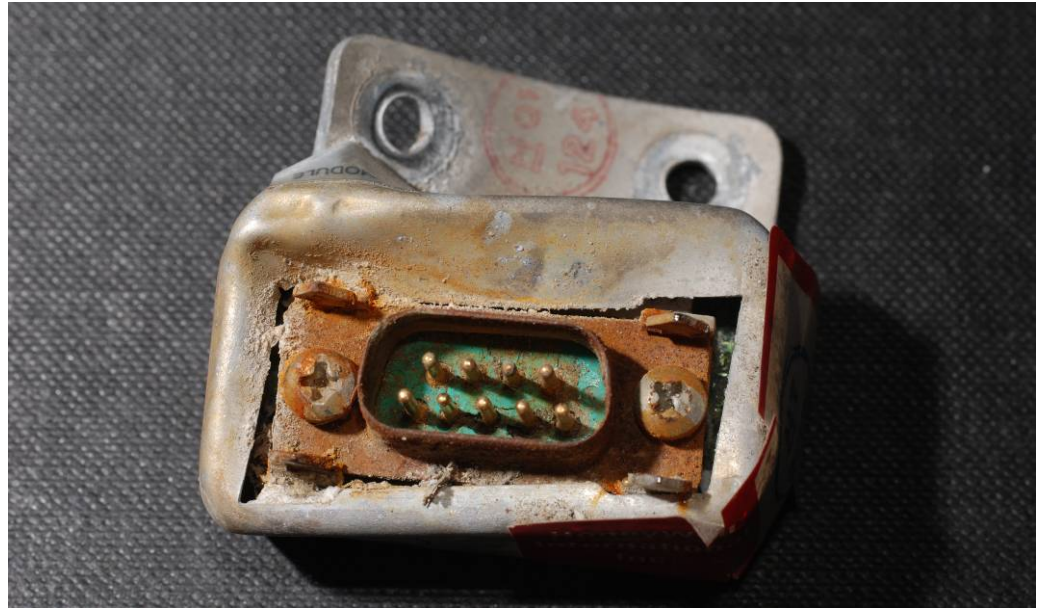
Fig 12. The autopilot's KCM 100 unit. Photograph source: SHK.

On removal from the aircraft wreckage it was found that the unit was quite badly damaged, and also corroded. After contacting the manufacturing company, the unit was sent to the Honeywell laboratory in Kansas, USA, for examination.
