Statens haverikommission
Swedish Accident Investigation Board

Report RL 2007:8e

**Aircraft accident to SE-GIT
at Umeå airport, AC county, Sweden,
on 13 March 2006**

Case L-06/06

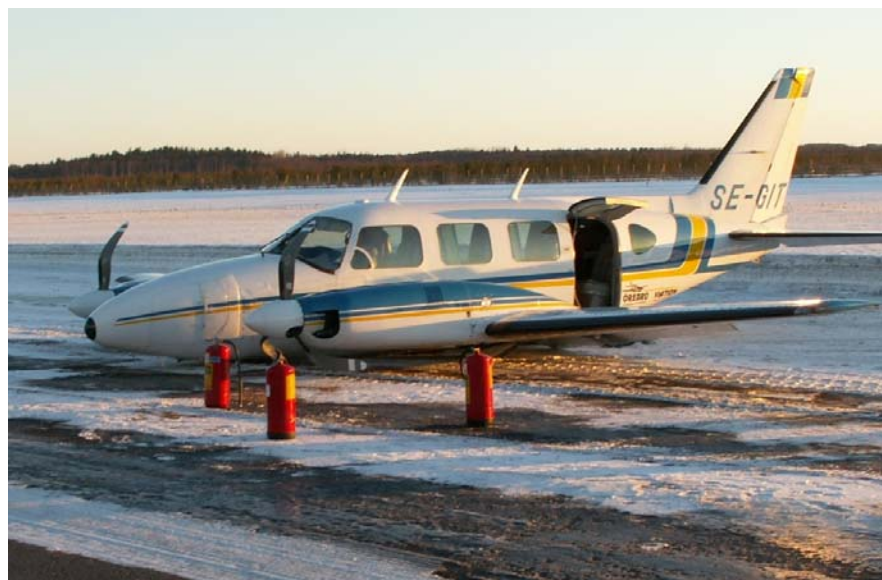
Fig 4. The aircraft after the emergency landing

During the emergency landing the aircraft incurred damage to the engines and propellers. Structural damage also occurred to the fuselage and wing flaps.

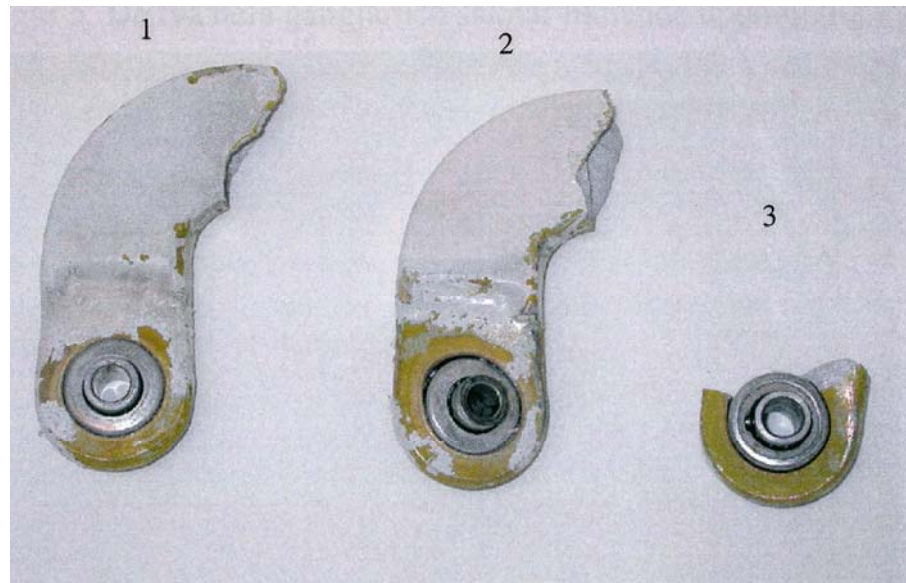
After recovery of the aircraft it was transported to a hangar at the airport for technical inspection under SHK supervision. During the inspection it was established that the left main landing gear front hinge assembly (New Improved Door Hinge assembly P/N 47529-32) had broken. The hinge assembly on the right main landing gear had also broken. The front hinge assemblies on both doors showed fracture surfaces with signs of metal fatigue.

Fig 5. Broken front hinge assembly from the left main landing gear door (1). Front hinge assembly from the right main landing gear door (2). Rear hinge assembly from the right main landing gear door (3)

The fracture surfaces on the broken front hinge assembly showed an area of fatigue that began from the inside of the hinge knuckle. The extent of the fatigue was greatest in the left door hinge assembly (see fig. 6). The fatigue marks extended down to a depth of about 10 mm in the left door hinge assembly and about 5 mm in the right door hinge assembly. In both the hinge assemblies, the fatigue damage had developed over a long time. The break in the right main landing gear door rear hinge assembly (no. 3 in fig. 5) was a straightforward overload failure.

In addition to the fracture surface character it was found that the hinge assembly for the left main landing gear door, with the greatest area of fatigue, was not deformed, while both hinge assemblies for the right door were deformed and twisted. The absence of deformation usually indicates that the fatigue cracking had reached a critical depth.

- Takes action so that the hinge assemblies of this particular type are inspected at suitable intervals in respect of crack generation.
(*RL 2007:08e R1*).

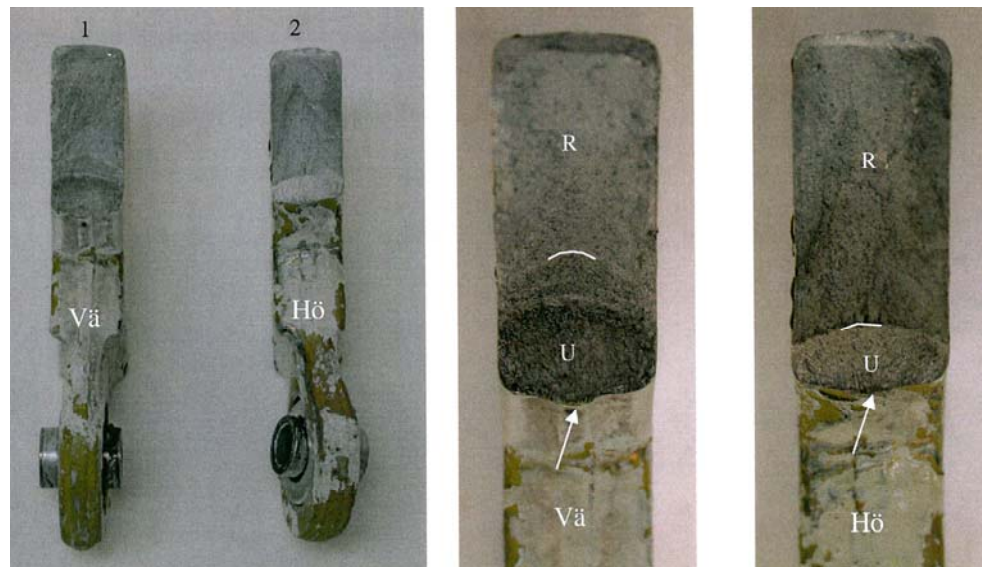
Fig 6. Left main landing gear door front hinge assembly (Vä = left) and right main landing gear door front hinge assembly (Hö = right). The starting point (arrow) and boundary between fatigue (U) and remaining fracture (R) are marked

Examination of the fracture surfaces under high magnification in a sweep electron microscope showed that both fractures originated from a raised portion of the inner diameter of the hinge assemblies. The two complete hinge assemblies did not show this type of raised portion. Similar raised areas in forged material normally derive from joints in the manufacturing tooling.

The reason for the fracture of the front hinge assembly was a fatigue crack. According to the investigation it could be established that the crack began at the inside of the hinge knuckle. Closer analysis showed that the starting point of the fatigue in both doors was a raised portion of the knuckle. It is probable that this protrusion originated from the division of two halves in the tool that was used during manufacture (forging) of the front hinge assemblies in question.

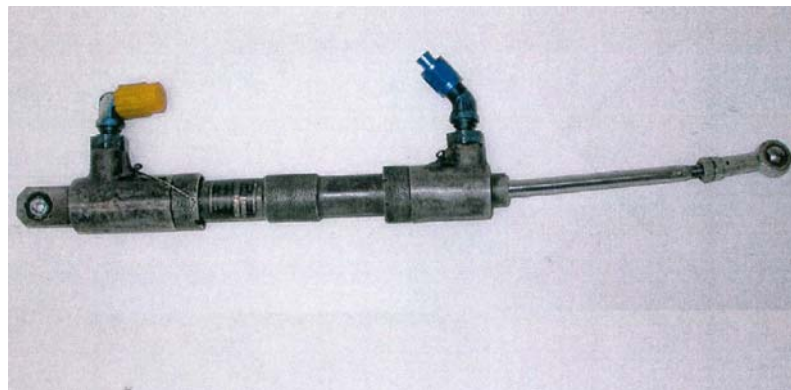
The actuating rod of the hydraulic cylinder that controlled the operation of the left door was bent. The bent actuating rod had wedged against the opening at the end plate of the hydraulic cylinder.

Fig 7. The hydraulic cylinder for the left door

Once the cylinder had been dismantled and all the tension relieved, it could be established that the actuating rod was bent more than it was when installed.

The actuating rod moved towards completely open door, but the door did not open, as the hinge assembly closest to the hydraulic cylinder was broken, so that no leverage effect took place. In connection with this the actuating rod bent in its maximum extended position. When the door then closed during the pilots' re-cycling attempt, the bent actuating rod jammed in between its extended and retracted positions. This held the door in its half-open position and blocked the main landing gear at the next gear lowering attempt, since the wheel came to rest on the top of the half-open door.

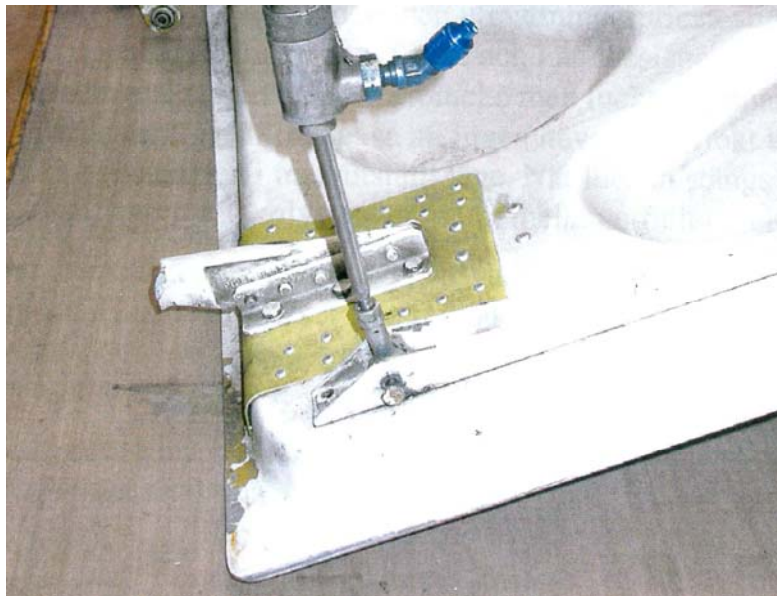
During examination of the left main landing gear door it was seen that a repair had been carried out to the inside of the door. The repair was localised to the area of the hinge that had the most fatigue in the fractured surface. A green-painted plate had been riveted under the hinge assembly and bent around the inner edge of the door (see fig. 8). This repair had meant that the hinge assembly would be located an estimated 1.5 to 1.8 mm above its original position.

Fig 8. Left main landing gear door showing the repair

The technical company had performed the repair to the left main landing gear door mentioned in 1.16.4 above. In Work Order 2004, page 3/4, No 9, there is the following remark in the field for work/remarks dated 13 June 2005:

“Cracks in L/H inner LDG door fwd fitting attachment”

A free interpretation of this means that cracks were found in the front fitting attachment for the left main landing gear door. The response was that a repair had been performed in accordance with AC 4313. In an interview with the company it transpired that a crack had been discovered in the plate at the hinge assembly securing point. The hinge assembly had been dismantled and a new plate riveted over the location of the crack, after which the hinge assembly was secured to the new plate.

According to the findings of SHK, the company that was responsible for the technical inspection of the aircraft detected cracks in the sheet metal of the left inboard main landing gear door. With reference to the fact that the work description in document AC 43.13 forms “approved data”, the design of the door was altered by riveting a new plate over the old plate in the area of the damage.

On the other hand SHK considers that the fact that the front hinge assembly on the right side main landing gear door also showed signs of metal fatigue indicates that the heightening of the hinge assembly location that came about as a result of the repair did not to any great extent affect the metal fatigue in the fractured left door hinge assembly.
