## ***Report RL 2007:09e***

**Aircraft accident to helicopter SE-JHD  
at Södra Åsjön, Blekinge county, Sweden  
on 1.March 2006**

Case L-04/06

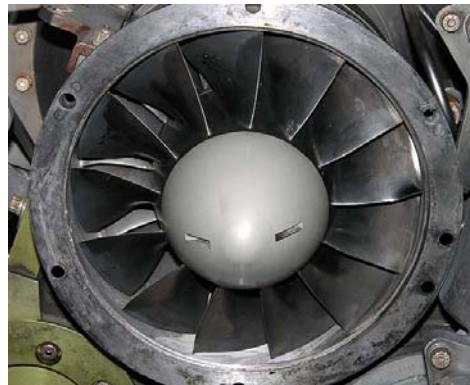
*First compressor stage*

The engine gas generator and free turbine could be rotated without restrictions or abnormal noises. It was noted that the outer sections of three of the first stage compressor blades were “gently” curved forwards and without sharp edges (see the photograph below).

The damage to the compressor blades that was discovered does however tend to show that the engine was subjected to FOD. The appearance of the damage indicates that an easily crushed material, such as ice or packed snow, could have been drawn into the engine.

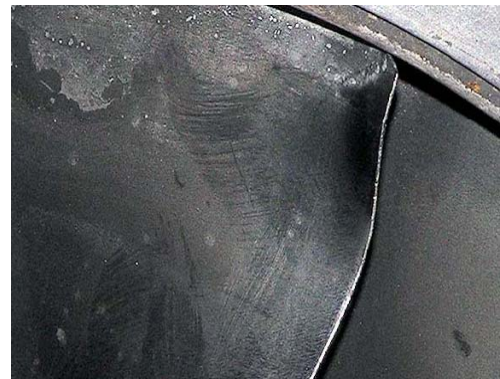
*Damage to the compressor blade*

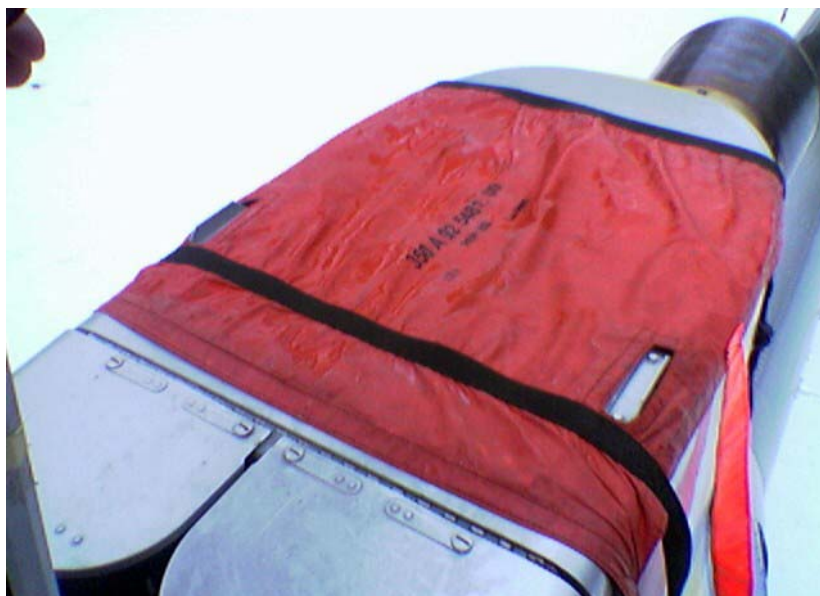
The helicopter was parked outdoors on the night before the accident flight, and the engine air intake above the cabin was at that time covered by a tarpaulin (see the photograph below).

*Tarpaulin covering the engine air intake*

Certain parts of the tarpaulin are porous, and an examination was carried out to establish its ability to retain free water and ice. The examination concluded that in certain circumstances the tarpaulin could absorb up to 300 grams of water that would not run off due to gravity.

During the evening and night before the accident the helicopter had been parked outside in snowfall. It is possible that a certain amount of snow could have entered the engine air intake before the tarpaulin was fitted. Heat from the engine could also have melted snow, on the tarpaulin and the top of the engine housing, which then in the form of water passed through or past the tarpaulin. Water could in partly frozen form have collected in or under the sand filter, or alternatively somewhere in the space between the filter and the engine.

- in a suitable manner point out to operators of this particular type of helicopter the importance of ensuring that ice, packed snow and water cannot be drawn into the engine, since even small amounts can cause the engine to stop (*RL 2007: 09e R1*), and to
- make efforts to have the Auto Ignition System introduced as standard in this type of helicopter (*RL 2007: 09e R2*).
