Statens haverikommission
Swedish Accident Investigation Board

Report RL 2007:10e

**Aircraft incident to SE-LPT
at Umeå airport, AC county, Sweden,
on 19 September 2006**

Case L-25/06

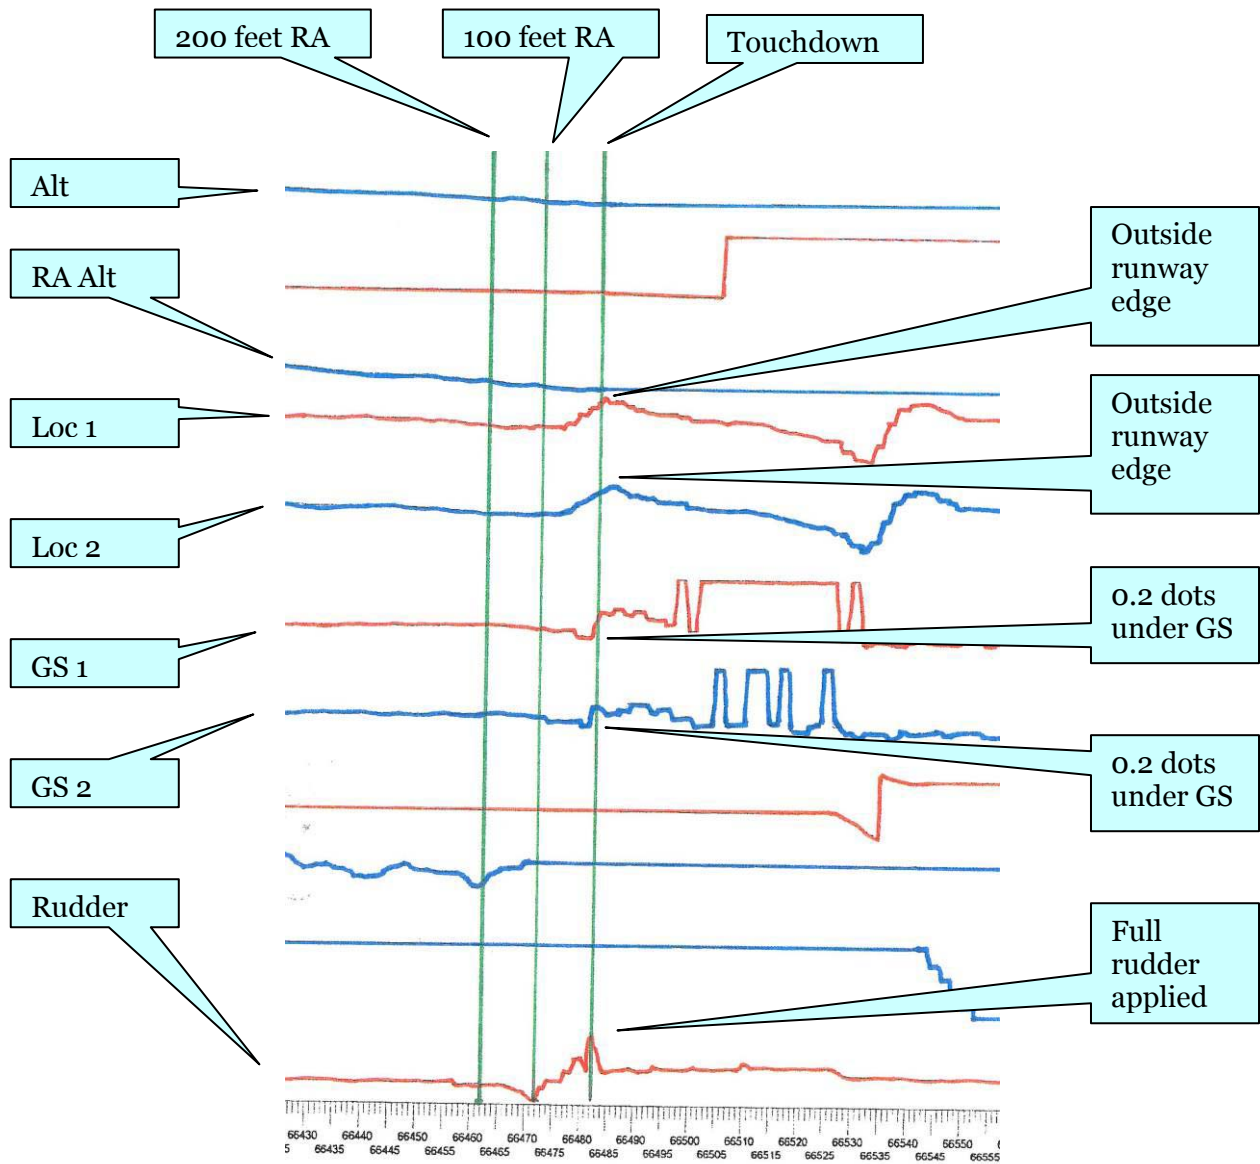
Fig 1.

The printout reveals that the aircraft began to veer to the left at about 75 feet radar height, and that touchdown was at the left edge of the runway. After touchdown the aircraft continued further out to the left, but the heading was later corrected so that it came back on to the runway. Very large rudder deflections took place just before and in connection with touchdown.

The FDR printouts show that the last part of the approach was not stabilised and that large rudder deflections were required to control the aircraft. The commander had also stated that the aircraft had not been trimmed correctly so as to minimise the lateral drift in connection with landing.

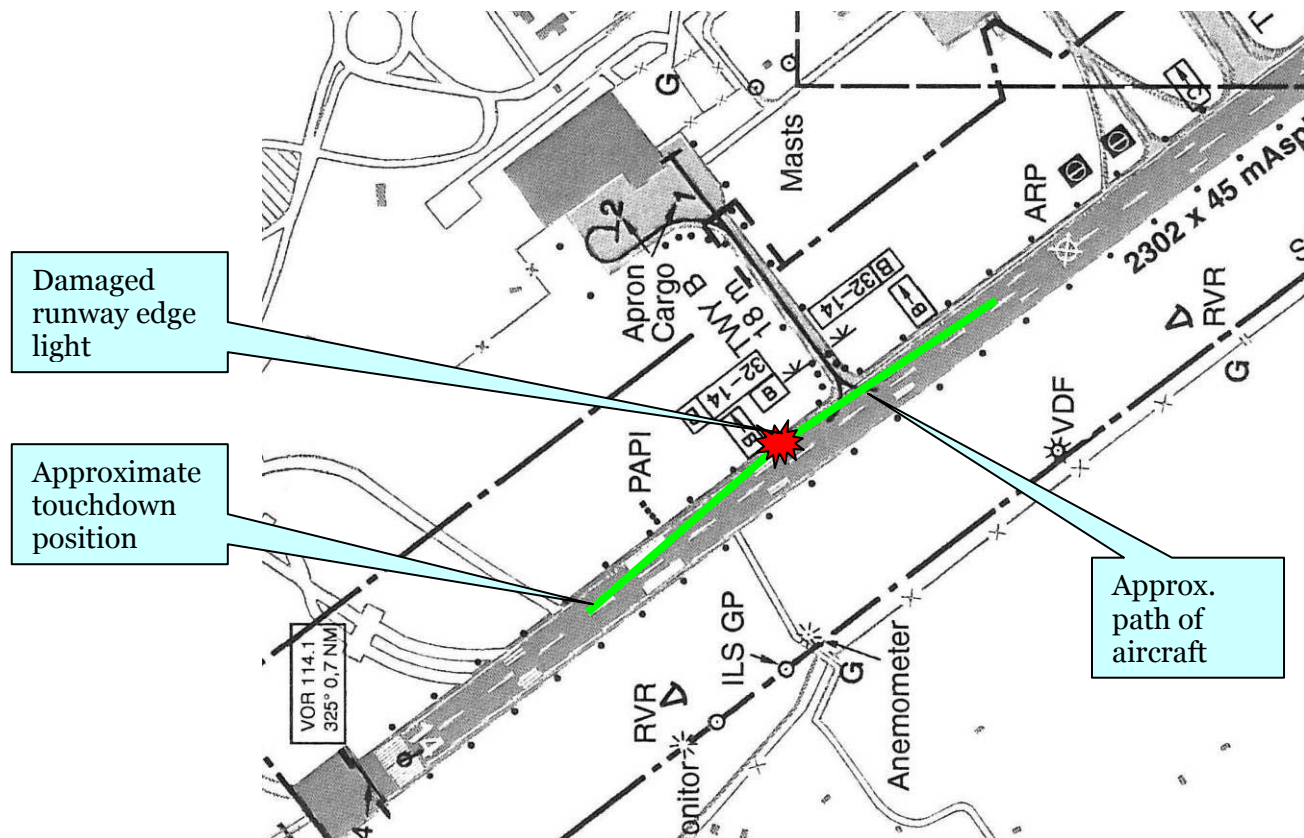
Fig 2. Runway 14 at Umeå airport.

The damaged runway edge light

Wheel tracks from the aircraft

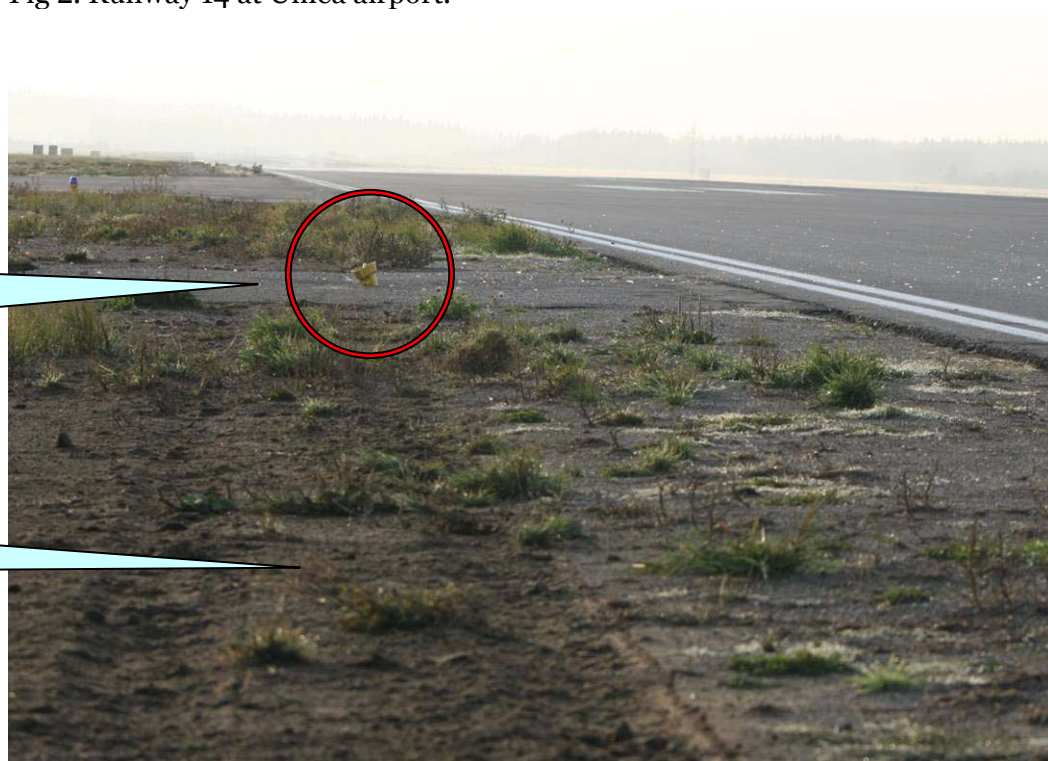
Fig 3. Location of the incident. Left side of runway 14.

A further runway inspection was carried out and all the glass shards were removed from the runway before next take off. Inspection of the electrical department log revealed that a fault had occurred in a runway edge light at 02:07, i.e. at the same time that the aircraft in question had landed. Tracks in the sand off the edge of the runway, which could be associated with the event, showed that the left main landing gear wheel pair had been about 2.5 metres beyond the edge of the runway before returning to the runway. While rolling outside the runway, the wheels struck one of the runway edge lights.

One edge light fixture at the left side of runway 14 was damaged by collision with the aircraft wheel.
