Statens haverikommission
Swedish Accident Investigation Board

Report RL 2007:07e

**Aircraft accident to HB-CXF
at Ängelholm Helsingborg airport, M county,
Sweden, on 11 December 2004**

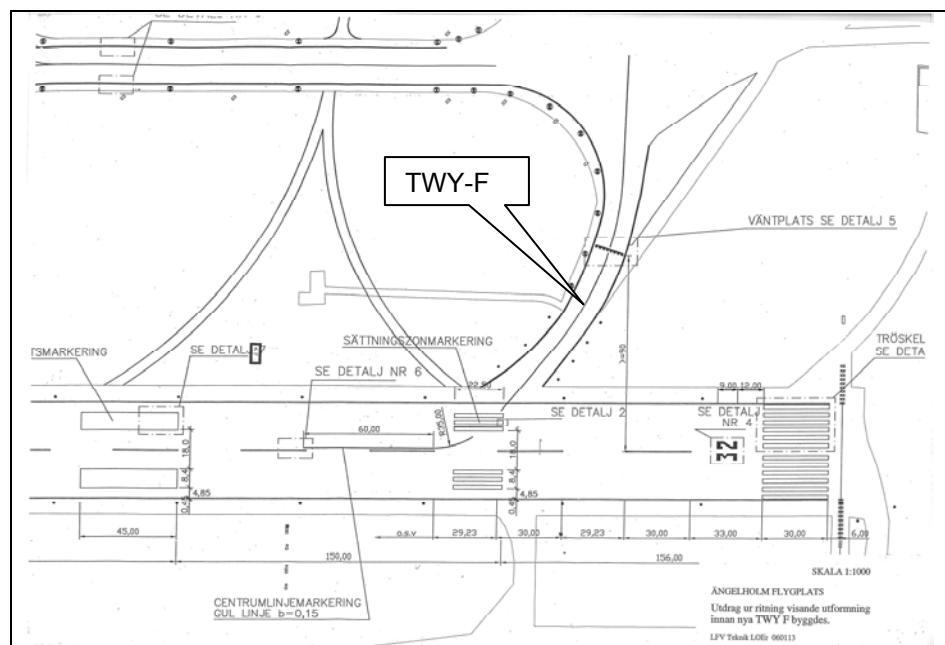
Before reconstruction

So that commercial aircraft could more easily be able to use the whole length of the runway, during the autumn of 2004 a taxiway called TWY-F was moved about 60 m closer to the threshold of runway 32. The connection angle to the runway was at the same time rebuilt from about 45° to 90°. (See below.)

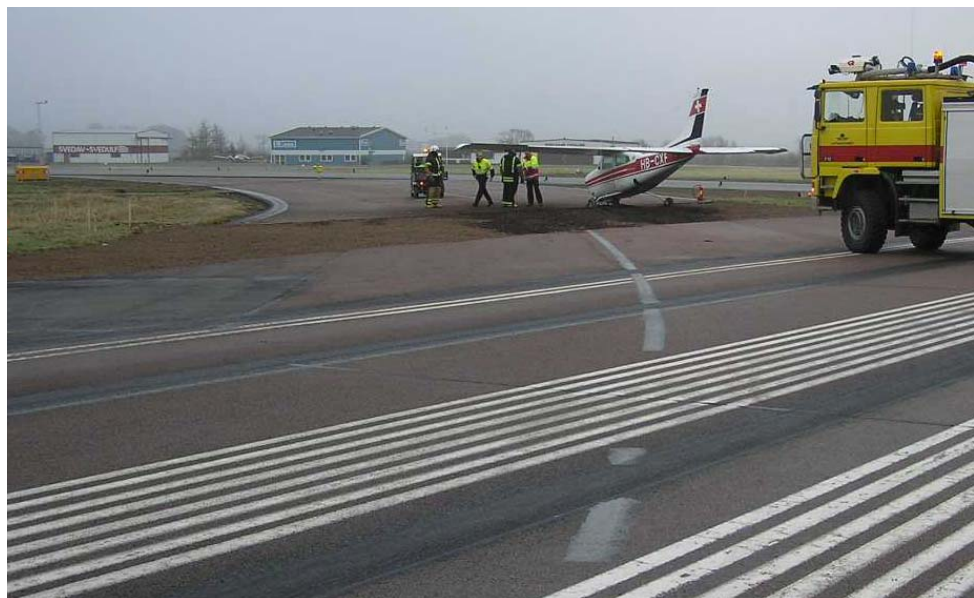
At the time of the accident, about seven metres of the black asphalt layer of the old TWY-F had been removed and replaced by dark-coloured earth. The old centreline had been overpainted with gray paint, but was still clearly visible. (See photograph below.)

Both the sign that indicated the original run-off to the taxiway and its centreline were still there. The old centreline had certainly been over-painted with gray paint, but was still clearly visible. The asphalt surface for the original run-off had been replaced by earth, which had approximately the same colour as the asphalt on the runway and taxi system. There was no suitable edge marking or other visual warning to show the pilot that the original run-off was unusable.

In these circumstances it is therefore understandable that the pilot, after passing the incorrectly marked sign to TWY-F perceived the original run-off as the correct one and turned into it. He did not notice until it was too late that the run-off surface had been partly replaced by earth, and that its centreline had a different colour.

After the accident the edge of the runway at the location of the removed taxiway was marked by fluorescent poles and tape until the new sign could
