Report RL 2007:05e

**Incident involving aircraft SE-LIP
at Stockholm/Arlanda airport, AB county,
on 1 June 2006**

Case L-11/06

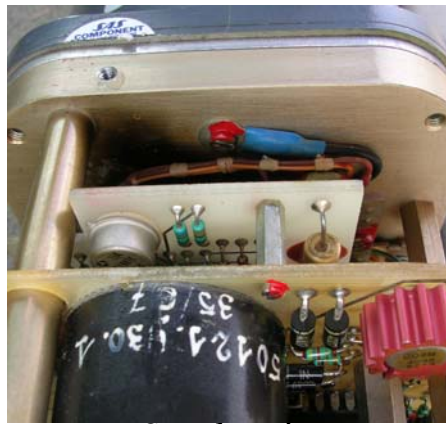
The altimeter, a Thomson P/N 60121-001-1, S/N 256 manufactured in November 1988, has been examined at the instrument workshop. The examination showed that overheating and possibly fire occurred in a capacitor forming part of the electronics part of the instrument. A short circuit had probably taken place due to an electrical wire, that had been trapped between the capacitor and a metal base plate, after long use in a vibrating environment, gradually causing mechanical damage to the capacitor. According to the airline and the instrument workshop there was no knowledge of a previous case of the same type of fault.

Soot deposits

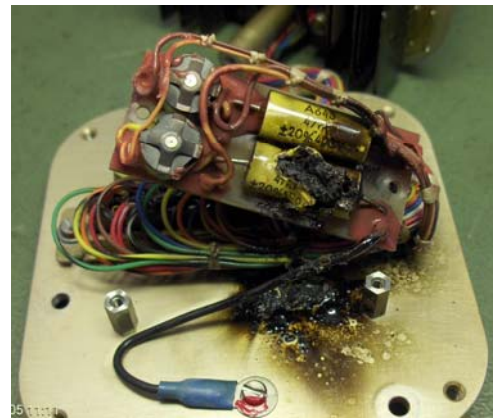
Burned capacitor and wiring

The incident was caused by a short circuit in the left side altimeter.
