## ***Report RL 2007:20e***

**Accident to the aircraft SE-GAV  
at Norra Djurgården, Stockholm, AB county,  
on 12 April 2007**

Case L-05/07

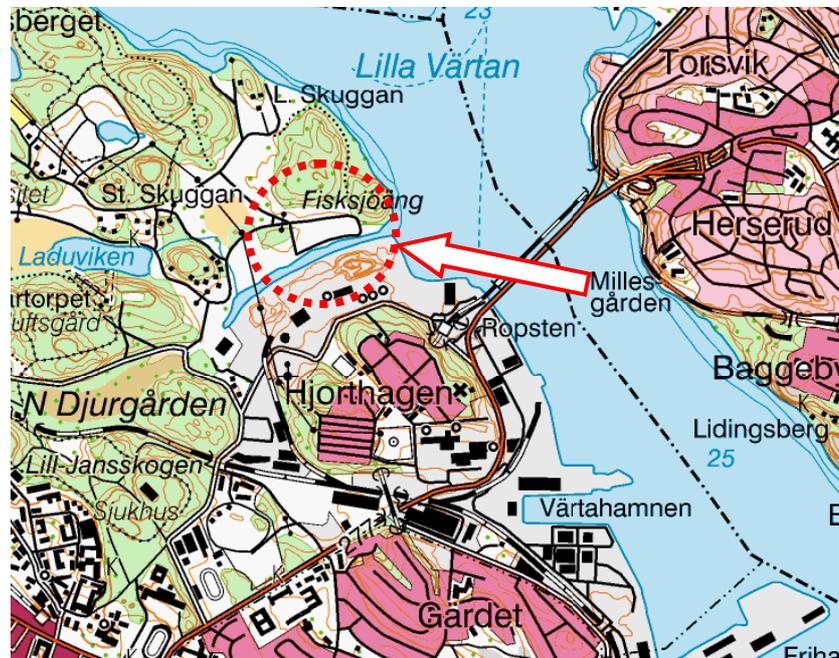
*Approach*

The aircraft was landed on an open field, approximately 100 x 300 m., between a channel and rising ground (see map). The undulating surface had a growth of unmown meadow grass. The direction of approach was approximately 280°.

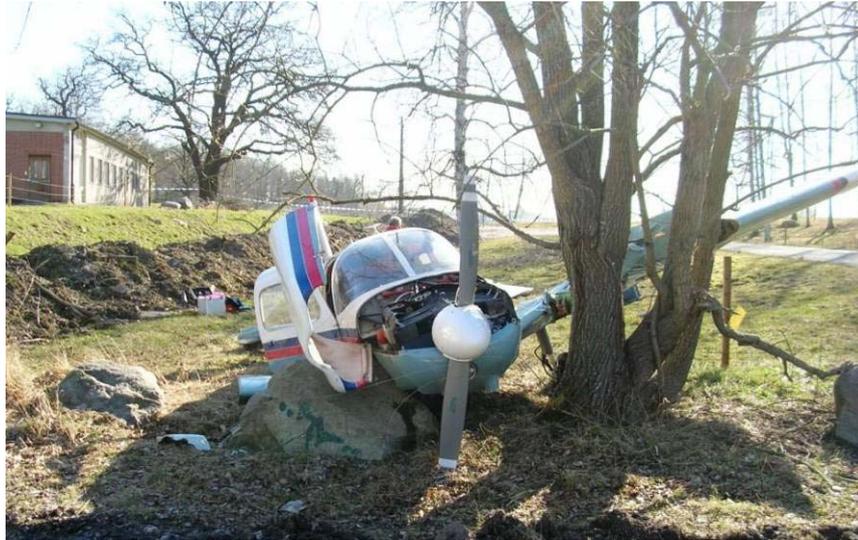
*Accident site*

The entire right wing of the aircraft was broken off by impact with a tree after which the aircraft skidded a further 10 m before being stopped by an outcropping rock and another tree.

Apart from the loss of the right wing, the aircraft suffered considerable damage to the left wing and the fuselage.

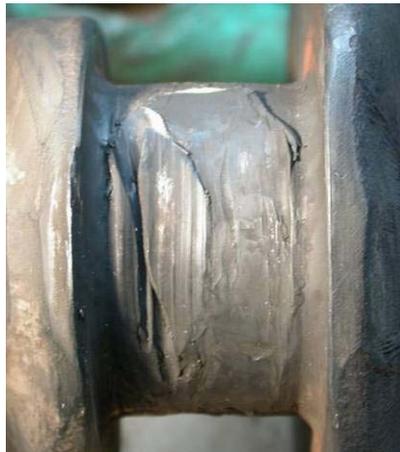
*Bearing race no. 2*

The internal damage to the engine was so extensive that it was not possible to dismantle it in the normal way. After the dismantling, it was seen, inter alia, that the cap on connecting rod no. 2 for the crankshaft bearing had fractured. Parts of the connecting rod had caused extensive damage in the crankcase.

All of the crankshaft bearing surfaces for the connecting rods were dry and had been overheated and deeply scored. Some of the bearing material had melted and been pressed out between the crankshaft and the connecting rods. The no. 2 bearing race had been damaged extensively (see photo below).

Aluminium fragments in the lubrication system, insufficient lubrication and cooling are therefore the probable explanation to the seize of the crankshaft bearings and the final overheating and failure of the connecting rod in cylinder no 2. A factor contributing to this failure may have been the defect in the oil supply channel to the bearing. This defect may have restricted the oil flow thereby reducing its lubricating and cooling effects.

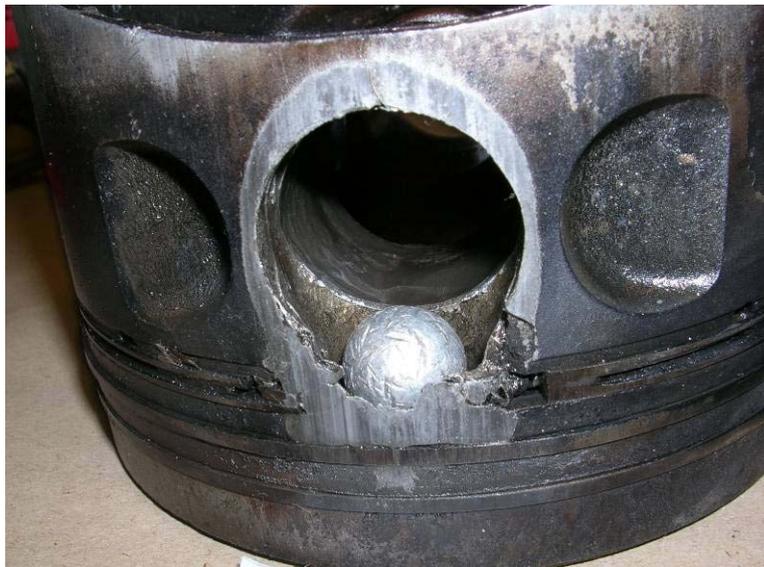
The outer part of one of the two aluminium plugs in piston-pin no. 4 had broken loose. This had had then, during operations, mechanically worn a cavity in the piston-pin hole and itself been formed into a spherical ball (see photo on next page).

*Piston no. 4 with part of plug*

It has also been found that part of an aluminium plug to piston-pin no. 4 had broken away and lodged in the space between the piston-pin and the cylinder wall. It has there, during the operation of the motor, "bounced" backward and forward, mechanically abrading the piston. The damage to the piston and the form of the loose plug section indicate that it had broken away on a previous occasion and that the damage was caused progressively during a number of hours of operation before the engine failure.

This document requires the replacement of piston-pins in this type of engine with a new version as soon as the engine has been dismantled for any reason.

The piston-pins in the engine concerned were of the earlier type and, according to Service Instruction No. 1340A, were to be replaced during the next overhaul with piston-pins of a different design, reducing the risk of the type of damage causing the accident.

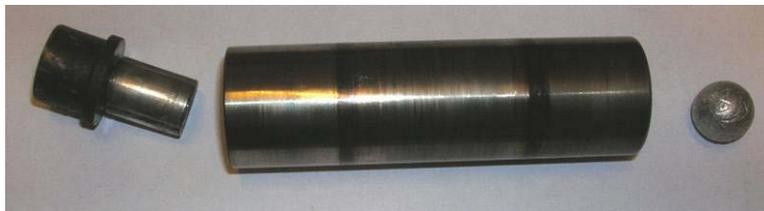
*Piston-pin no. 4 with plugs*

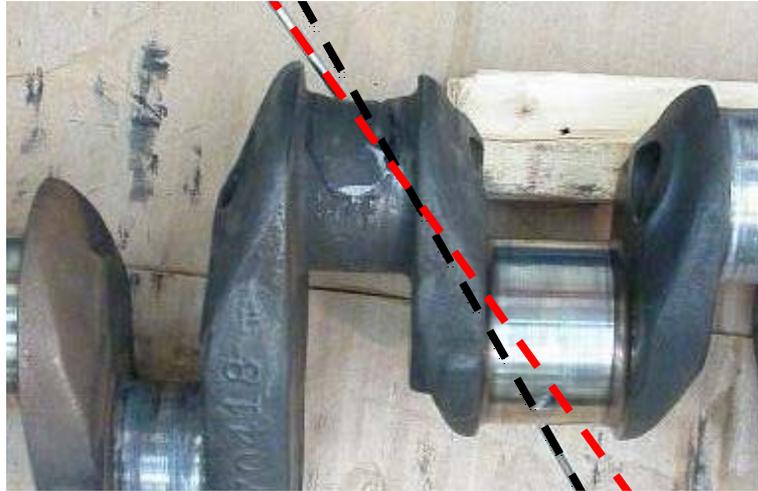
An inspection of the crankshaft showed that the oil supply channel to crankshaft bearing no. 2 had a manufacture defect. The hole was drilled from two sides. The holes did not meet in the centre and were not lined up.

*Directions of two drill holes in the crankshaft*

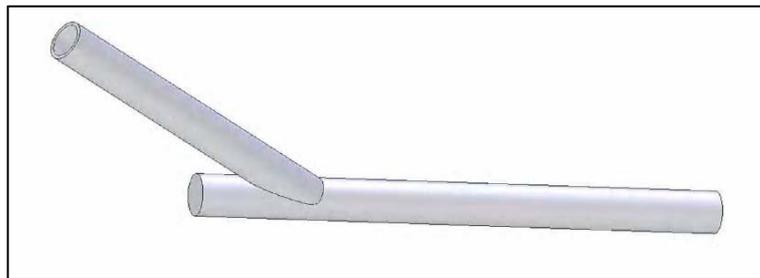
*Principle drawing of the manufacturing fault*

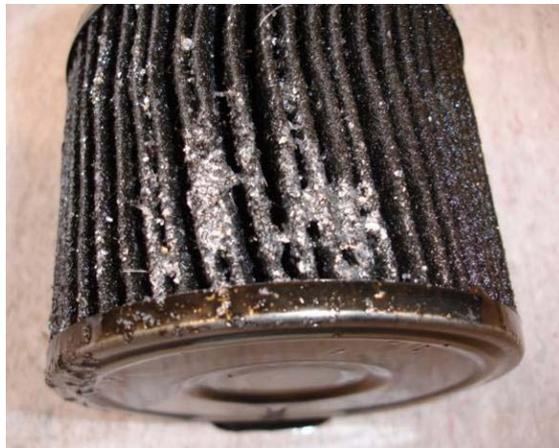
*Oil filter*

A considerable volume of aluminium fragments was found in the bottom of the oil filter container and on the filter cartridge.

The oil filter was to a great extent clogged by the aluminium fragments. It is therefore very likely that the pressure differential over the filter may have been so great that its bypass valve opened partially and allowed oil containing aluminium fragments to pass into the engines lubrication system.
