Statens haverikommission
Swedish Accident Investigation Board

Report RL 2007:03e

**Incident involving aircraft TC-AAP
at Skellefteå airport, AC county,
on 3 May 2006**

Case L-10/06

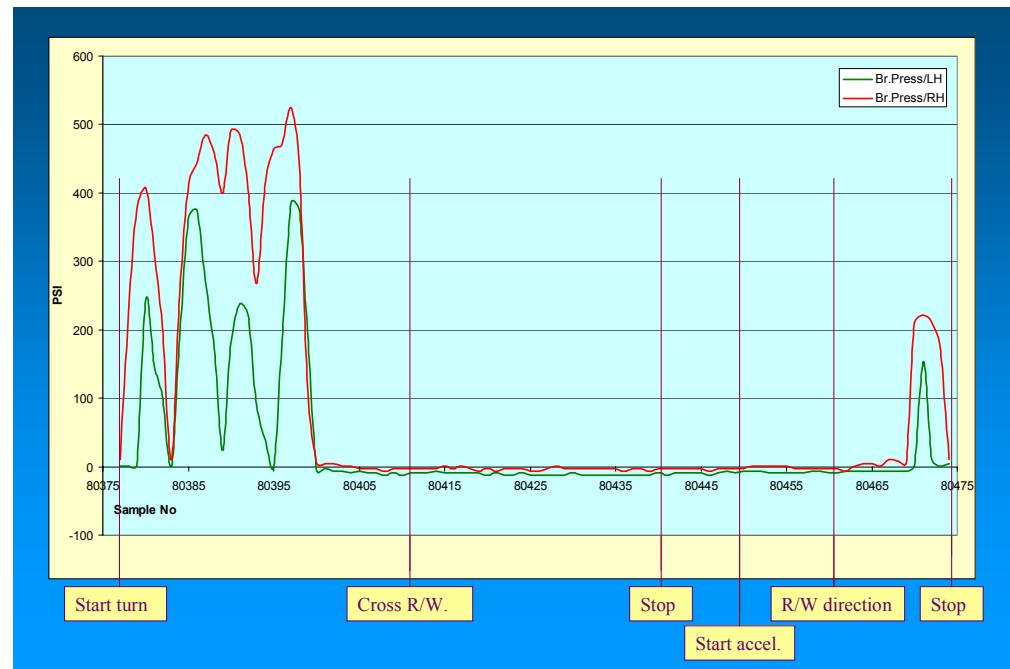
Brake pressures in the left and right brake systems

Immediately before the aircraft left the runway, the pilot applied the wheel brakes, but it is evident from the diagram in section 1.11 that the brakes were applied too late and that the braking pressure was too low for this to prevent leaving the runway.

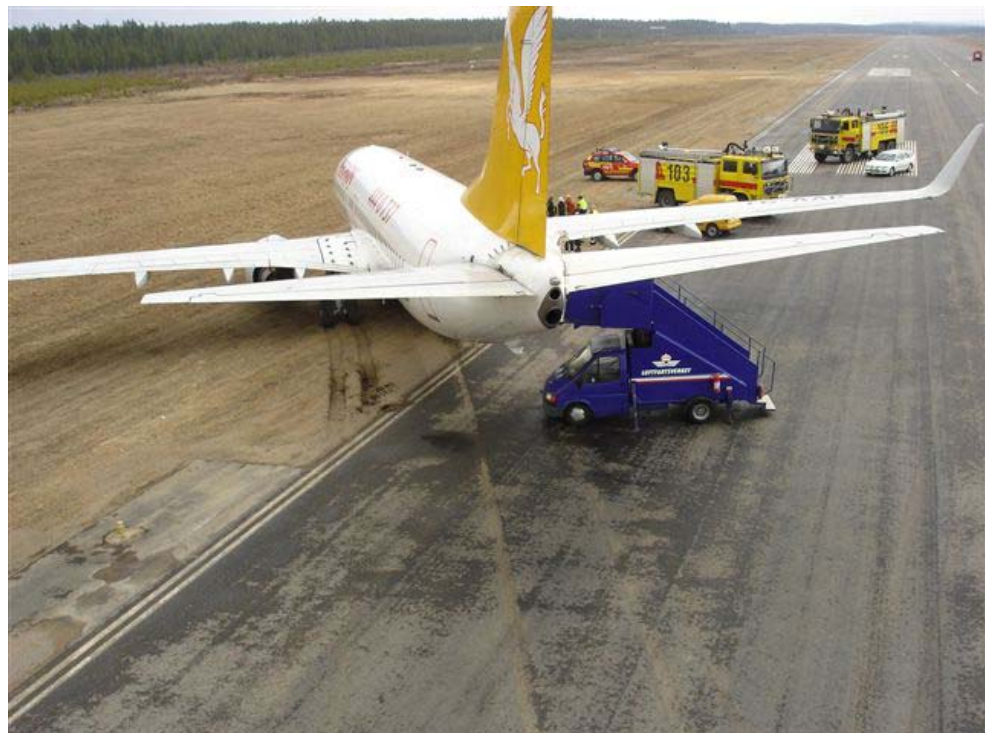
Marks on the runway showed that the aircraft nosewheel was about four metres to the left of the centreline when acceleration began. The aircraft then moved to the left, and finally finished up with all wheels off the left edge of the runway. The nosewheel ploughed a ten metre long and about 30 cm deep furrow in the ground before the aircraft stopped.

The nosewheel markings, partly on the asphalt, and partly on the ground beyond the edge of the runway, showed that it had “jumped” or “skidded”, which indicates that it had been positioned at a large angle in relation to the direction of the aircraft. No clear signs of braking could be seen.
