Statens haverikommission
Swedish Accident Investigation Board

Report RL 2007:11e

**Aircraft incident to SE-LNX
at Luleå/Kallax airport, BD county, Sweden,
on 13 October 2006**

Case L-29/06

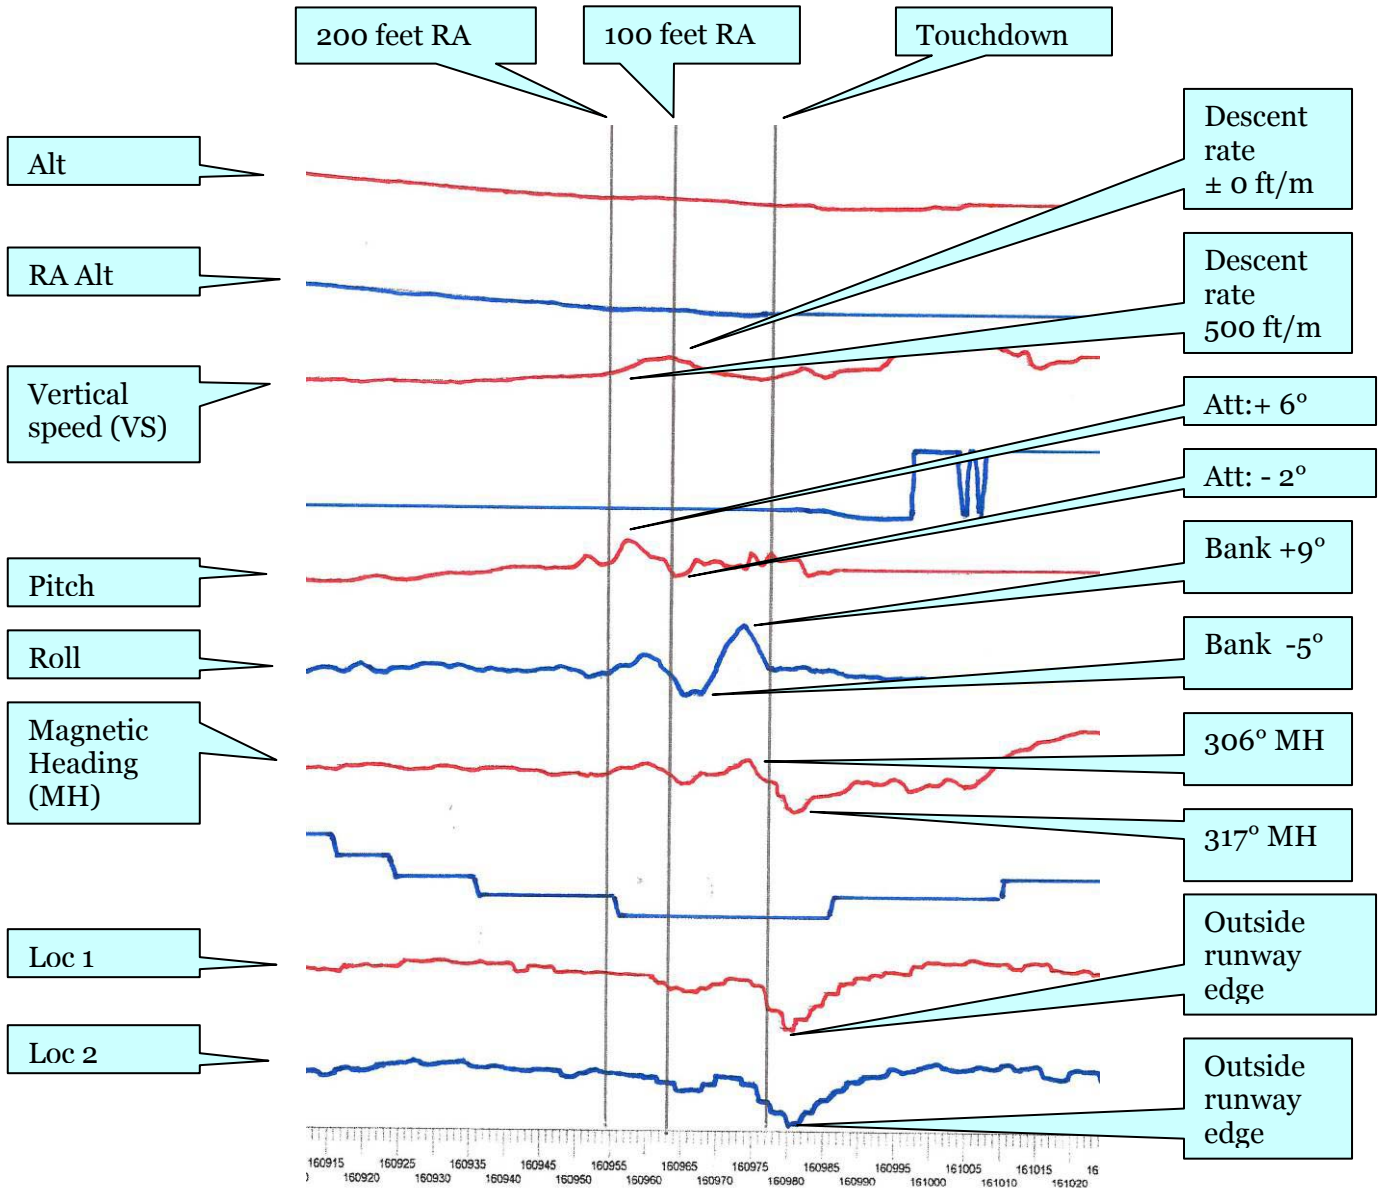
Fig 1. Flight information parameters from the FDR.

The printout shows that there were very large variations in the aircraft attitude and pitch during the final part of the approach, down to touchdown. The FDR recorded a strong deviation of heading to the right, starting at about 30 feet height, until about five seconds after touchdown.

The FDR printouts show that the final part of the approach was not stabilised, and that there were large fluctuations at low height in respect of both pitch and roll. From about 200 feet height, when the autopilot was disconnected, the heading varied by more than 10° until touchdown, which is a remarkable heading deviation when landing in 550 m RVR. The pilots stated that the engine powers differed at similar throttle lever positions, and that this was the reason for the unstable approach.

On the reduction of power to flight idle, which took place at 50-25 feet height, the difference in engine power reduced. SHK finds it probable that the pilot, in connection with the power reduction, did not reduce the amount of rudder to less than had been necessary earlier, with the result that the aircraft, as power reduced, began to move to the right. According to the FDR the misalignment with the runway began at a height of 30 feet.

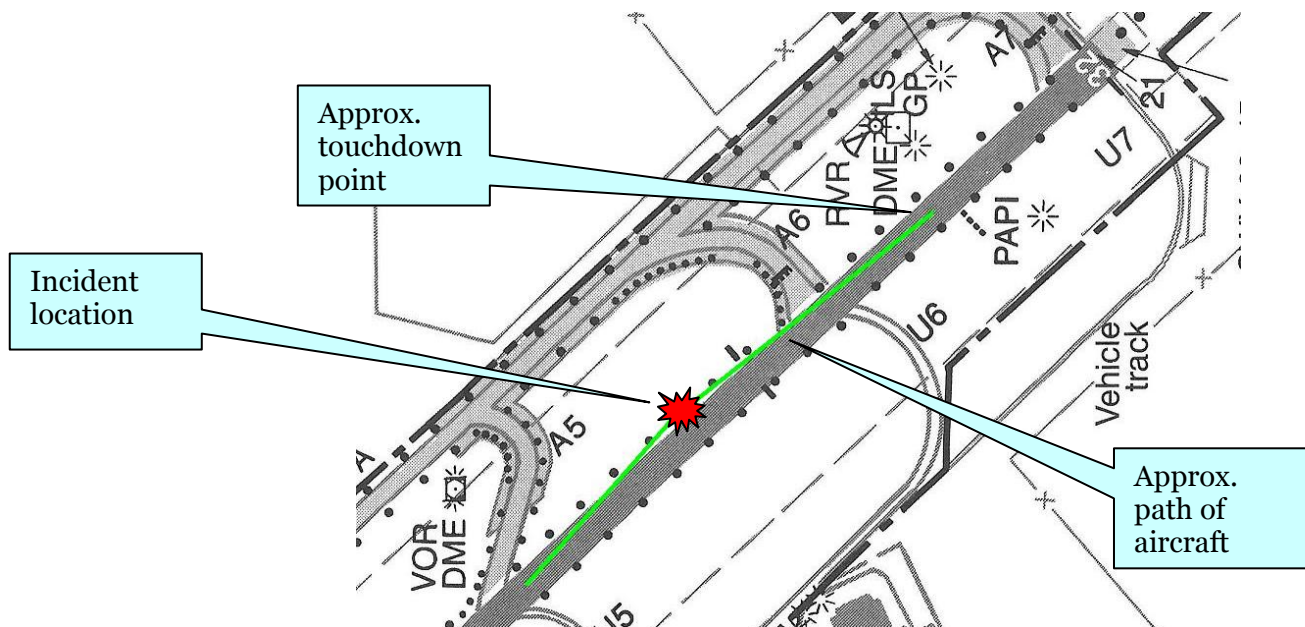
Fig 3. Luleå/Kallax airport, runway 32.

The runway edge lights at Luleå/Kallax airport are 4 metres away from the asphalt-covered edge of the runway. At the time of the incident, as far as SHK can ascertain, no application had been sent to the supervisory authority for a dispensation.

At Luleå/Kallax there were no centreline lights on the runway, which probably contributed to the pilots realising too late that the aircraft was far out to the right of the runway centreline. The fact that the edge lights were located four metres beyond the edge of the runway may have contributed to the pilots not realising in time that they were too close to the runway edge.

After the incident an application was sent in from Luleå/Kallax airport to the Swedish Civil Aviation Authority requesting dispensation from the BCL F requirements. The application was received on 31 October 2006. It was approved and issued by the Swedish Civil Aviation Authority on 13 November 2006.
