Statens haverikommission
Swedish Accident Investigation Board

Report RL 2006:20e

**Aircraft accident to OO-DJN
at Gothenburg/Landvetter airport, O county,
on 10 March 2006**

Case L-05/06

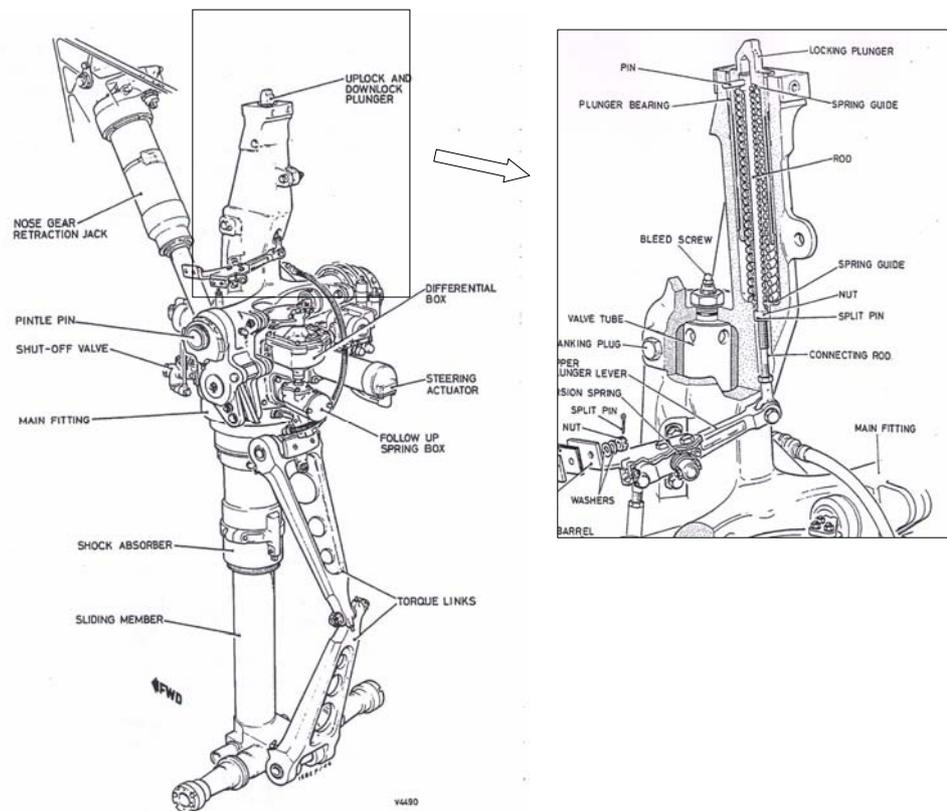
The plunger is spring-loaded to its locked (pressed out) position by means of a compression spring. At the end of the landing gear extension and retraction movements the plunger moves a small distance on a cam in front of each respective latch before, with the aid of spring pressure, it is pushed out to its locked position. Unlocking takes place by means of the locking plunger, with the aid of a linkage system connected to the landing gear hydraulic cylinder, being pulled into the landing gear leg so that it is released from the locking latch before the extension or retraction movement begins. (See the illustration below.)

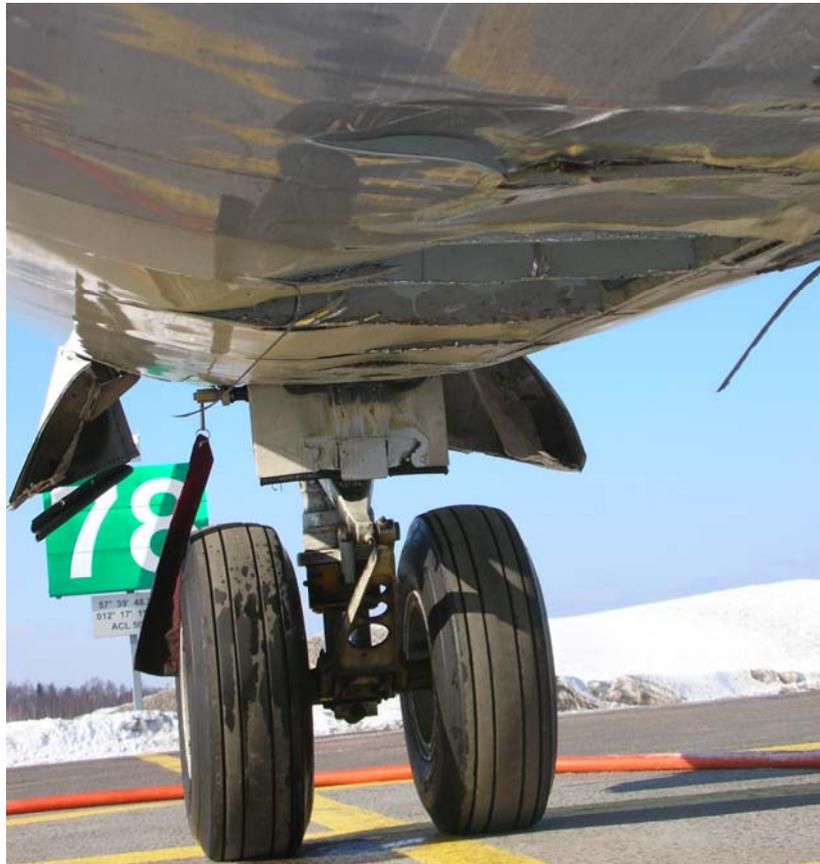
Extensive damage was caused, including damage to the underside of the cabin nose and to the nose landing gear doors.

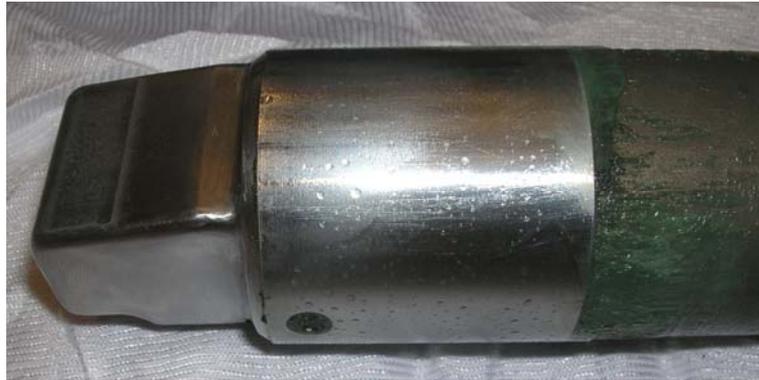
Plunger

Dismantling and inspection of the landing gear were carried out by the ordinary landing gear maintenance workshop in the presence of representatives of organisations including SHK (The Swedish Accident Investigation Board), the aircraft manufacturer, the landing gear manufacturer and the aircraft operating company. On dismantling the landing gear locking plunger water was found to be present on its sliding surfaces. There was very little lubricating grease on the plunger and its cylinder, and such grease as was present was discoloured and contaminated by water.

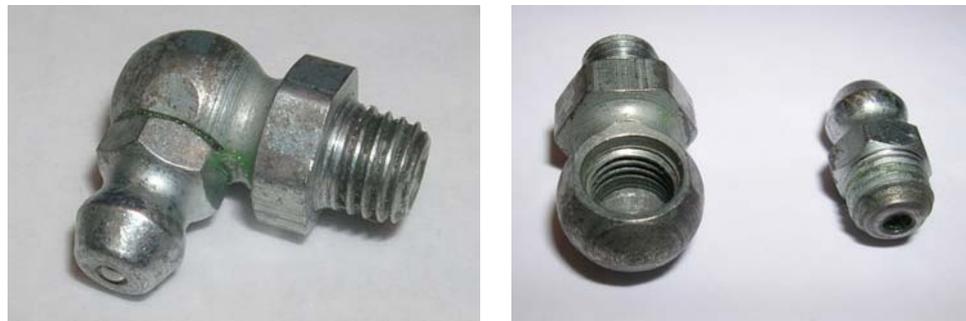
On closer examination of the lubricating nipple, MS 15001-4, which is attached to the landing gear leg, and through which grease to the locking plunger must pass, it was discovered that it had been incorrectly manufactured and had no hole for grease at all. (See the illustration below.)

The actual grease nipple

The accident was caused by seizure of the nosewheel locking mechanism as a result of a blocked grease nipple, which prevented correct lubrication.

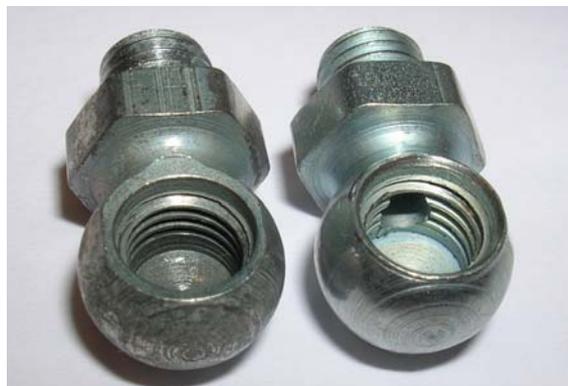
The actual grease nipple and a correctly manufactured grease nipple

At overhaul of the landing gear normally all grease nipples are replaced. The actual grease nipple was manufactured by the Alemite company and distributed via the Wesco or Valtec companies. It has not been possible to obtain any explanation for the incorrect manufacture.
