Statens haverikommission
Swedish Accident Investigation Board

Report RL 2006:23e

**Aircraft accident to helicopter SE-HVY,
south-west of Lundsbrunn, O county,
on 4 October 2005**

Case L-37/05

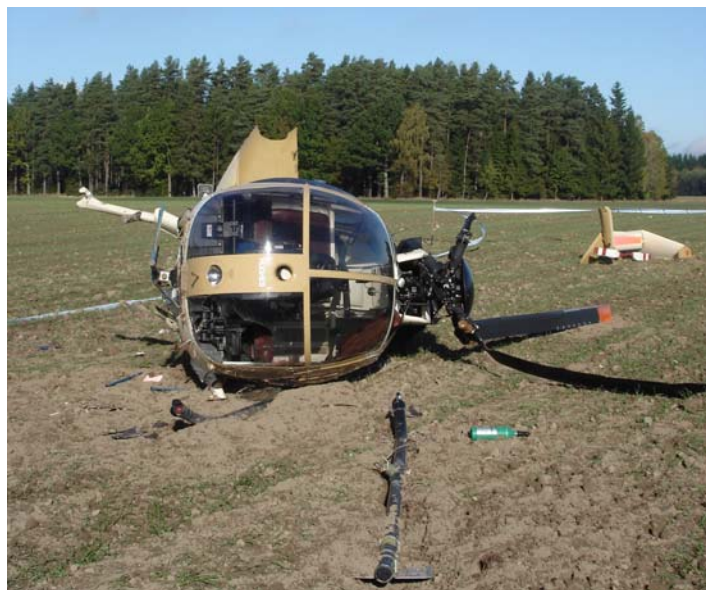
The landing gear was destroyed and extensive damage occurred to the helicopter structure. The tail boom was detached and all the main rotor blades were damaged.

Figure 1. Aircraft wreckage

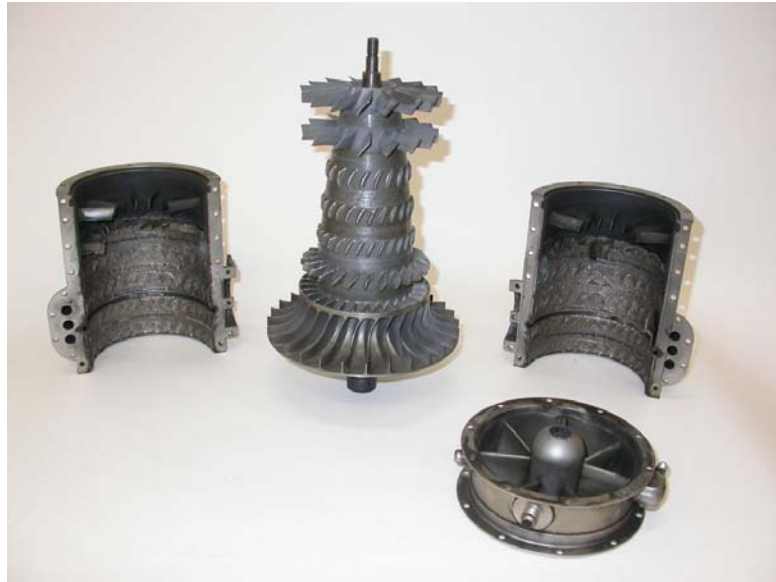
The engine was later dismantled at an authorised engine maintenance facility in the presence of representatives of the SHK and of the engine manufacturer, Rolls-Royce (advisor for the NTSB – National Transport and Safety Board – accredited representative). This revealed a failure in the engine compressor, with major damage to both the blades and the guide vanes, see Figure 2. In addition extensive resultant damage could be seen in the direction of flow. Slight traces of impacts by foreign objects on the front guide vanes and rotor blades could also be seen. Selected parts of the compressor were later subjected to metallurgical examination in a materials laboratory under the guidance of SHK and in the presence of the manufacturer's representatives. The results showed that the failure began with a fatigue fracture present at the root of one of the blades in the third compressor stage, see Figure 3.

Figure 2. Principal parts of the compressor after dismantling.

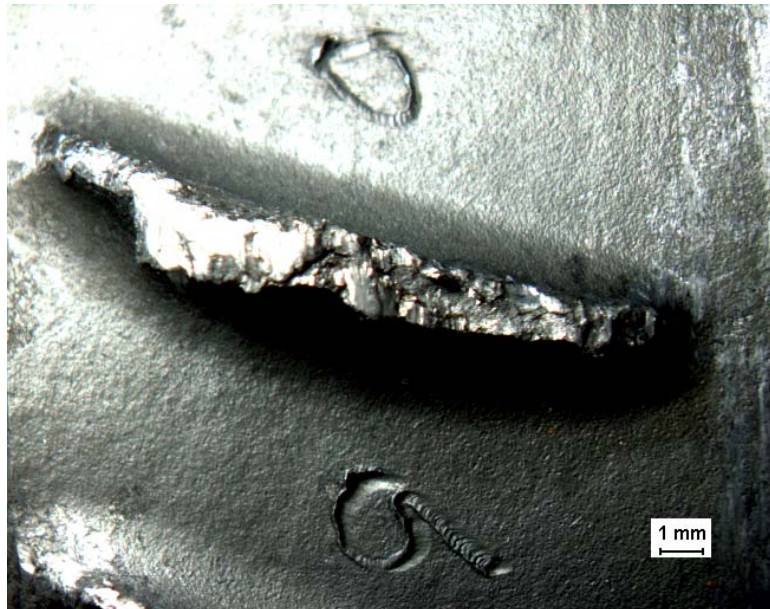
Figure 3. The root of the third stage compressor blade showing the fatigue fracture.

Closer examination under an electron microscope revealed a small corrosion mark there and at other locations close to the blade roots. These appeared as very small holes in the aluminium-based coating on the surface of the rotor. In some cases they extended more deeply into the rotor base material. This coating is intended to act as a sacrificial anode and thereby protect the rotor material from corrosion. If necessary it can be replaced by a new coating.

The technical inspection of the engine showed that the engine stopped due to compressor failure, probably as a consequence of a blade breaking in the third stage. The investigation indicates that the blade failure was in turn caused by high cycle fatigue originating from a fatigue crack that was initiated by corrosion close to the blade root. Extensive subsequent damage made it difficult to assess the status of the remaining blades.

- suitable measures are taken to inform operators using this type of engine of the risk of blade corrosion and the importance of regularly washing the compressor in accordance with the manufacturer's recommendations (*RL 2006:23e R1*).
