***Report RL 2008:12e***

**Accident to aircraft SE-FYK at Nyckelsjön, D län  
(Södermanland county), on 7 June 2008**

Case L-10/08

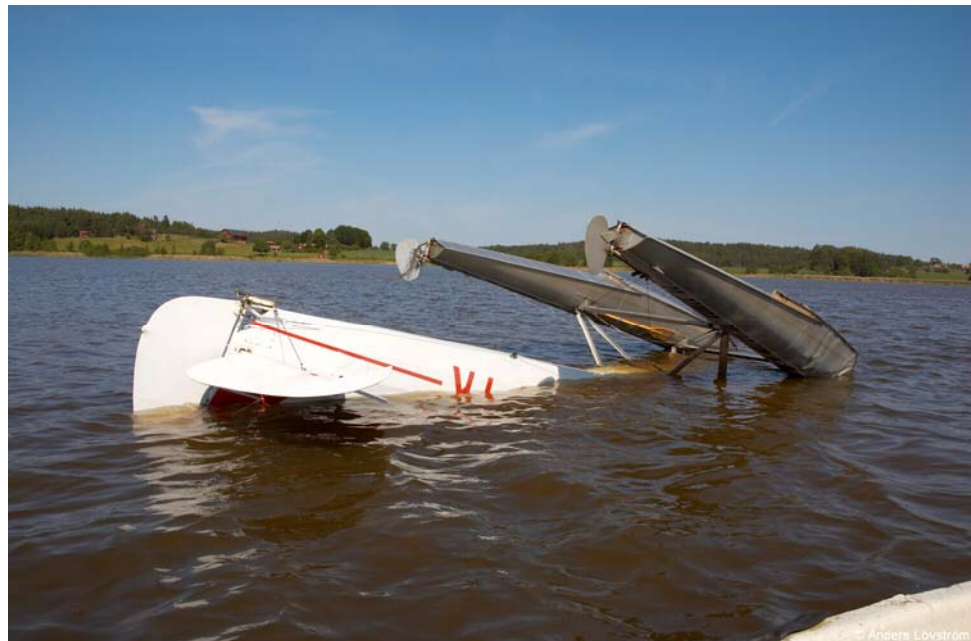
According to the pilot, after the collision the aircraft stood vertical on the bottom of the lake, balancing on the tips of its floats. The depth of water at impact was about 1.5 m. Both on board were uninjured and were able to leave the aircraft. Soon afterwards the aircraft tipped over and ended upside down supported by the wings, resting on the bottom. Both occupants inflated their life vests and by alternately swimming and wading reach the shore, about 500 m from the point of impact.
