Rapport RS 2007:5

Olycka med fartyget MT PROSPERO i Milford Haven, Wales, Storbritannien, 2006-12-10

Report on the investigation of
the loss of control of product tanker

Prospero

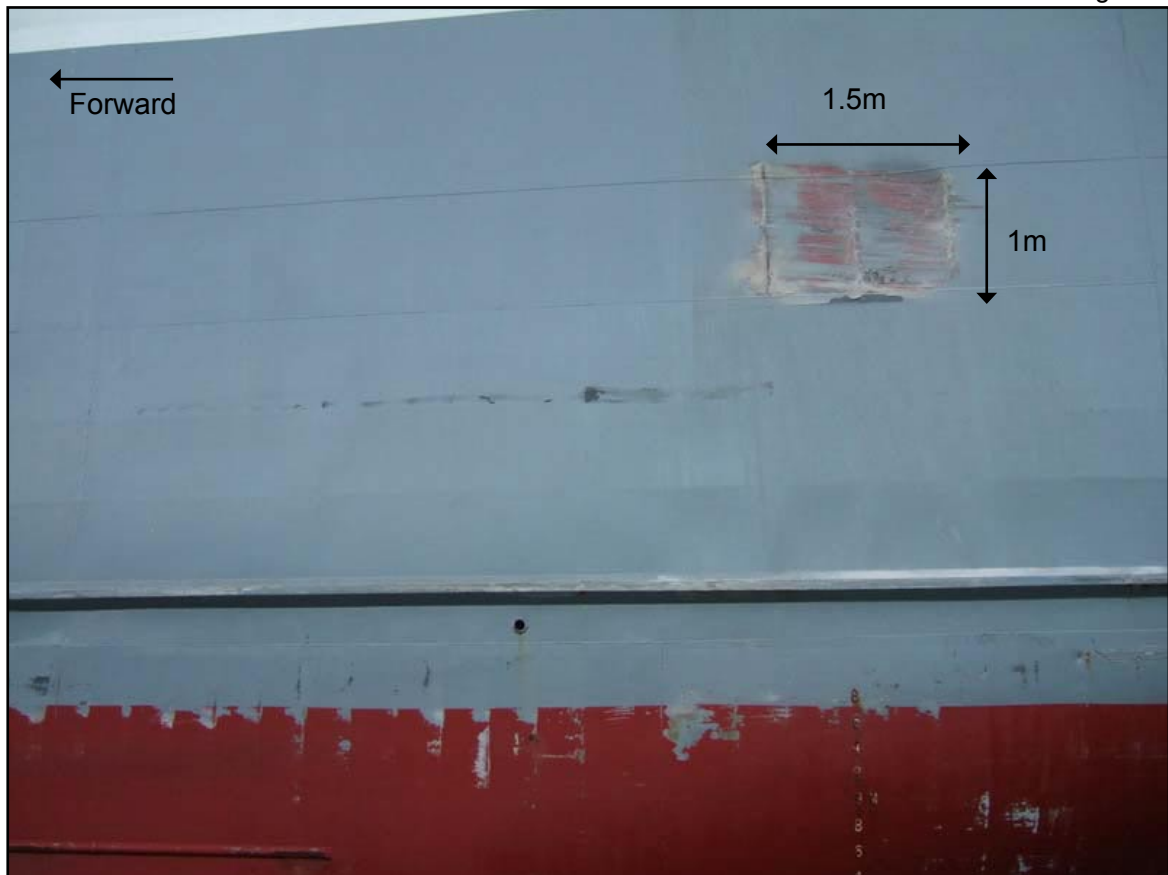
Figure 2

Damage to port quarter of *Prospero*, by jetty edge capping

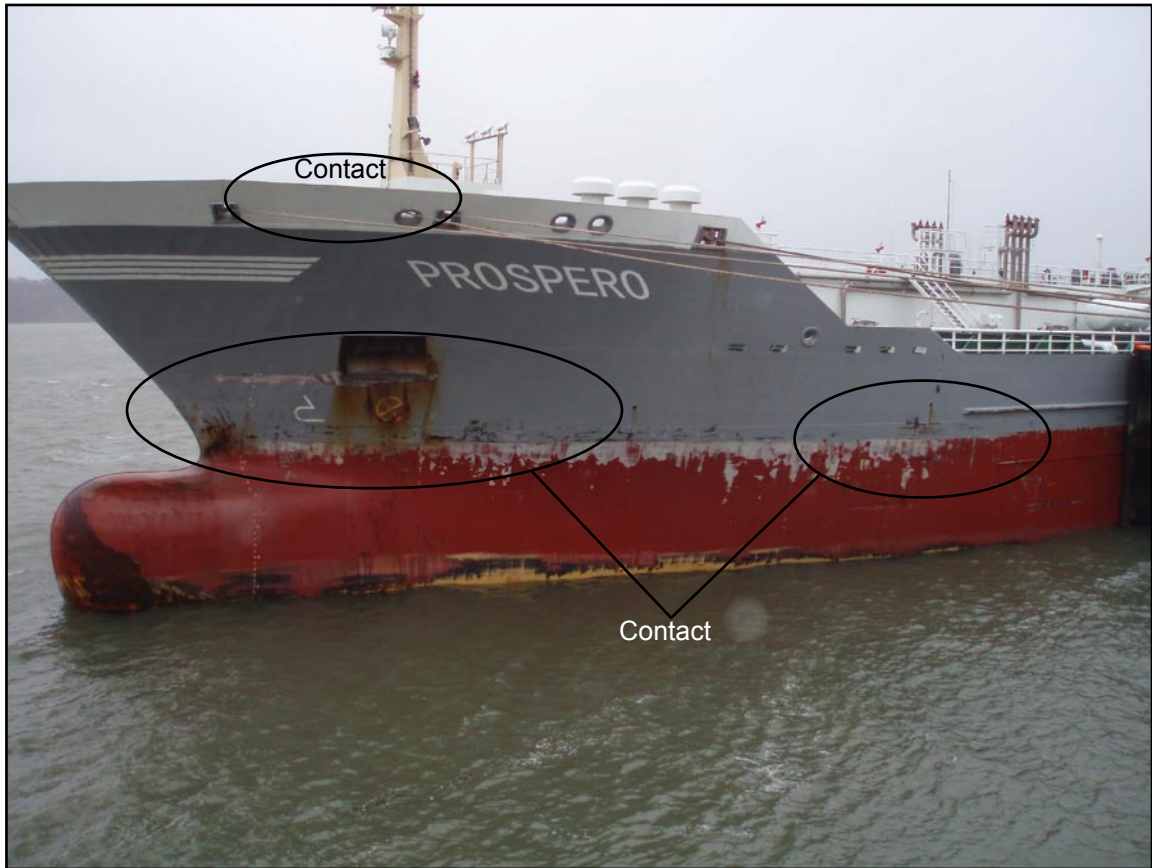
Figure 3

Bow of *Prospero*, showing damage by jetty and gantry

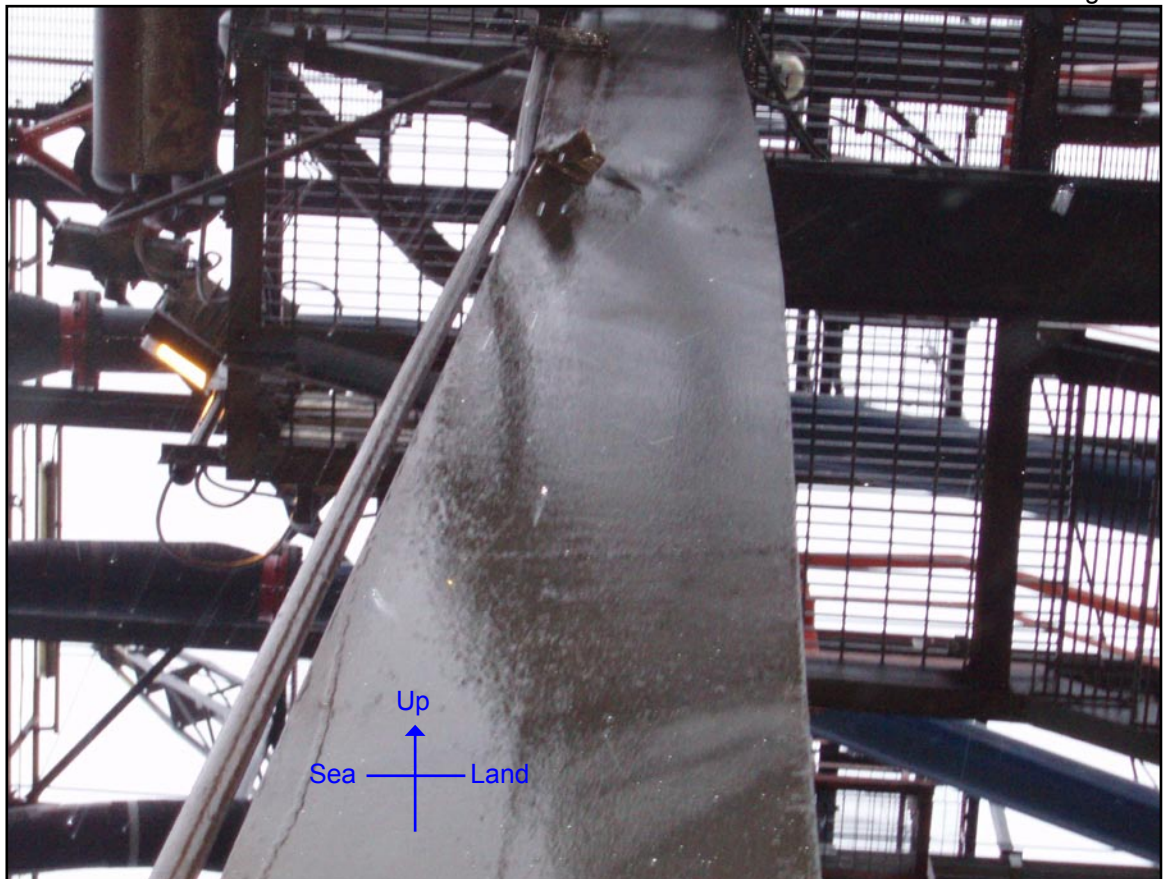
Figure 4

Damage to loading arm gantry, by bow of *Prospero*

The jetty was originally designed for vessels of up to 165,000 DWT, but due to the extent of the damage caused by the contact, it was necessary to impose a long-term restriction on this berth limiting the berth's capacity to 100,000DWT.

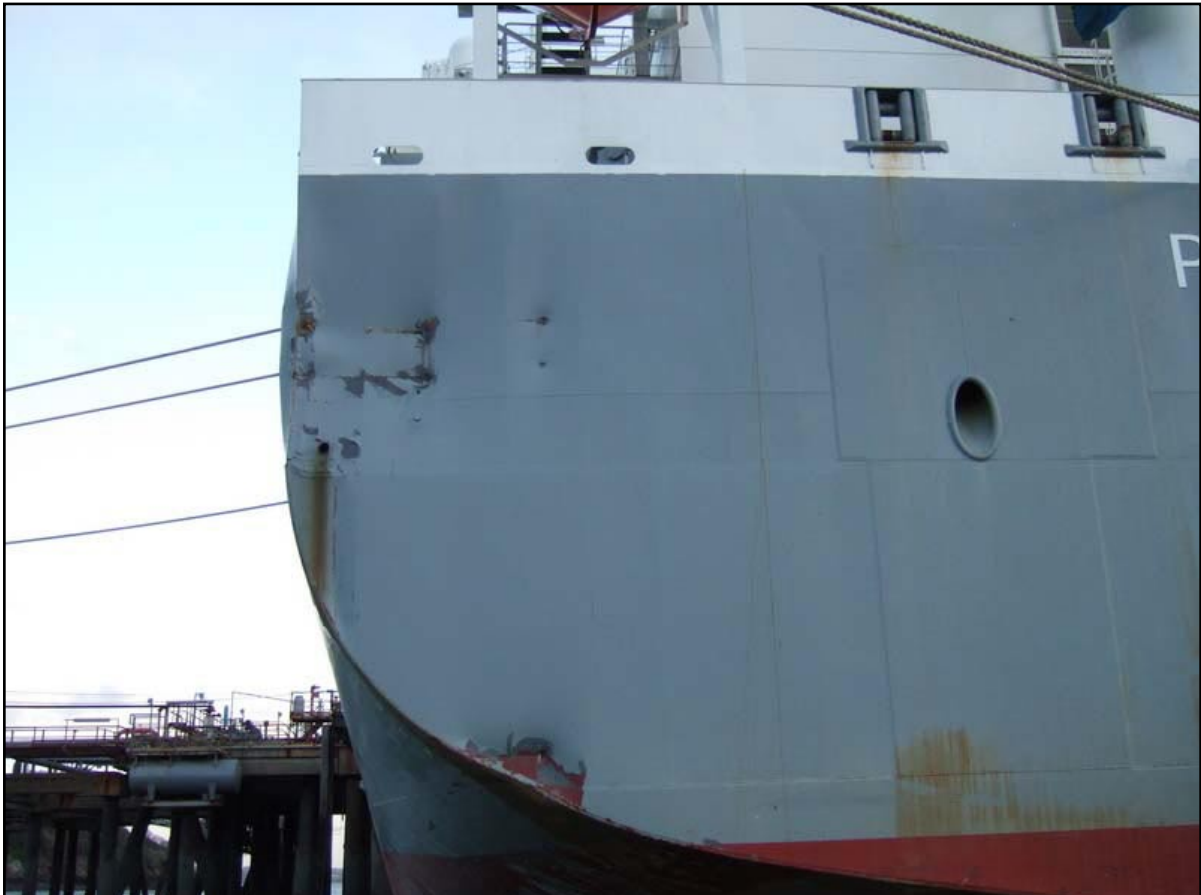
Figure 5a

Shortly after this second, undemanded, application of power, the vessel's port quarter made heavy contact with the first of the mooring dolphins to the west of the jetty. She then continued moving astern to also make contact with the second dolphin, resulting in significant damage being caused to both the vessel and the mooring dolphins (**Figures 5a, 5b and 6**).

Damage to stern of *Prospero* by jetty dolphins, from aft.

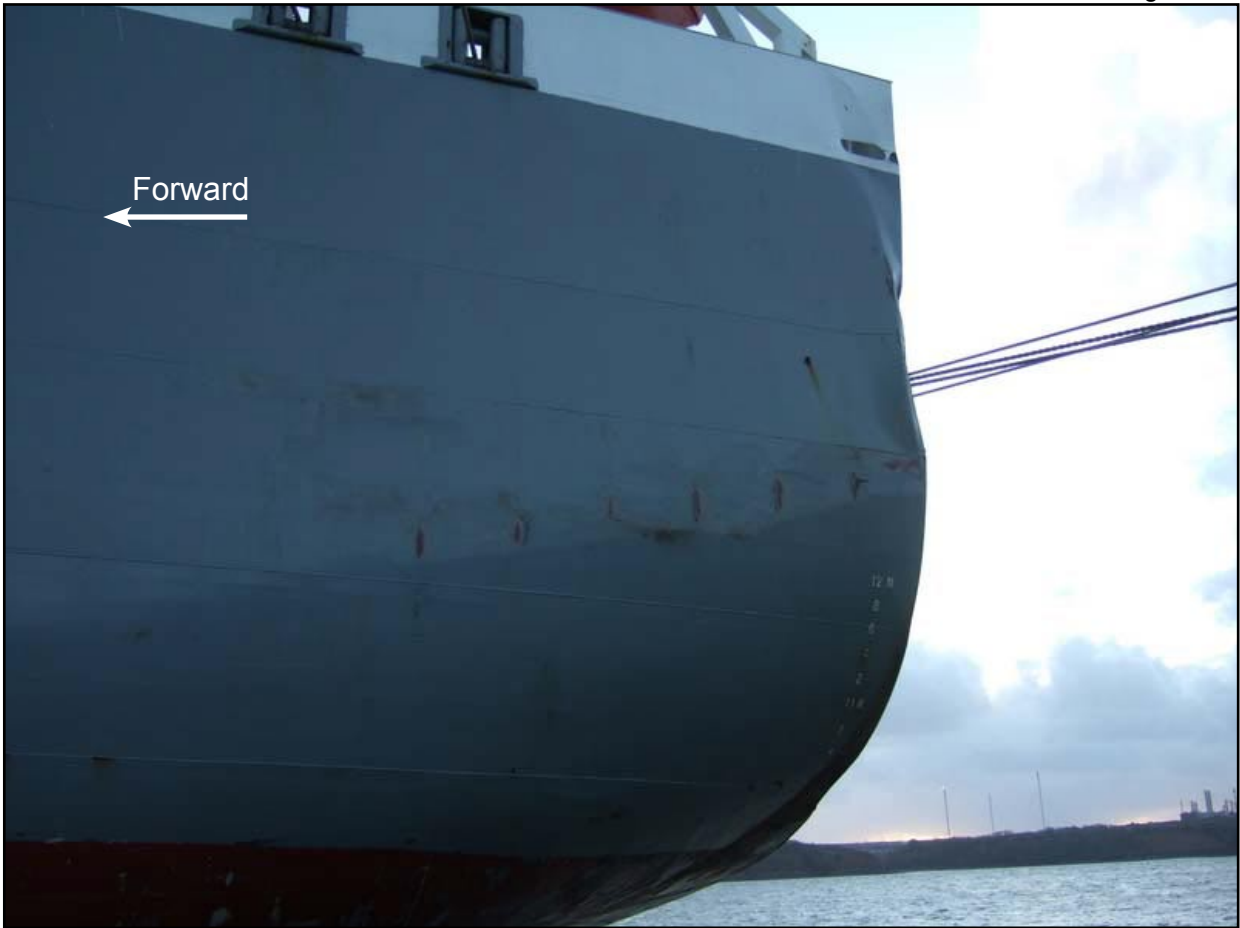
Figure 5b

Damage to stern of *Prospero* by jetty dolphins, from port side.

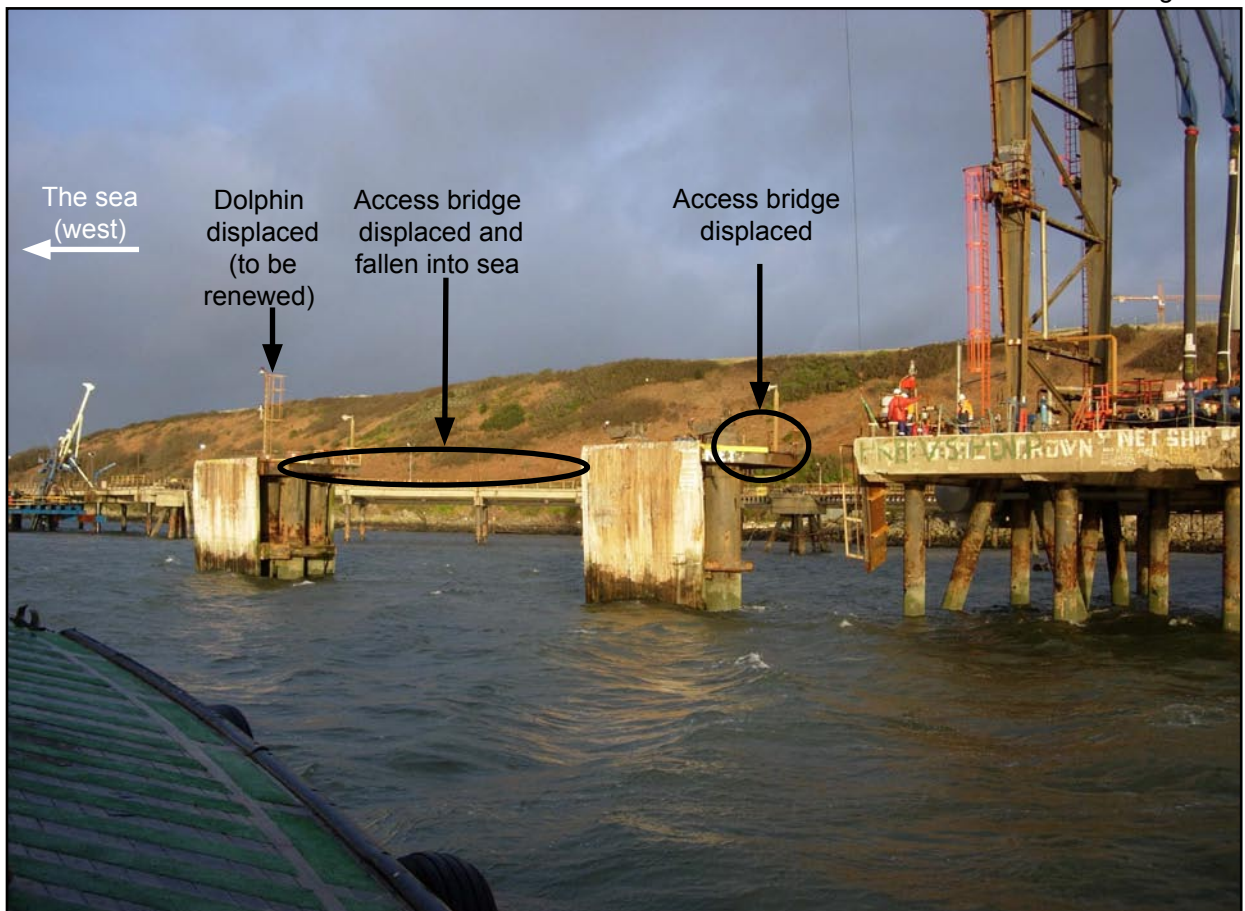
Figure 6

Damage to jetty dolphins, one displaced but attached, the other displaced and fallen into the sea.

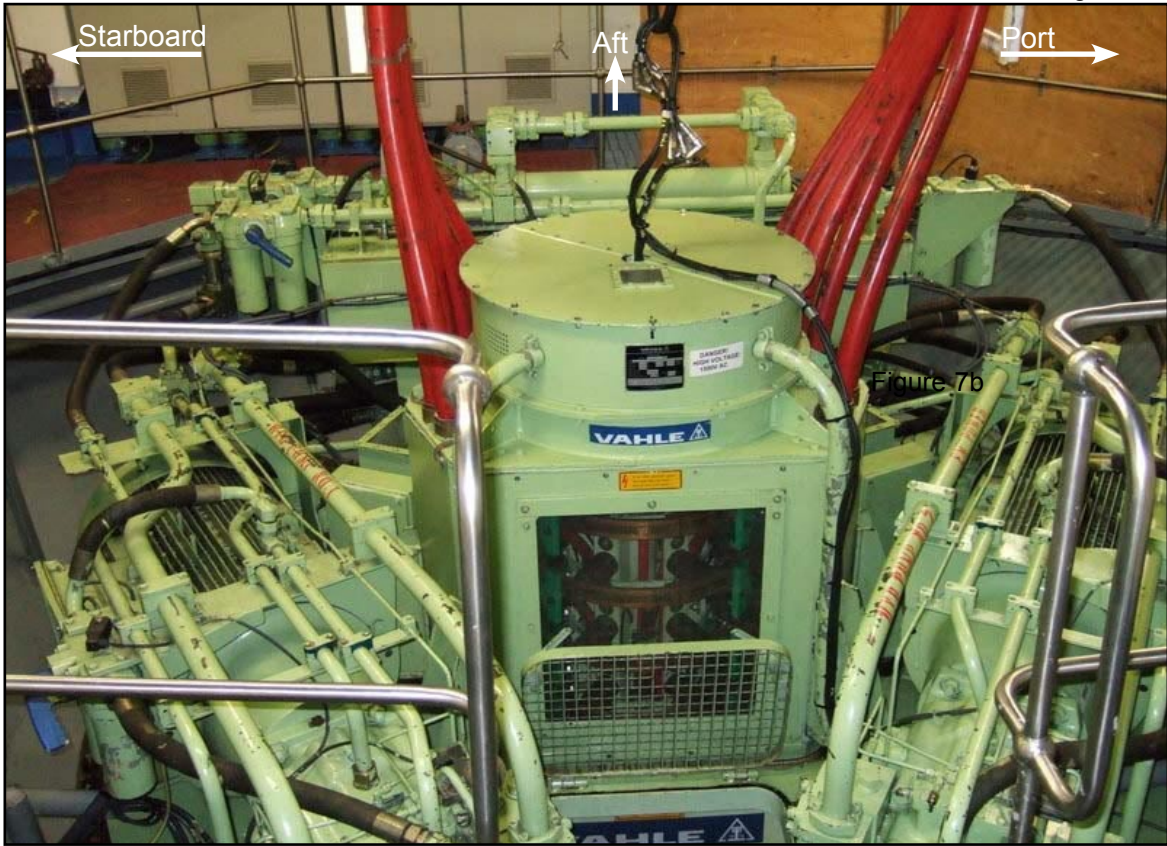
Figure 7a

The faulty unit (the gauss transmitter⁴) was sent ashore for repair but, because of a lack of available spares, it was necessary to effect temporary repairs to allow the vessel to continue in service. By using existing back-up arrangements and making temporary modifications to the wheelhouse control levers, service engineers adjusted the SSP control system; the result being a functional, but less versatile pod. Pod azimuth was limited to 180° either port or starboard of amidships; it was not possible to continuously rotate the pod through 360°, but power/speed control was not affected. A sea trial was made and, attending surveyors being satisfied (**Annex A**), *Prospero* continued to trade while awaiting permanent repairs.

Pod room showing the temporary gauss transmitter arrangements.

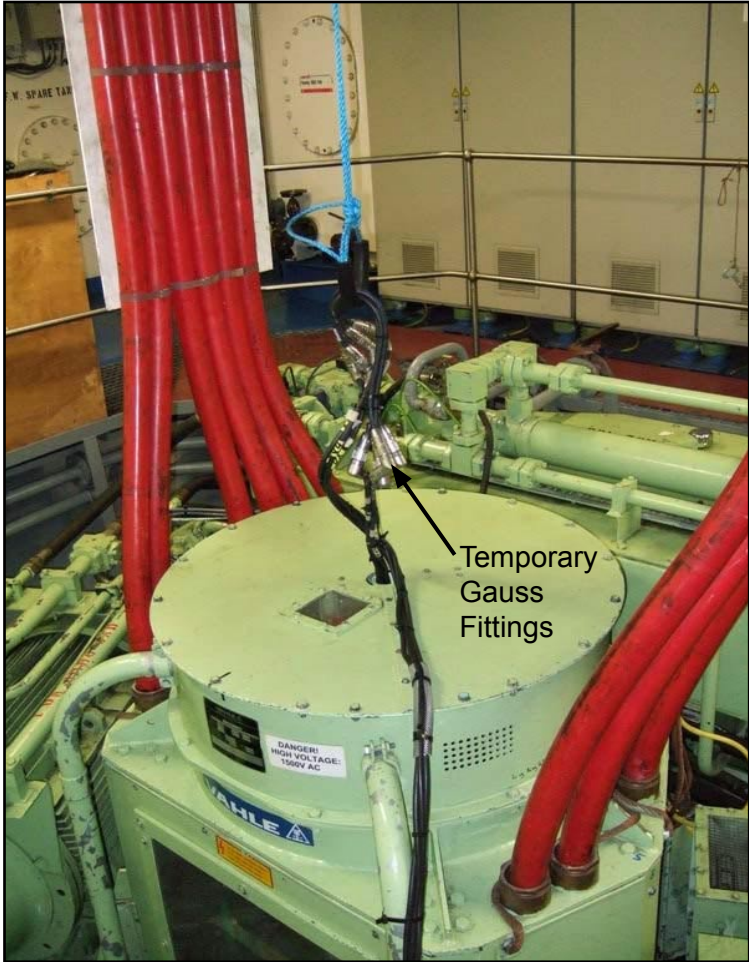
Figure 7b

Close-up showing the temporary gauss transmitter arrangements.

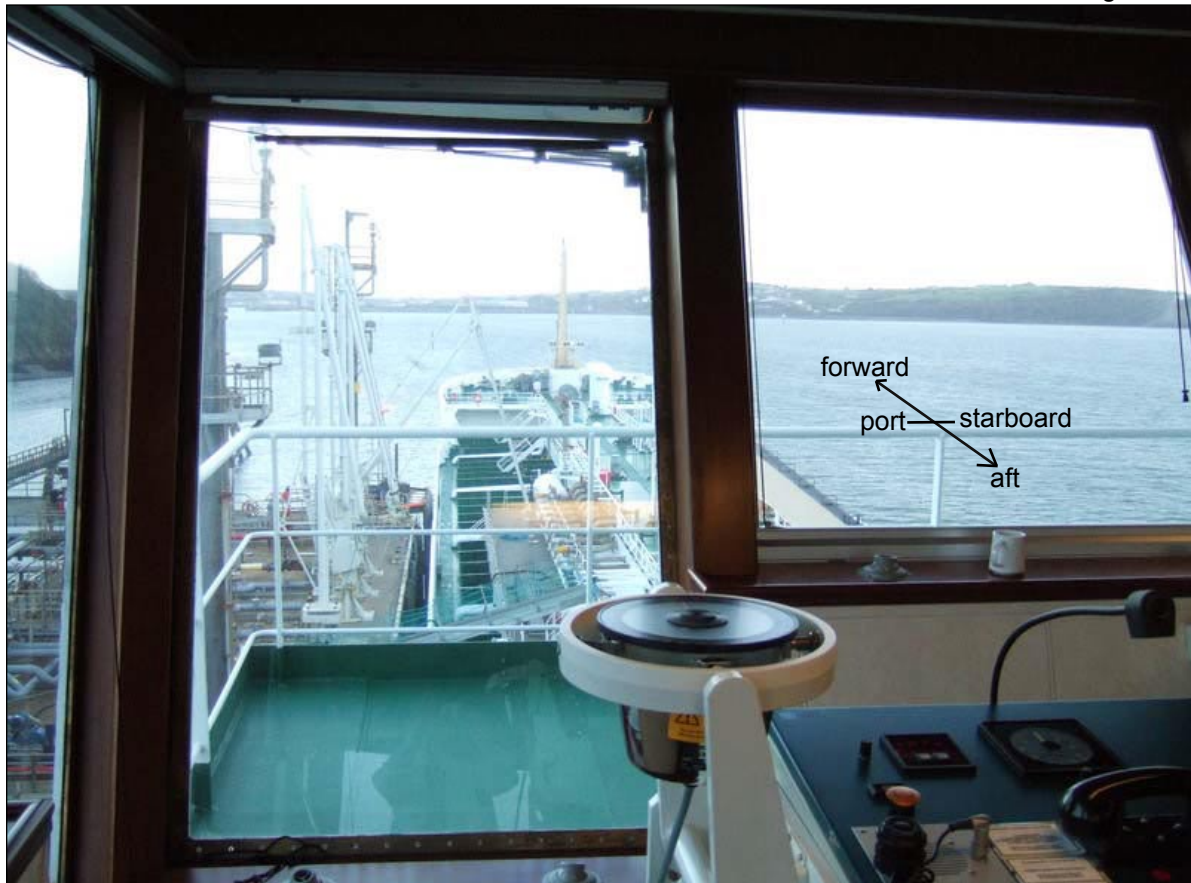
Figure 12

Visibility of the ship's side from the wheelhouse wing control consoles was restricted by the tops of the deckhouse below (**Figure 12**), and the person controlling the ship needed to move from the control console to the side windows in order to get a better view of the ship's side. This problem has been corrected on later vessels of the class.

Looking forward from wheelhouse port console, showing obstructed view.

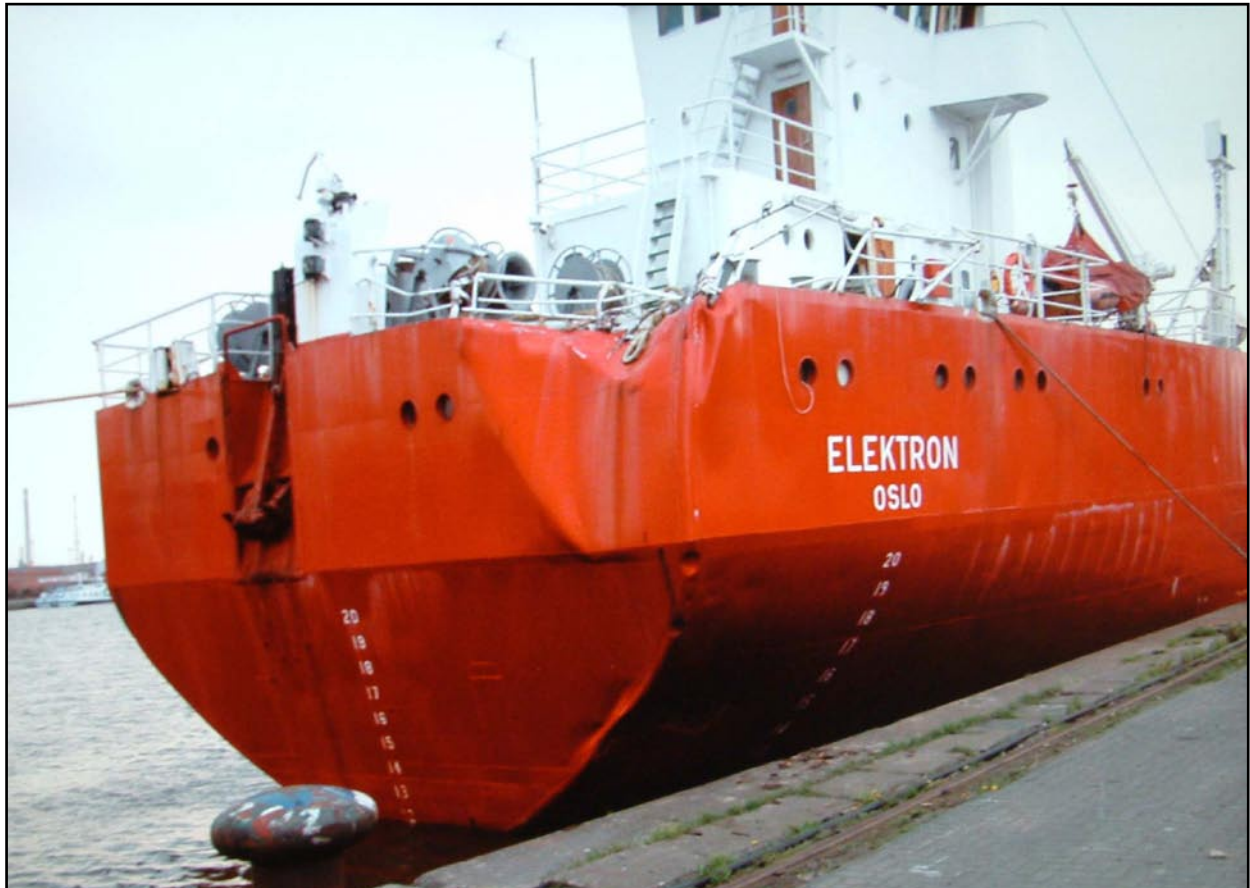
Figure 15

Damage to stern of *Elektron*, due to collision with bow of *Bro Sincero*

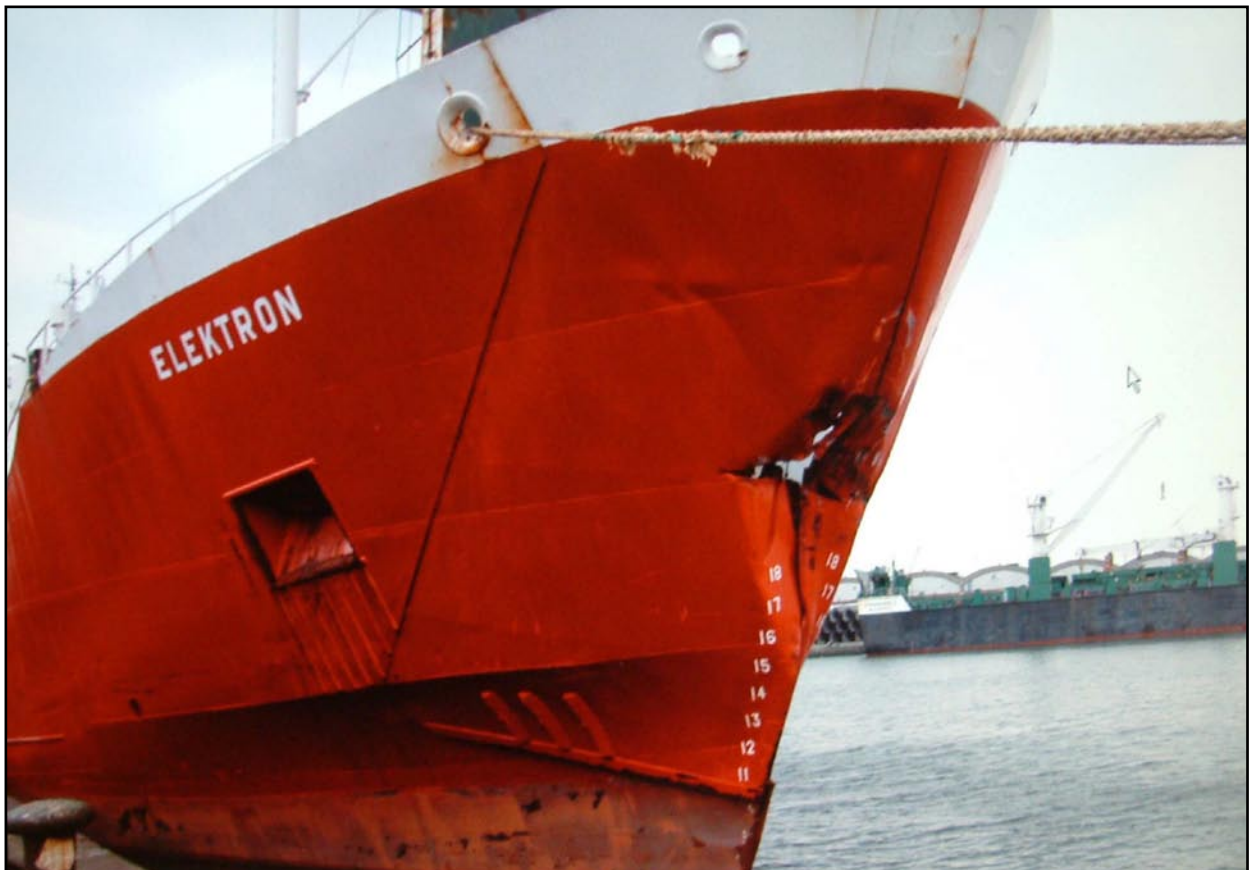
Figure 16

Damage to bow of *Elektron*, due to contact with lock gates.

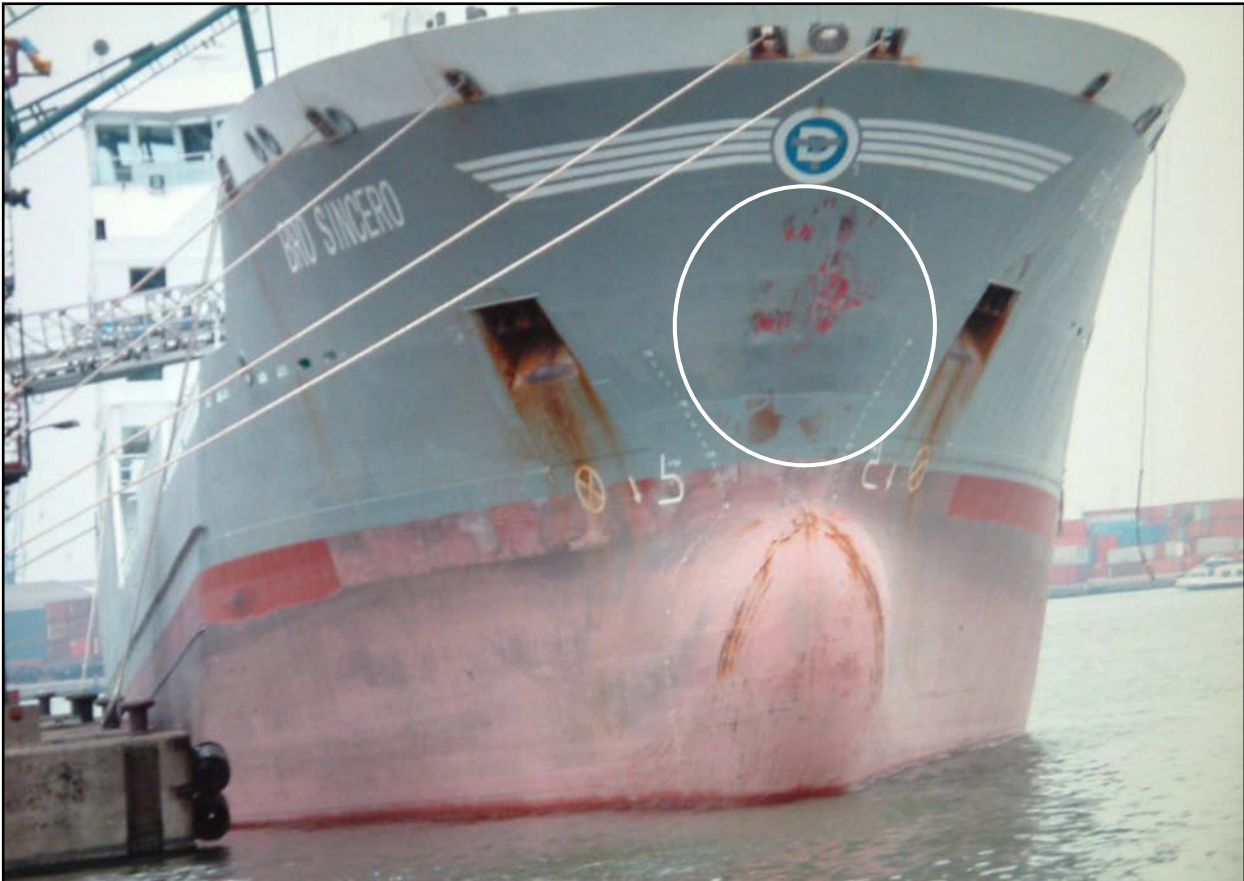
Damage to bow of *Bro Sincero*, due to collision with stern of *Elektron*.
