Statens haverikommission
Swedish Accident Investigation Board

Report RS 2005:03e

**Collision between dry-cargo vessel Joanna
and ro-ro passenger ferry Stena Nautica off
Varberg, N county, Sweden, 16 February 2004**

Case no. S-02/04

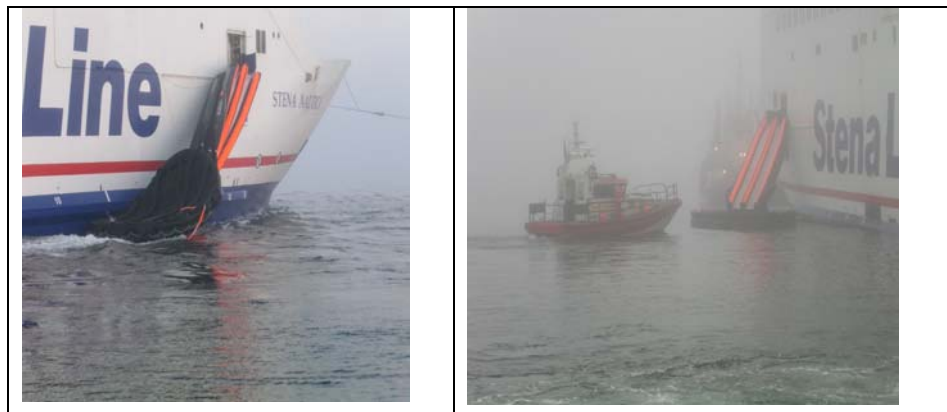
Starboard malfunctioning MES

The port side functioning MES

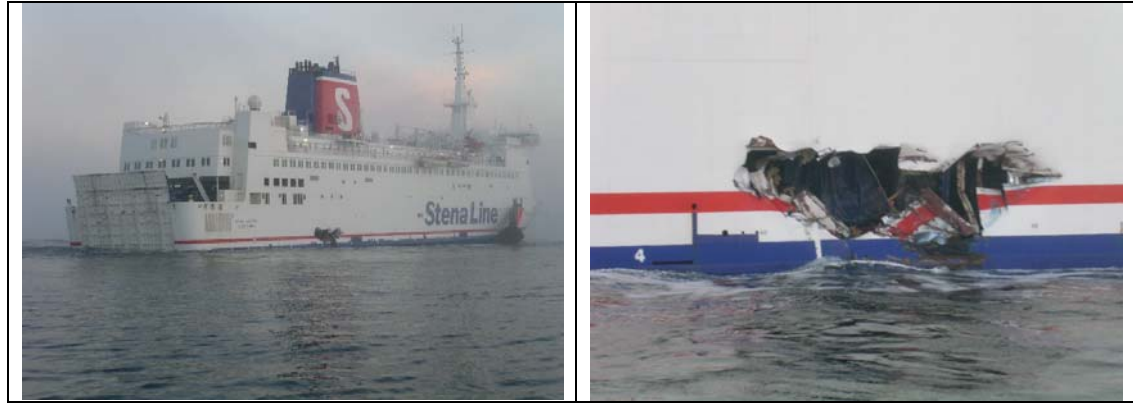
Stena Nautica was seriously damaged in the collision. Joanna's stem struck her side plating almost at right angles at frames 44-45 on the starboard side. Joanna's speed was approximately 7-8 knots and the collision was brutal but brief. The sharp part of the Joanna's stem was met by the heavy cargo deck of the ferry. The deck split about one metre inwards.

The upper part of the damage in to the cargo deck

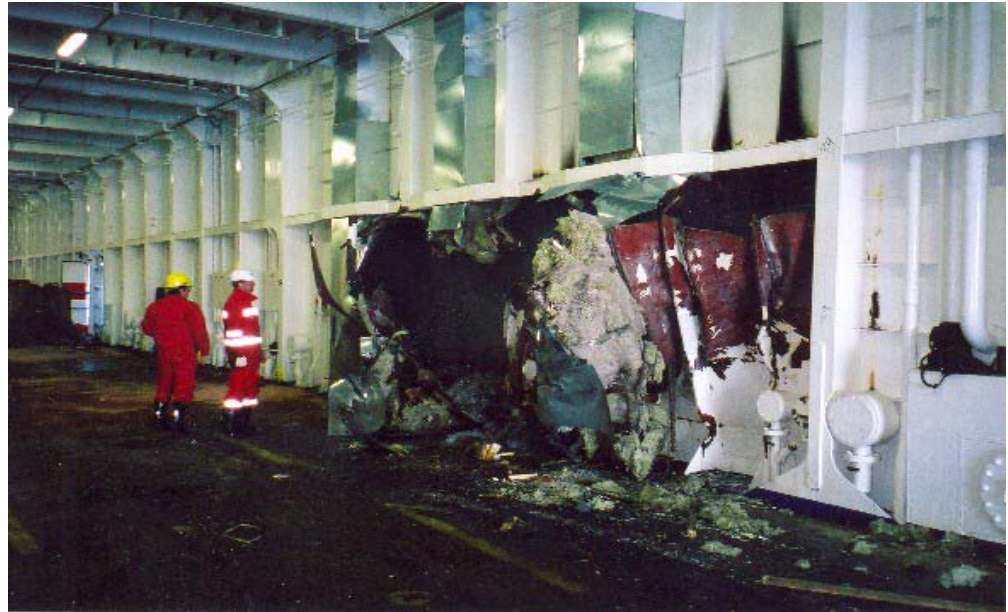
The damage in Stena Nautica seen from the cargodeck

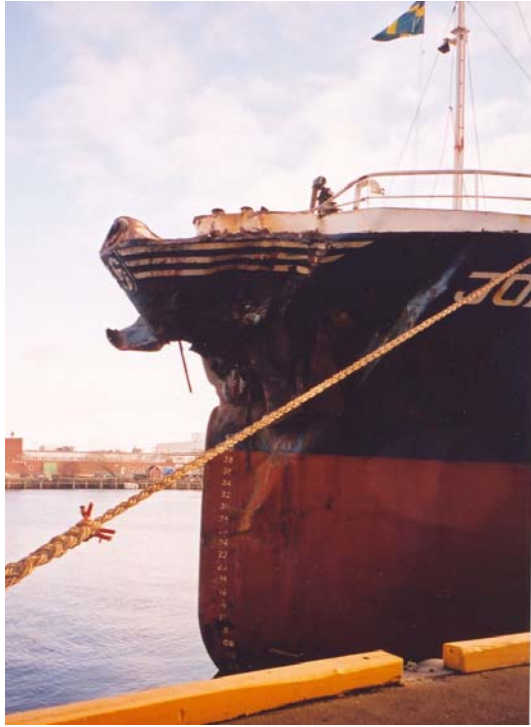
Damage to the Joanna was comparatively minor. The fo'c's'le with bulwark and deck was demolished. The sharp part of the stem was compressed and sustained fairly small dents and scraped paint. A fairly small leak was sprung into the forepeak tank. The leak was repaired at quay in Falkenberg and the Joanna continued unassisted to a yard for further repairs.

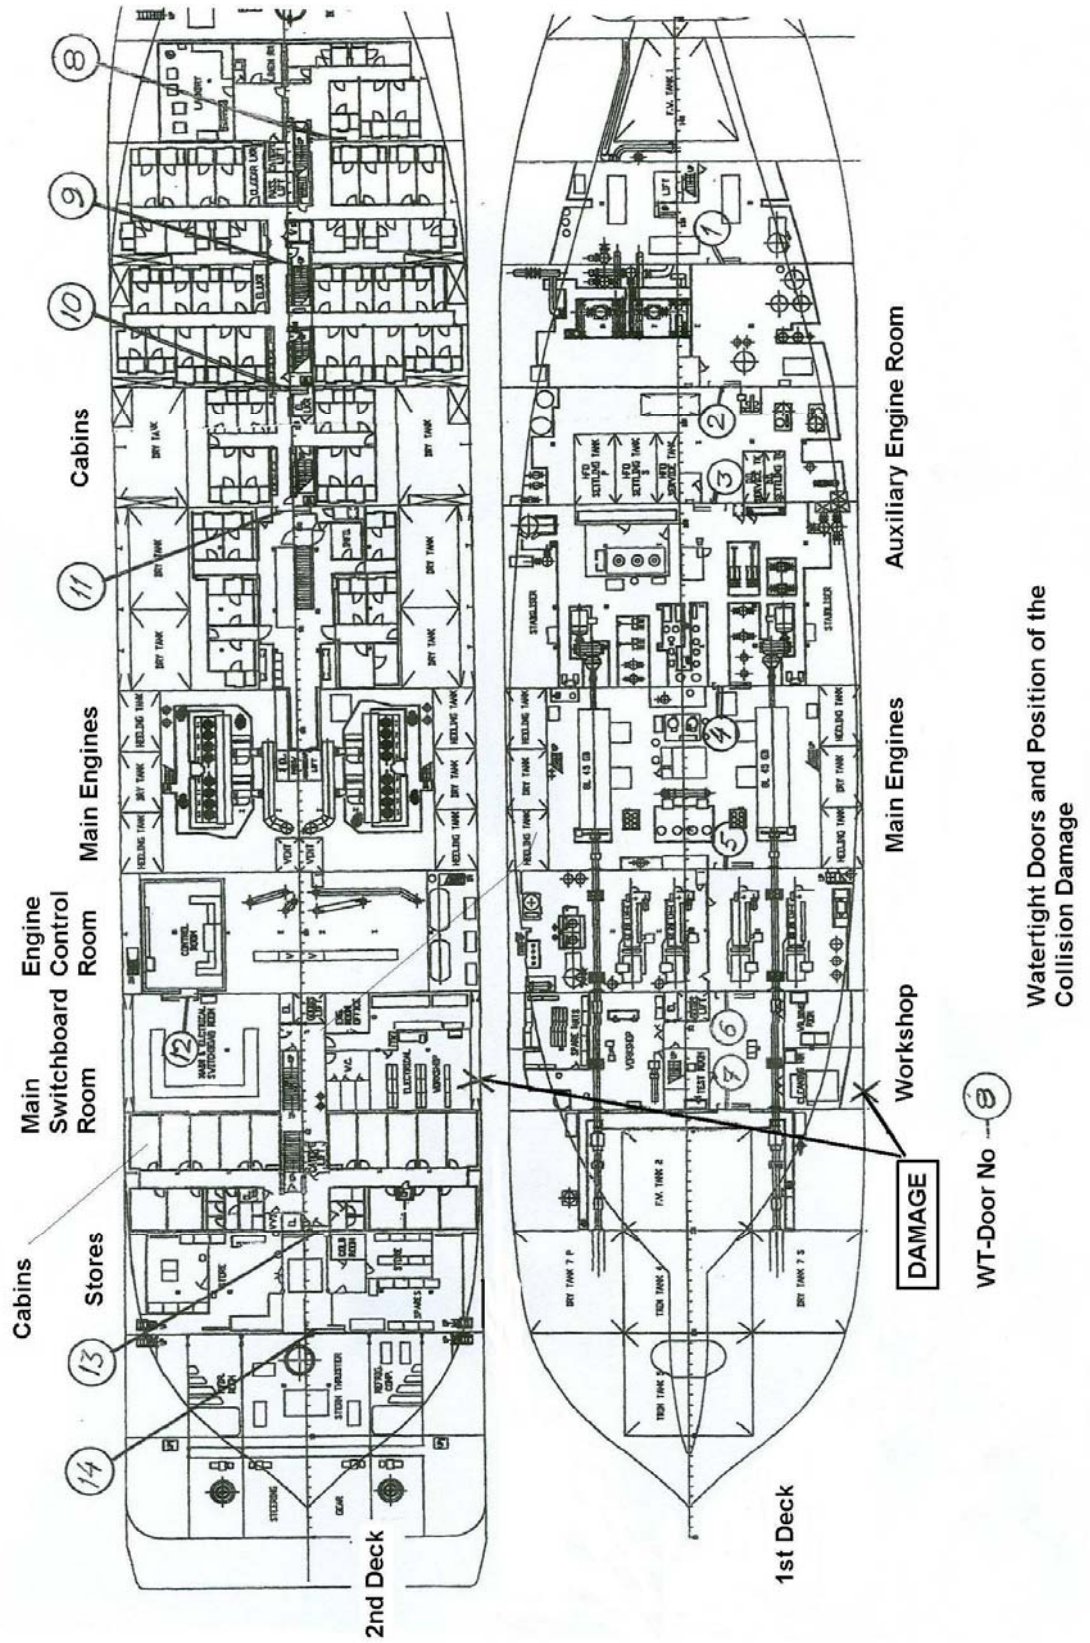
Watertight Doors and Position of the Collision Damage

A diver using "umbilical" life-support equipment was sent down to dive through the engine rooms. He found the watertight doors nos 5 and 6 open. In no 6 doorway he found a loose floor plate. He could not reach door no 4 since his umbilical did not reach far enough; nor could he see the door in the muddy water. Once the diver had shut doors nos 5 and 6, the engine rooms could be pumped dry.

The floor plates in the engine rooms had been loose and were washed away by the gushing water. One of the plates had come to rest in no 6 doorway. It is however unclear whether the door, which stopped near the edge of the plate, had really been stopped by the plate; it may have been stopped by a short-circuit before it reached the plate.

The watertight door no 3 in the bulkhead at frame 120, which was open at the time of the collision, was shut. There had evidently been time for it to be shut by the All doors knob before the gushing water caused a short-circuit.
