Report RS 2003:01e

Accident involving passenger ferry M/S VISBY in Visby Port, I County, Sweden, 10 April 2002

Case S-002/02

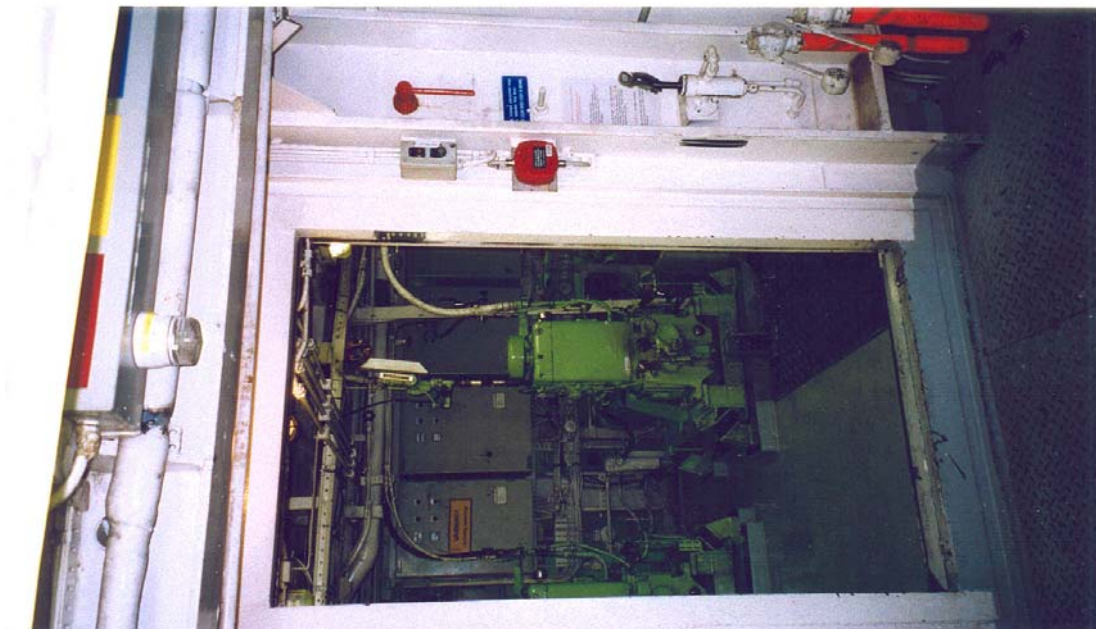
Dörren sedd akterifrån

He was found caught fast in door no. 11 with the door itself pressed against his back and the door-frame against his chest. Both arms were free and from his position he could have reached the two levers used to operate the door locally.

SHK considers it most probable that the repair mechanic was crushed in the door when he had not opened it completely and that the accident thus occurred according to alternative 5 or possibly alternative 4.

The door where the accident happened, WT door no. 11

- that the knobs in the central panel be touch-protected, e.g. under a removable cover (*RS 2003:01 R3*).
- that the closing time for WT doors should comply with the latest SOLAS recommendations (*RS 2003:01 R4*).
