***Final report RM 2013:02e***

**Accident involving a Royal Norwegian Air Force aircraft of type C-130 with call sign *HAZE 01*, on 15 March 2012 at Kebnekaise, Norrbotten County, Sweden.**

Ref no M-04/12

22/10/2013

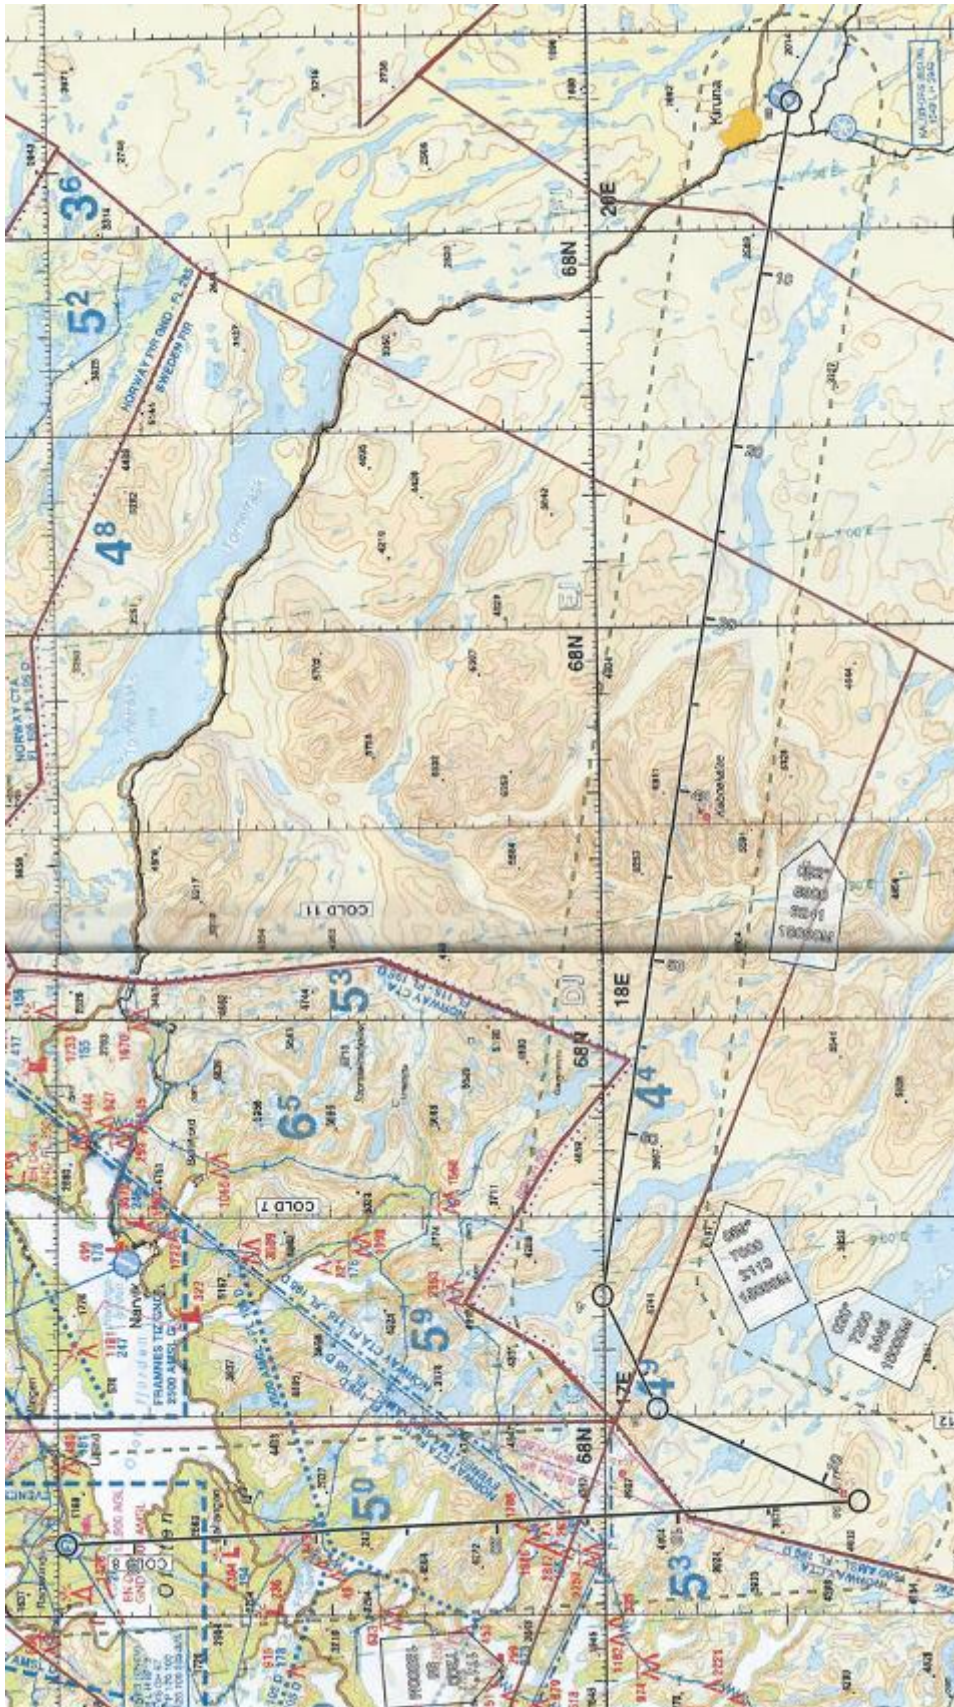
Fig. 1. LFC with entered route and Doghouse for each section of the route. The figures in blue in the various coordinate boxes state Maximum Elevation Figures (MEF) on the Norwegian side of the border.

Figures), with figures in blue. The figures stating this altitude were partly on the Swedish side of the border between Sweden and Norway, but concerned the altitude on the Norwegian side of the border in the respective box. There were no MEF values pertaining to the terrain on the Swedish side of the border. Other elevations were stated in feet in black figures for terrain, with the exception of the elevation of Kebnekaise, which was stated in red figures. Elevations for obstacles were stated in feet in red figures on the Norwegian side of the border. Kebnekaise was also marked with a red dot with a white cross.

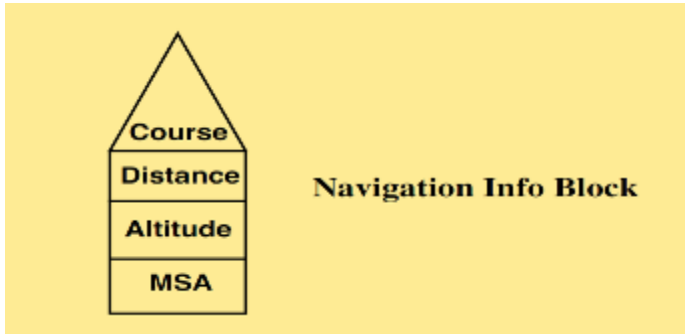
The Norwegian Air Force's *Basic Employment Manual* contains recommendations on the design of *Flight Information Blocks*. A minimum of heading, distance, flight altitude and *MSA* (*Minimum Safe Altitude*) is to be noted. On the chart in question, *MSA* had been replaced with *ESA* values.

Fig. 2. Flight Information Block, also known as Doghouse.

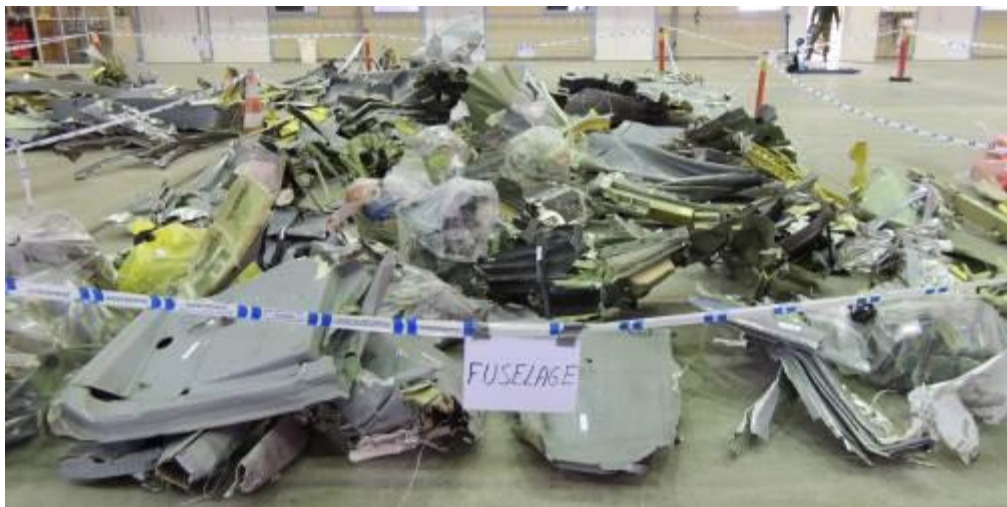
The aircraft collided with the Kebnekaise massif, just below the ridge between Kebnekaise's south and north peaks at an altitude of 2,014 metres. The aircraft broke up very severely, see Fig. 5.

Fig 5. Parts of the wreckage collected in a hangar in Kiruna. (Picture: SHK)

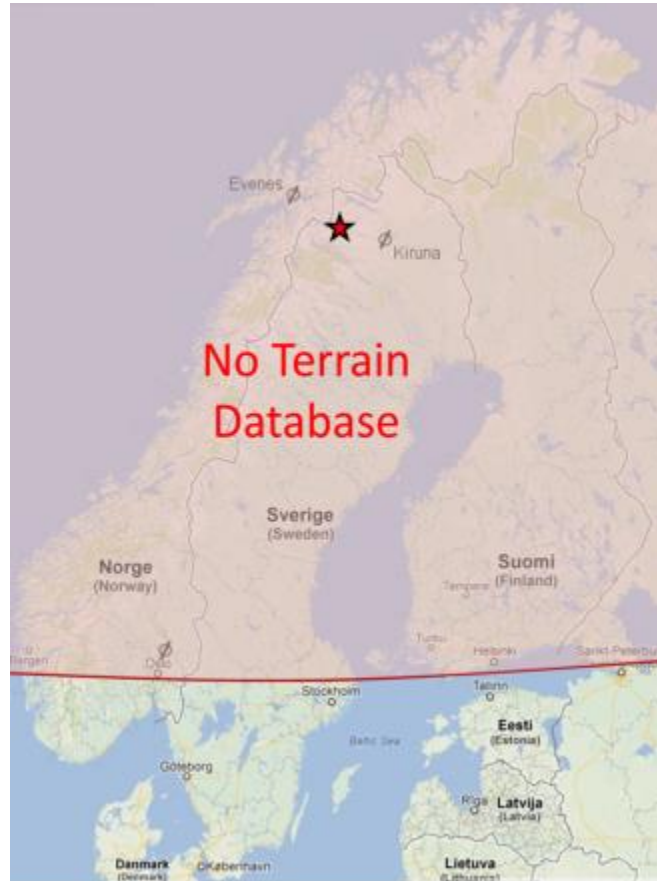
The 60th parallel north passes just outside Oslo and Uppsala, see Fig. 10. At the accident site, the aircraft with TAWS in *Tactical* mode has no forward-facing terrain avoidance function due to the limitation in tactical terrain data. North of 60° N, the warning system is thus limited to “downward-looking” GCAS, while the forward-looking capability only covers obstacles such as masts and towers with a height above ground level  $\geq 100$  feet (about 33 metres).

Fig. 10. Map of Scandinavia. In the red area, TAWS in Tactical mode has no terrain warning function. The crash site is marked with a red star (Map view from Google Maps)

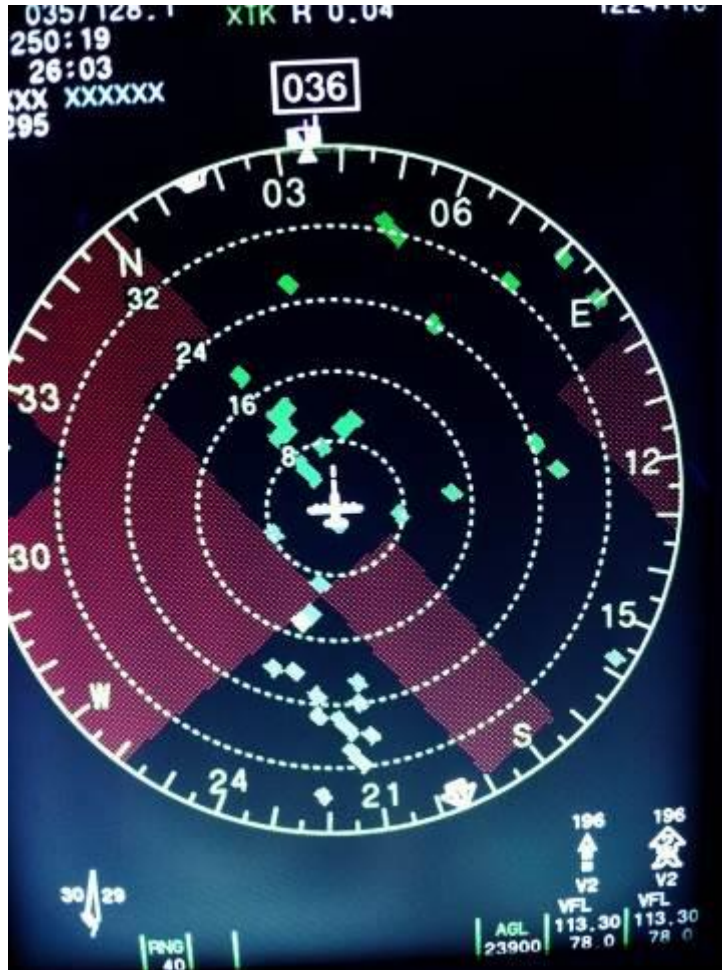
Fig. 11. Photo of the TAWS display at a position north of 60° N. Areas with “voids” appear in magenta. The green dots show obstacles. When flying in black areas, the VOID message is off. (Picture: Norwegian Air Force)

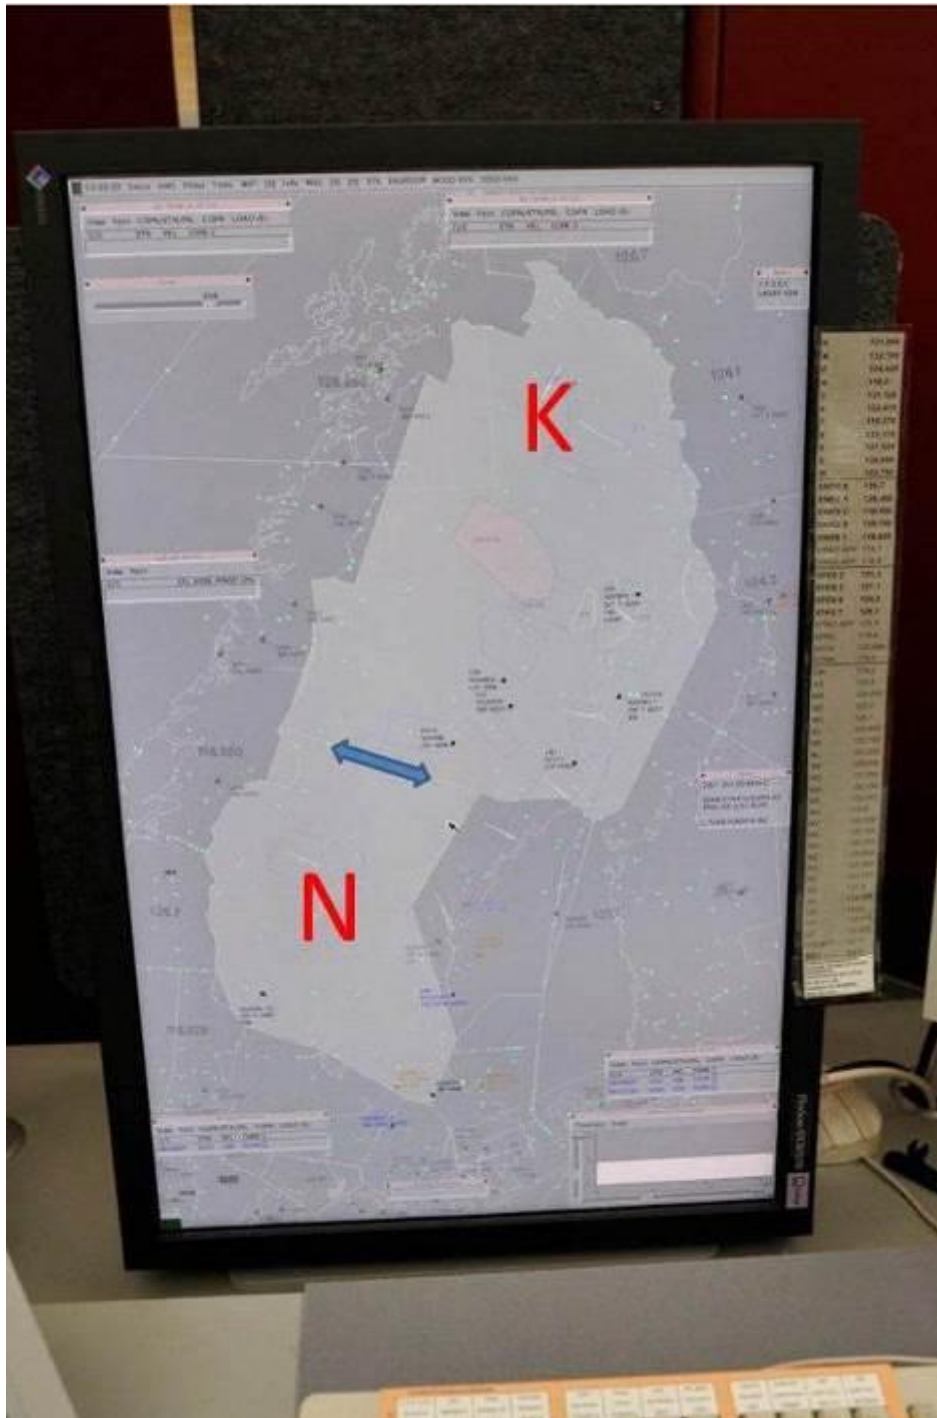
Fig. 16. The P position's radar screen. The letters K and N illustrate the different sectors, the letter K positioned where Kiruna TMA is located. The blue arrow marks the division between the sectors (the red letters and the blue arrow have been inserted by SHK). The list outside the screen to the right contains frequencies for various air traffic services units. At the time of the incident, Kebnekaise was not marked on the radar chart.

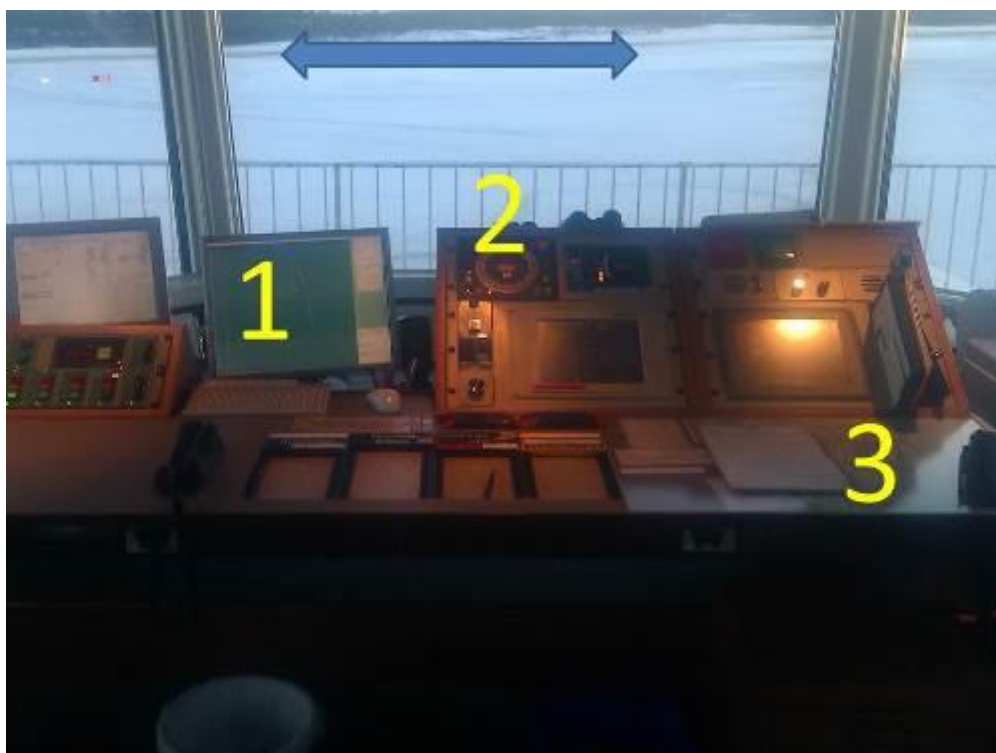
Fig. 18. The air traffic controller's work position at Kiruna Tower. The figures mark the following equipment: 1=radar screen, 2=direction finder, 3=chart. The horizontal arrow marks the runway location, the direction of which is 03/21. At the time of the incident, Kebnekaise was not marked on the radar screen.

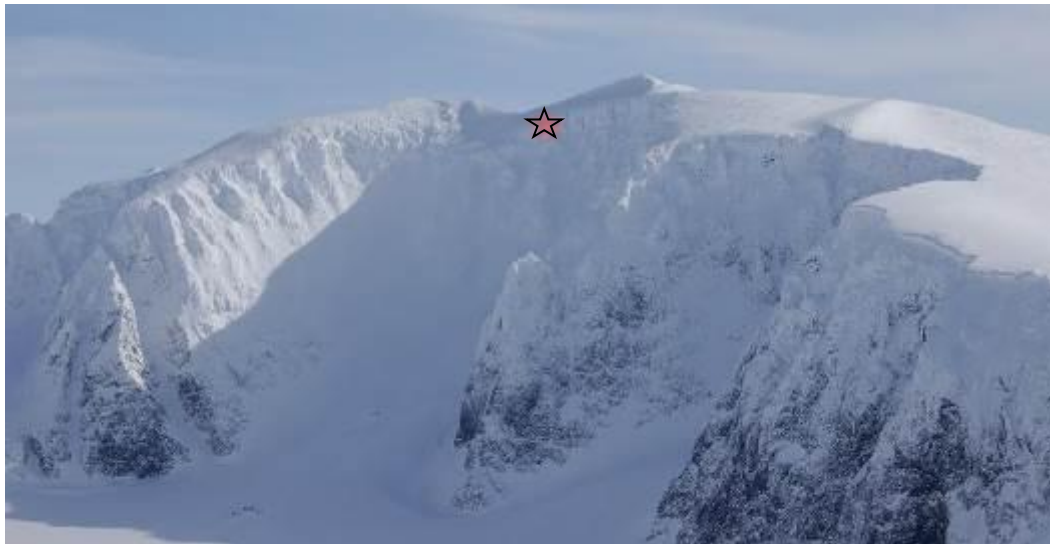
The aircraft collided with terrain around 170 metres from the south peak of Kebnekaise and the sloping part of the ridge that runs between the north and south peaks. The point of collision is located just below the dividing line between the ridge's sloping surface and the nearest vertical rock face; see figs. 25-26. The distance to Kiruna is around 42 NM (77 kilometres). The area is very inaccessible.

Fig. 25. Photo of Kebnekaise. The photo is taken in the direction of approach at the same altitude as the point of impact (marked). (Photo: SHK)

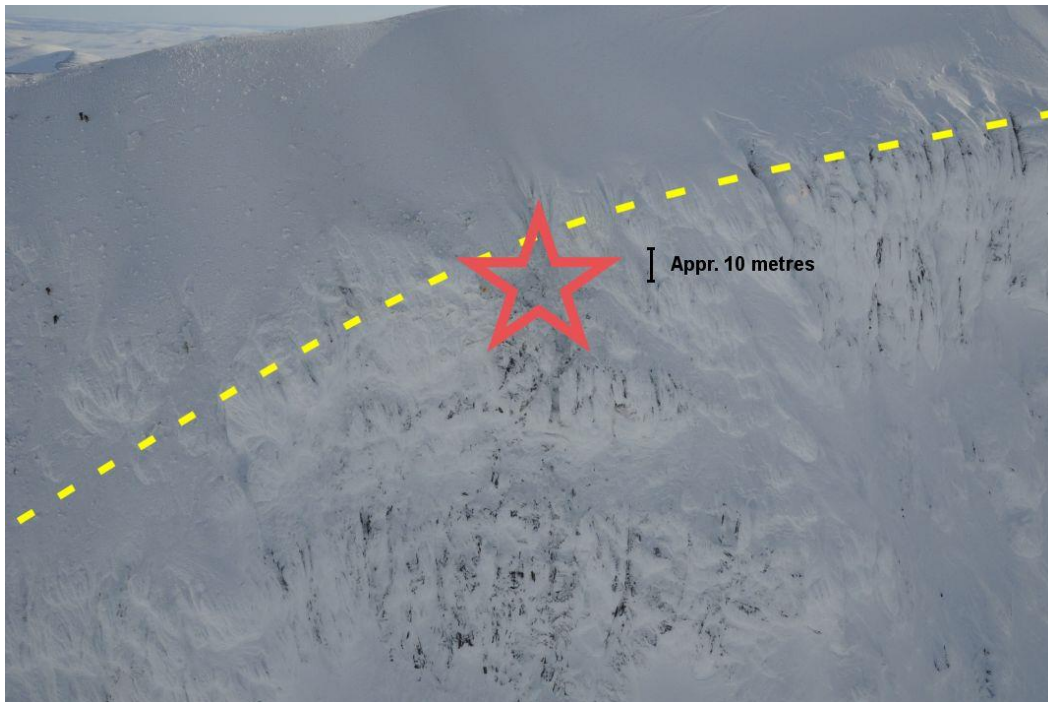
Fig. 26. Photo of the point of impact on the west side of Kebnekaise. The dividing line between ridge and vertical rock wall is marked by a dotted yellow line. Note the salvage crew on the left side of the image. (Photo: SHK.)

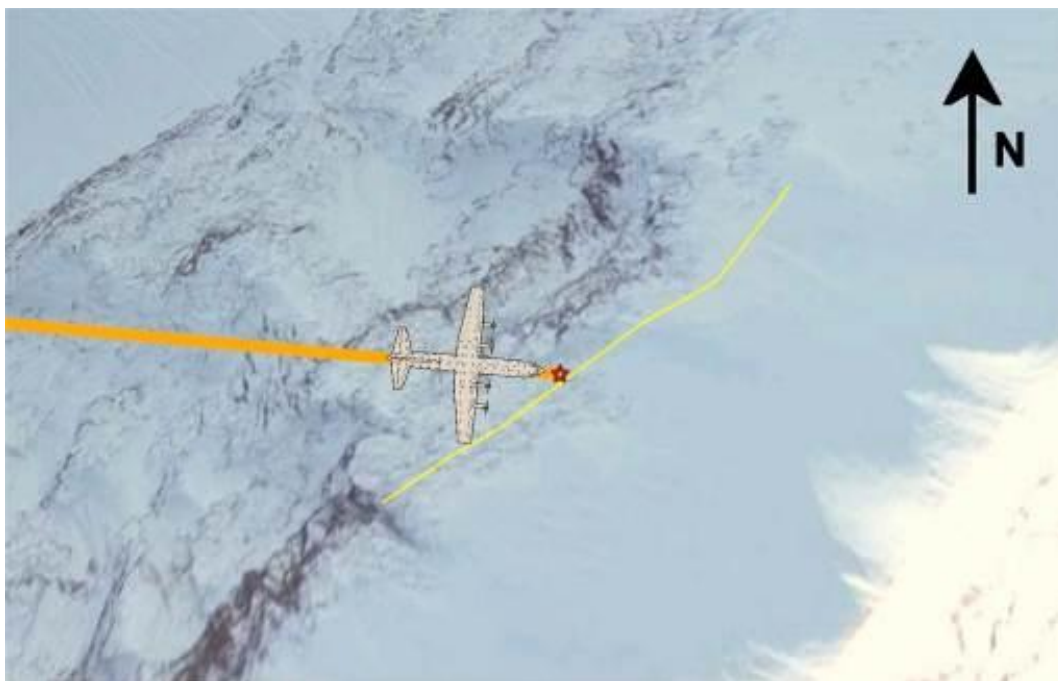
The aircraft's heading was approx.  $095^\circ$  when it collided with the terrain. The principle bearing of the ridge is approx.  $045^\circ$ , which meant that the aircraft hit the mountainside at an angle – see fig. 27.

Fig. 27. Photo montage of the point of impact, as seen from above. The contour line at the point of impact is marked with a yellow line, and the aircraft's approach with a thick orange line. (The picture is based on a satellite image from Google Earth.)

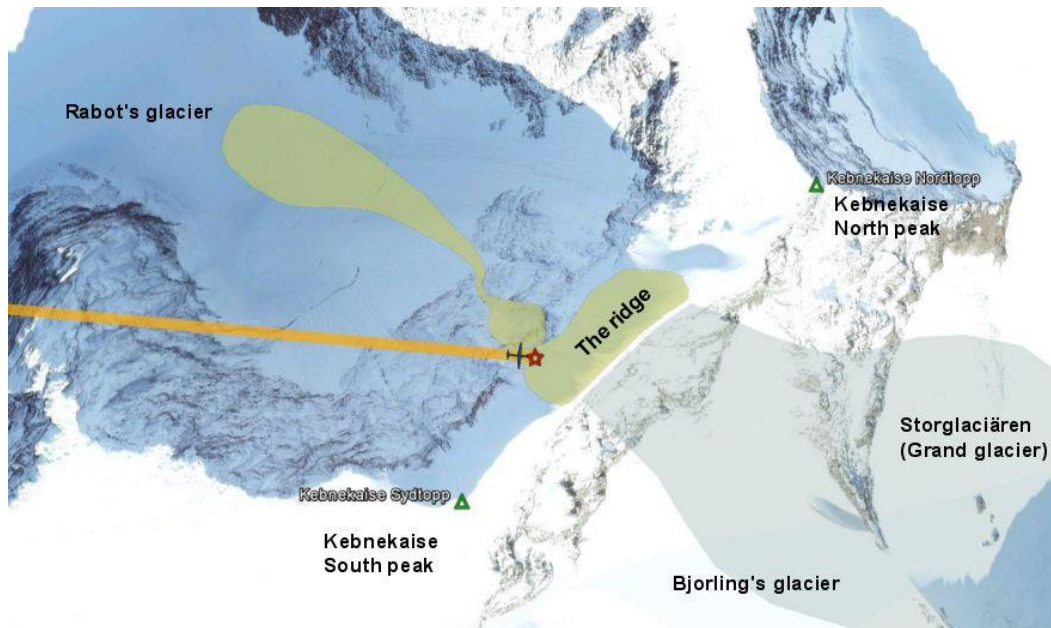
The parts of the wreckage were spread across a very large area, even up on the ridge. The strong westerly wind at the time of the accident caused a strong upward wind, which was a contributing factor in lighter parts of the wreckage being pushed over the edge, landing on the east side of the ridge – see fig. 28.

Fig. 28. Approximate spread of the various parts of the wreckage, most parts having been discovered on the ridge and on Rabot's glacier. (The picture is based on a satellite image from Google Earth.)

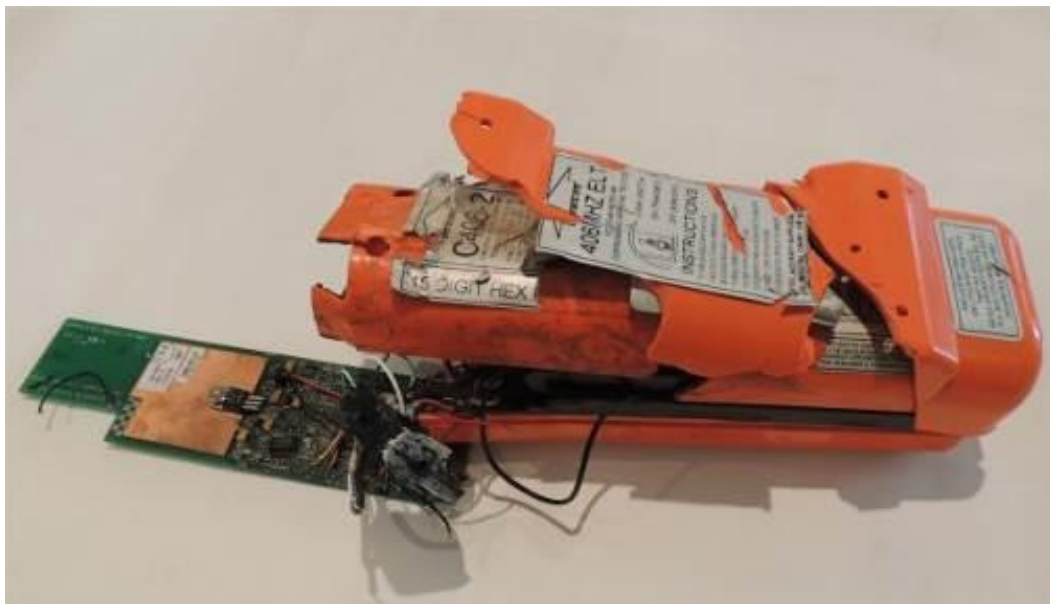
Fig. 31. Photo of the aircraft's ELT, Emergency Locator Transmitter. The damage to the unit is greatest in the forward part, on the left of the picture, where the antenna connection is located. (Photo: SHK)

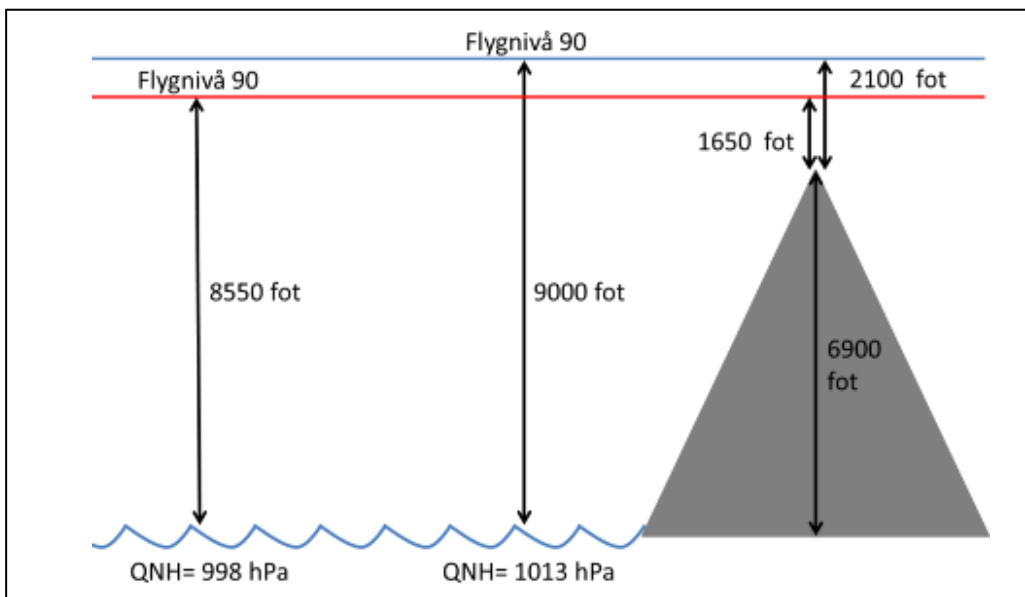
Flight level 90 therefore does not fulfil the requirement for an obstacle clearance of 2,000 feet; see fig. 34.

Fig. 34. The upper blue line shows the height above the terrain with the altimeter set at 1013 hPa for a local atmospheric pressure of 1013 hPa. The red line shows the height above the terrain with the altimeter set at 1013 hPa for a local atmospheric pressure of 998 hPa. N.B. Flygnivå = Flight Level, fot = feet.

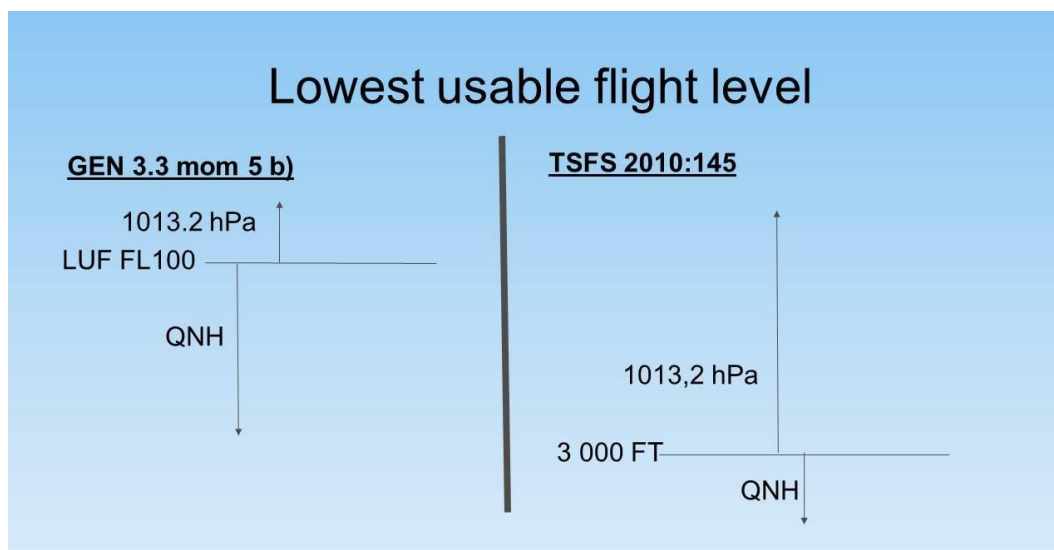
Fig. 43. The image shows the two variants of “lowest usable flight level” published in Sweden today, which are not compatible with one another when following the ICAO working method for “lowest usable flight level”.
