Report C 1997:49
**Incident involving aircraft SE-DRG,
13 January 1997,
in controlled airspace west of
Stockholm, AB county, Sweden**

L-05/97

Report C 1997:49

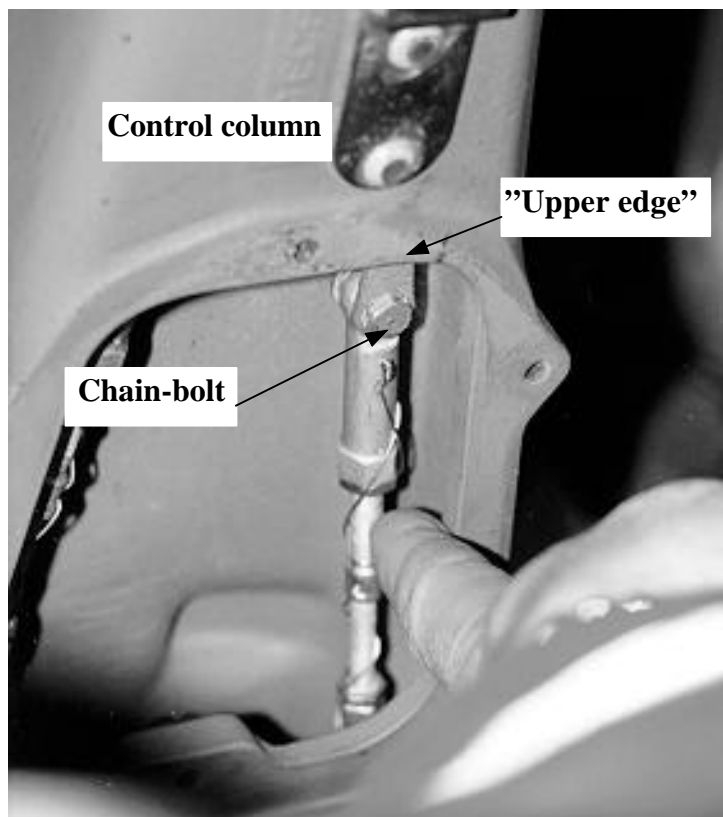
During the technical investigation of the aircraft after the incident performed at Norrköping/Kungsängen airport in co-operation with representatives of the manufacturer, British Aerospace (BAe), it was found that the chain in the right control column (Chain assy, P/N AS7877-24P) assembly which transfers the wheel movement to the right aileron control system was slack. With the column pulled fully back the chain could "fall back" allowing a bolt head on the chain (Bolt, P/N DHS 1426-2-5DD) to catch against the upper edge of the inspection hole in the column. Scratches in the paint on the upper edge of the hole indicated that there had been mechanical contact during a wheel movement to the right. "The feeling" in the control-wheel during a simulated locking was verified by the captain.

The left control column as well as all other control columns of the airline's other aircraft proved when checked also to have chains that were more or less slack.

The type of fault was new for BAe. In the manufacturer's Aircraft Maintenance Manual (AMM) the control column was defined as a "component" requiring no specified or periodical maintenance as long as it was mounted in the aircraft ("On condition").

Following the incident control columns and cover plates of all aircraft operated by the airline were checked and action taken. The task was completed within 24 hours of the defects being discovered.

- a) supplemented the AMM with a requirement to check the chain tension periodically and
- b) modified the cover plates in such a way that they will no longer cause jammed ailerons. In a Mandatory Modification Service Bulletin BAe will order replacement of all existing plates by the new ones, when manufactured.

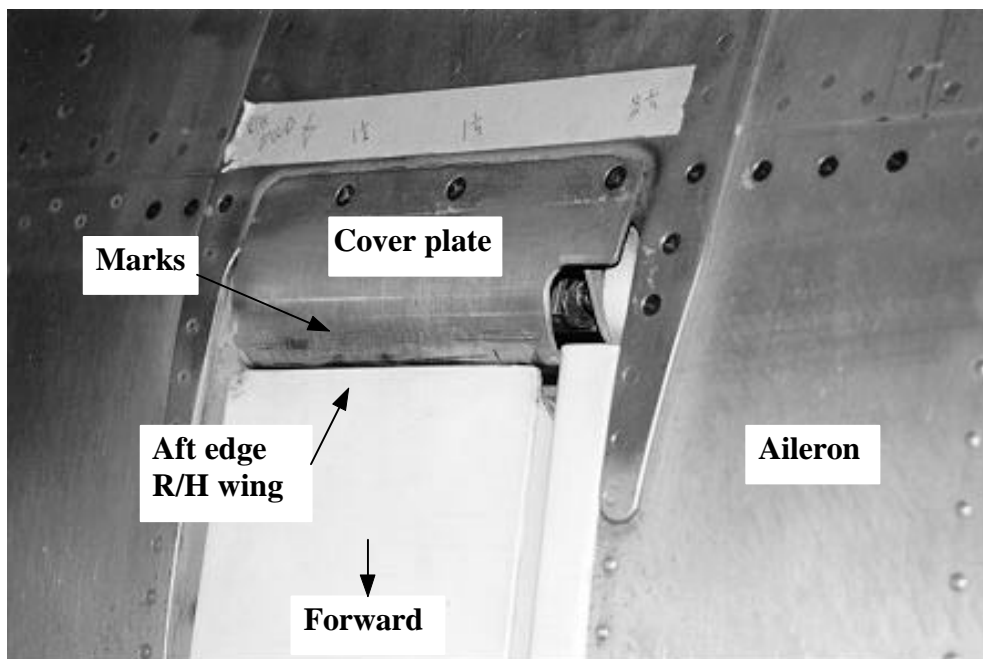
During the technical trouble-shooting at Gothenburg/Landvetter airport it was found that the top cover plate (Cover plate, P/N HC576H0032-001) over the centre hinge of the right aileron was loose. The three fixing screws (Bolt, P/N NAS4403-7) in the aft edge of the plate holding it fast to the aileron were not fully tightened. With the aileron in neutral position, the play between the forward edge of the plate and the aft edge of the wing at the level of the hinge was approximately 1.1 mm. In flight, however, the aerodynamic forces lifted the forward edge of the plate so that it could catch against the trailing edge of the wing skin thereby jamming the upward movement of the aileron (right wheel throw) at around neutral position.

Marks on the forward edge of the cover plate indicated that the aileron had been jammed on one or more than one occasion in connection with upward manoeuvring of the aileron.

All corresponding cover plates in question in the company's fleet were inspected. It was found that the screws were tightened but that the play at the aft edge of the wing varied between 0.0 and 2.0 mm.

Scratch marks on the control column and the covering plate indicate that either fault had at least once caused temporary catching or jamming. It is not possible, however, to establish with certainty which of these faults caused the jam during the flight in question. The fact that jamming also occurred during the test flight after the correction of the fault in the control column points to the loose cover plate as being the cause of the jamming after the takeoff from Stockholm/Bromma.

The probable cause of the incident was a loose cover plate on the right aileron which, under the influence of aerodynamic forces during flight could catch against the trailing edge of the wing skin thereby jamming the upward movement of the aileron.
