*Final report RL 2013:11e*

**Serious incident involving the aircraft  
PH-DCI and SE-MDC in the airspace  
north-east of Jönköping, Östergötland  
county, on 20 June 2012.**

Ref no L-53/12

2013-06-11

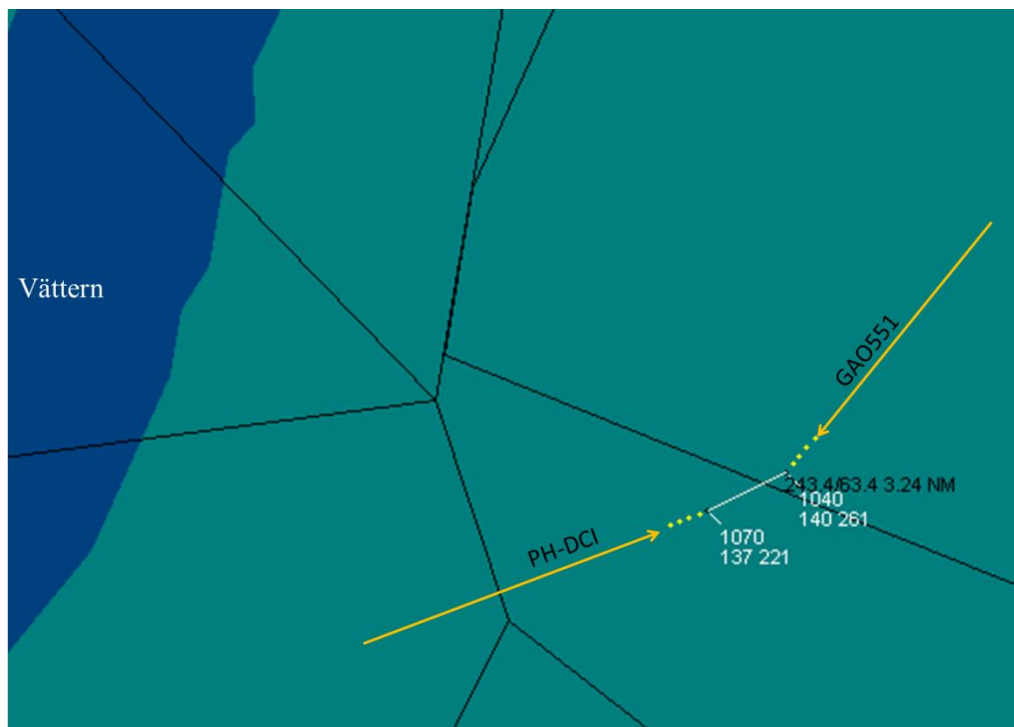
The least vertical distance between the aircraft was 300 feet at a horizontal distance of 3.24 nautical miles (nm). The least horizontal distance was 1.75 nm with an altitude difference of 800 feet, see Fig. 1.

Fig. 1. Radar tracks with the minimum vertical distance of 300 feet at a horizontal distance of 3.24 nm.
