Report C 1999:8e
Incident involving aircraft OY-KIK,
22 March 1998,
Kiruna airport, BD county, Sweden

Report C 1999:8e

The Swedish Board of Accident Investigation has investigated a serious incident which occurred on March 22nd 1998 at Kiruna airport , BD county, Sweden, involving an aircraft with registry OY-KIK.

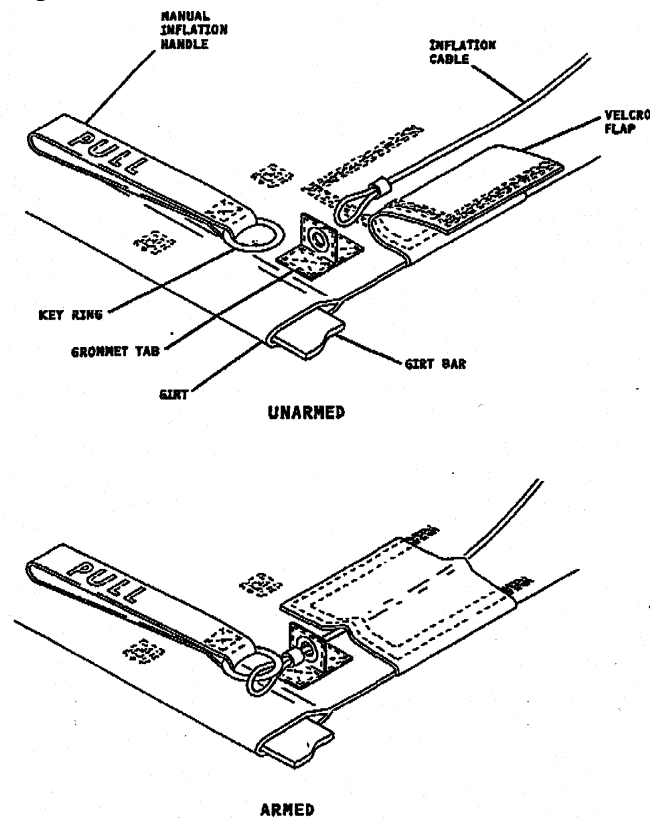
Both the cloth handle and the slide bar are connected at one end to a wire (Inflation Cable) whose other end is inserted into the inflation valve of the compressed gas tube. To prevent accidental inflation of the slide during transportation to and from an aircraft the inflation cable shall be removed from the cloth handle and slide bar and “parked” under a cloth flap (Velcro Flap).

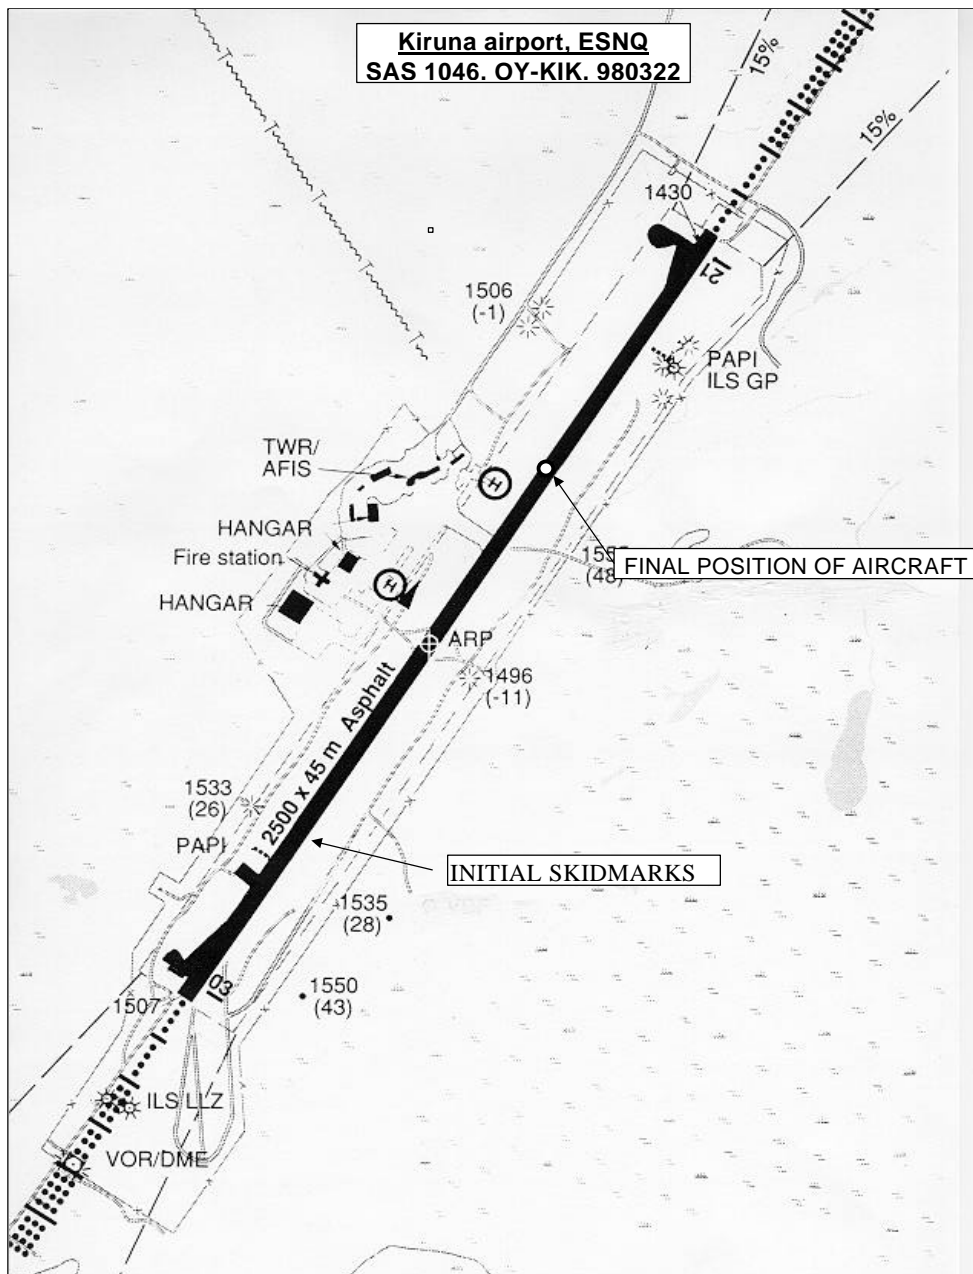
The smell of fire was discerned when the aircraft was in the airspace approximately 130 NM south of Kiruna. The incident lasted until such time as the emergency evacuation had been completed at Kiruna airport. The aircraft's touchdown took place about 300 meters down the runway and the skidmarks began on the runway centerline 537 meters from the runway threshold. The aircraft came to a stop 1744 meters from the threshold and slightly left of the runway centerline (ref. illustration).

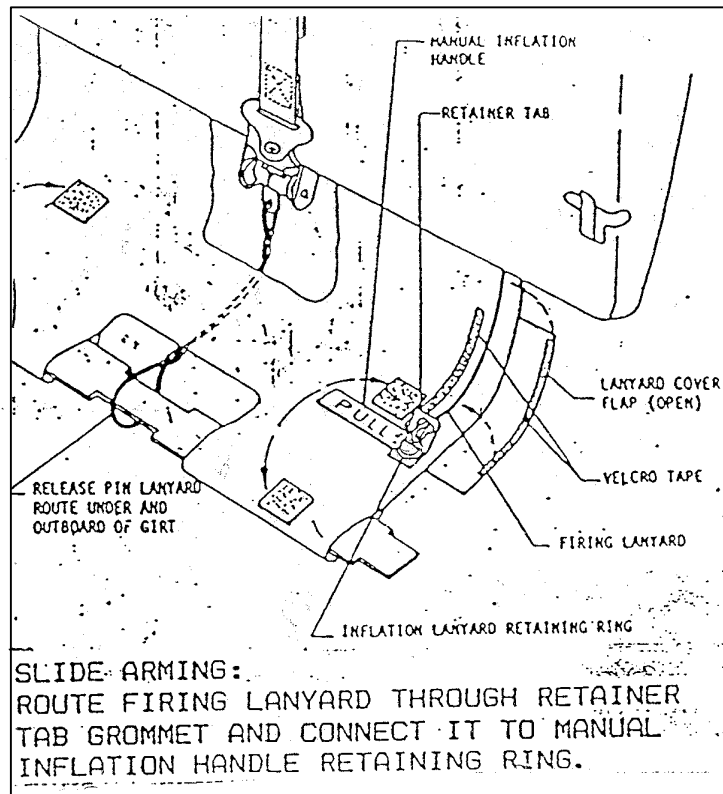
deploy automatically when the door was opened was, according to the investigation, that the firing lanyard was not attached correctly to the slide bar (Girt Bar). This has not been possible to verify subsequent to the occurrence as the lanyard was “completely extracted” in connection with the manual deployment.

The instruction illustration shown below (full size), concerning the installation of the firing mechanism, is included in the shipping carton of the emergency evacuation slide.

The emergency evacuation in this case took place under favorable conditions and the malfunction of one of the emergency evacuation slides had, in and of itself, minimal influence on the chain of events. In a similar but more critical situation the absence of automatic deployment of a slide could have serious consequences. It was therefore a serious deficiency in the installation of the slide if the firing lanyard was not correctly connected. The instruction illustration as to how the cable should be connected after it has been secured for transportation is physically small and it is not sufficiently evident therein how the cable shall be connected to both the retainer tab and the manual inflation handle. It is the opinion of SHK that the illustration should be made clearer.
