Statens haverikommission
Swedish Accident Investigation Board

Report RL 2009:21e

**Accident to helicopter SE-JGX north of
Katrineholm, Södermanlands county
Sweden, on 30 October 2006**

Case L-28/06

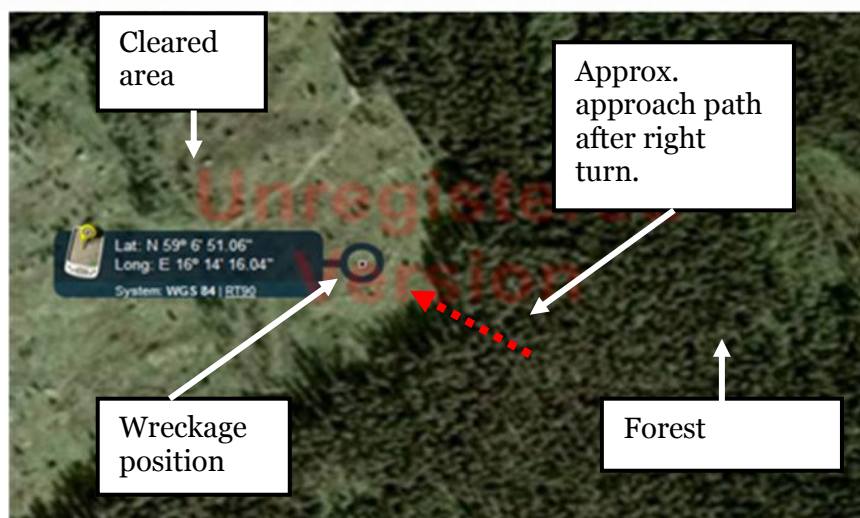
Fig. 5. The accident site.

The helicopter crashed on clear-cut ground about 6 km north-north-east of the settlement of Bie. The clear-cut area is surrounded by woods and was one of the few open areas along the route of the helicopter at that part of its flight path. The impact site was located about 50 metres into the cleared area on the probable route of the final track. The area is surrounded by relatively high masking trees. The cleared ground is uneven and rock-strewn in parts. Minor vegetation and brushwood dot the area. There was no sign of the trees having been struck in the probable descent path of the helicopter.

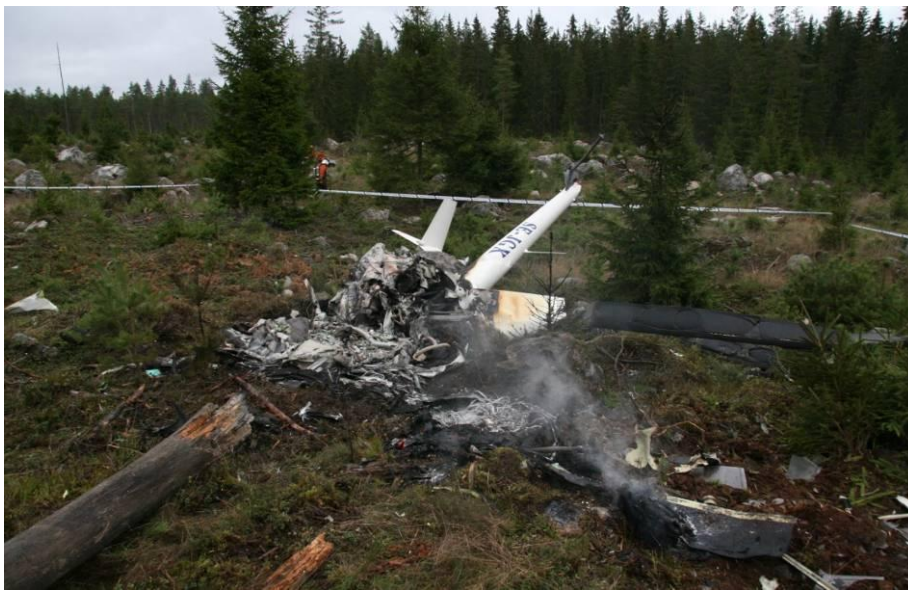
Fig.6. The helicopter wreckage.

The helicopter was completely destroyed on impact and was found to be inverted at the accident site. The forward parts of the left and right landing skids were found broken off and embedded in the ground about five metres from the wreckage at an approximate angle of 45° to the ground. The parts could be identified as pieces of the tubular construction (skids) that forms the helicopter landing gear. The rear parts of the skids were about 12 metres away from the main wreckage in the direction of impact. Other parts of the helicopter were grouped within a relatively limited area at the impact site.

Fire had obviously broken out, which meant that most of the helicopter had been destroyed. The complete cabin with its interior, engine cowling, rear fan cover and tanks had burned away. There was no trace of external influence (pieces of vegetation, remains of birds, etc.) in the wreckage or close to it.

The engine, with auxiliaries and components, showed signs of major damage. The firewall was severely deformed and the engine had suffered major fire damage. The oil sump, carburetor and one of the magnetos were all destroyed by fire. The other magneto was badly damaged by fire.

The tail section, horizontal and vertical fins with the tail rotor gearbox and blades had been torn away from the tail boom and lay about three metres away beside the wreckage. The main rotor transmission was relatively undamaged, as were also the tail boom and tail unit. Both main rotor blades were damaged.

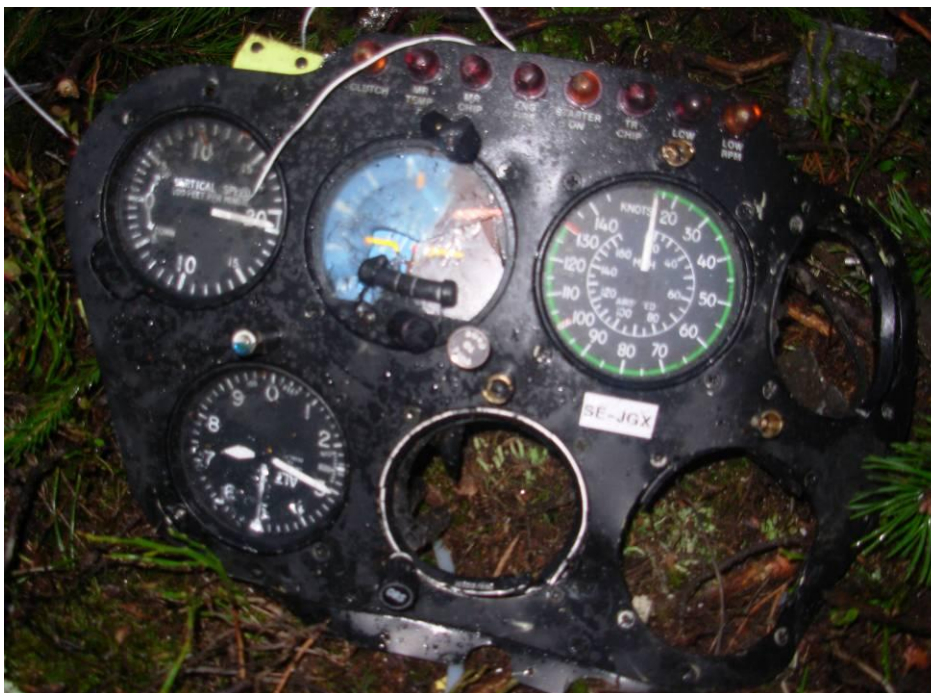
Fig.7. Part of the instrument panel.

Most of the instrument panel and the controls were damaged by the accident. The remains of the controls were examined as far as possible and were found to be intact. A small part of the instrument panel (see Fig. 7) had been thrown out of the wreckage and thereby avoided being burned.

- The altimeter indicated 730 feet/1019 hPa.
- The variometer indicated 2000 feet/min (descent rate).
- The magneto selection key was broken and burnt in its “OFF” position.
- The priming pump was not in its locked position.
- The clutch switch⁵ was set to “Disengage”.
- The carburetor heating control was pulled out.
- The mixture control was pushed in (rich mixture).

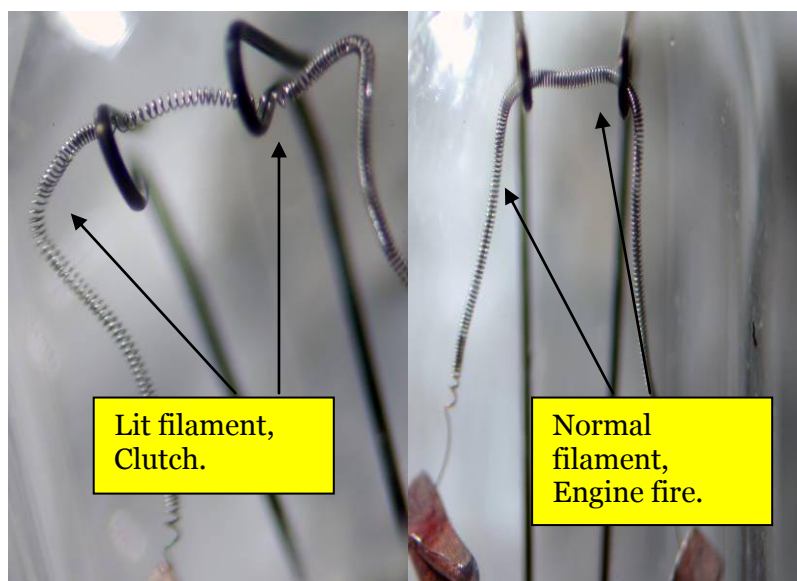
Fig.8. Examination of the warning lamps.

The warning lamps that were found in the part of the instrument panel that was found away from the wreckage were taken out and examined by SHK. The examinations were performed using a light microscope where certain results can be considered probable. It cannot however be claimed that the results were clear or definitive, since the units were subjected to forces and proximity to a long term fire.

Listed below are the lamps which could be examined. In general it can be said that there is a strong possibility that those lamps with filaments found to be intact were not lit when the accident occurred.

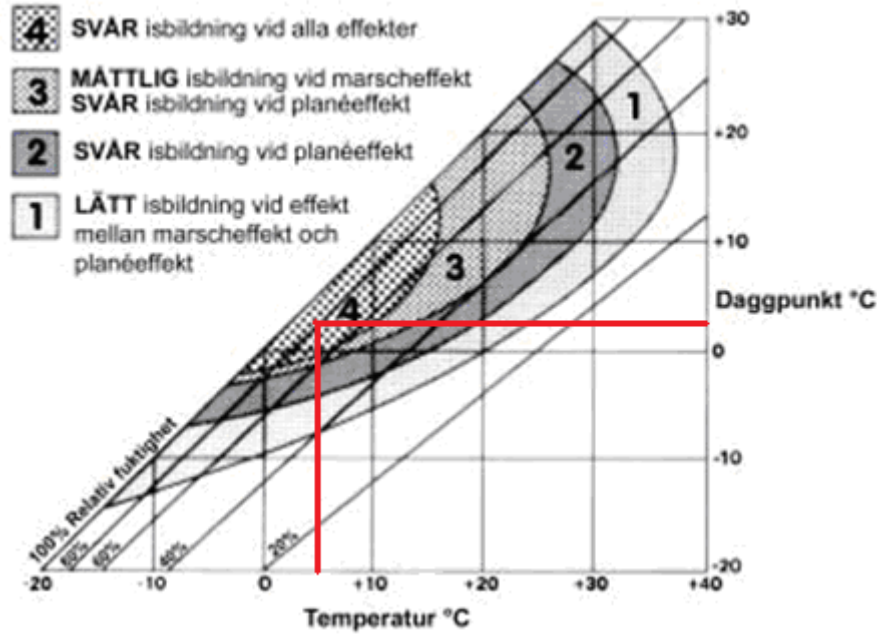
The diagram at Figure 9 shows the meteorological conditions for carburetor icing to build up on that particular day. The conditions at the time, with a temperature of +5°C, and a dewpoint of +3°C, show that there was a risk of severe icing at all power settings during the flight. The intensity and character of icing can vary depending on variations in the surrounding air. Small local changes in temperature and/or dewpoint can mean that the conditions for ice build-up quickly changes.

Fig. 9. Diagram showing the risk of carburetor icing. The prevailing conditions, according to the diagram, indicates that there was risk for severe icing at all power settings.

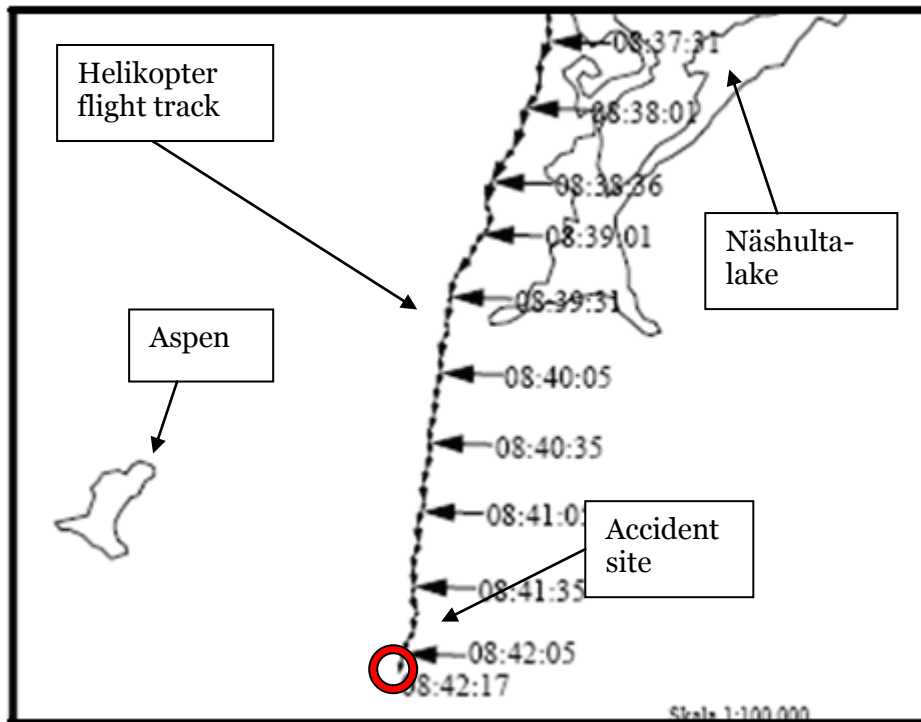
Fig.11. Part of the radar plot from FM.

According to radar images that were obtained from FM, these showed that the flight path was south-westerly at an altitude height of between 240 and 270 metres (790-890 ft). The last recorded altitude was 180 metres (590 feet).

The illustration at Figure 11 does not contain every return, for presentation purposes. The sampling time⁸ for that particular radar station is six seconds. The graphic shown above can therefore be supplemented by the penultimate recording of a return at 08:42:11, when the helicopter still maintained its altitude at 240 metres (790 feet). At the instant of the final recorded return at 08:42:17.95 – rounded off to 08:42:18 – the helicopter had descended to 180 metres (590 feet).

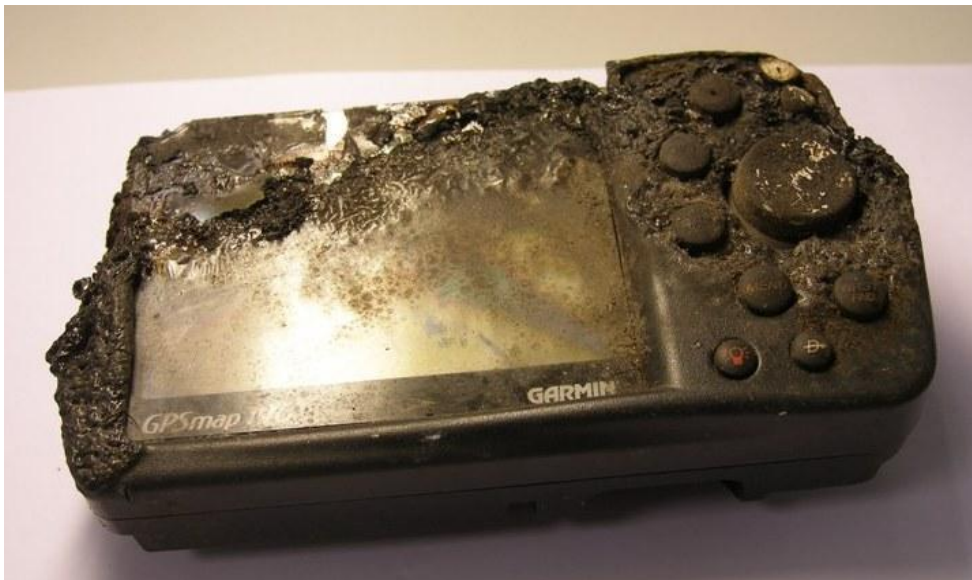
Fig.12. The helicopter's GPS. Photo: BEA

SHK sent the GPS to the British Aircraft Accident Investigation Branch, the AAIB, for examination. After a preliminary examination the unit was however forwarded to the French accident investigation authority, the BEA, for further examination, since the internal components and memory circuits were also fire damaged.

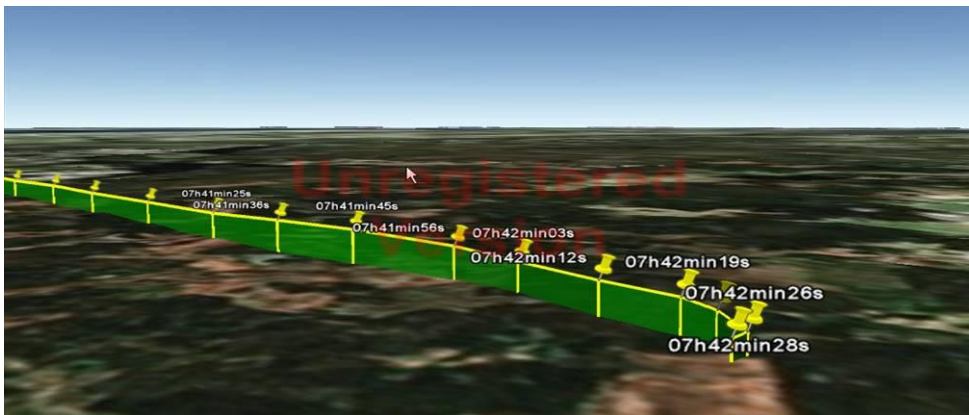
Fig. 13. Graphical presentation of the accident flight with data from the GPS.

Analysis of the data from the accident flight showed that take off took place at 08:17 (GPS time) and began according to plan until 08:42 when the helicopter started to descend. The helicopter began a mild course change to the right for less than 10 seconds and then started to turn right more definitely. The last data that was recorded from the GPS was at 08:42:28. The time from when the descent began until the power to the GPS was cut off by the accident was 16 seconds.

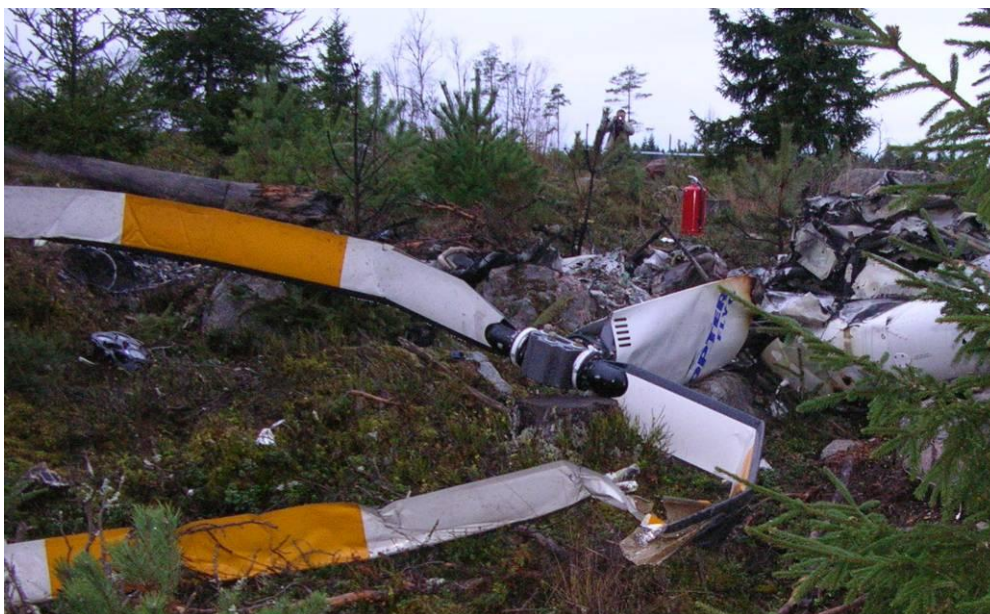
Fig.16. Parts of the main rotor at the accident site.

Both the main and tail rotors showed clearly identifiable traces of slow rotation at impact. Neither of the blades showed signs of rotation damage. The damage that had occurred was breaks, probably caused by the impact forces.

The main rotor bending damage with upwards coning is a clear sign of the forces that arise when there is slow or no rotation.

The damage to the tail rotor also indicates that it was hardly rotating on impact. The overall damage picture shows, according to SHK, that on impact
