**Statens haverikommission**  
Swedish Accident Investigation Board

## ***Report RL 2010:12e***

**Aircraft incidents to SE-DZB in airspace  
near Malmö/Sturup airport, Skåne County,  
on 9 November 2008**

Case L-27/08

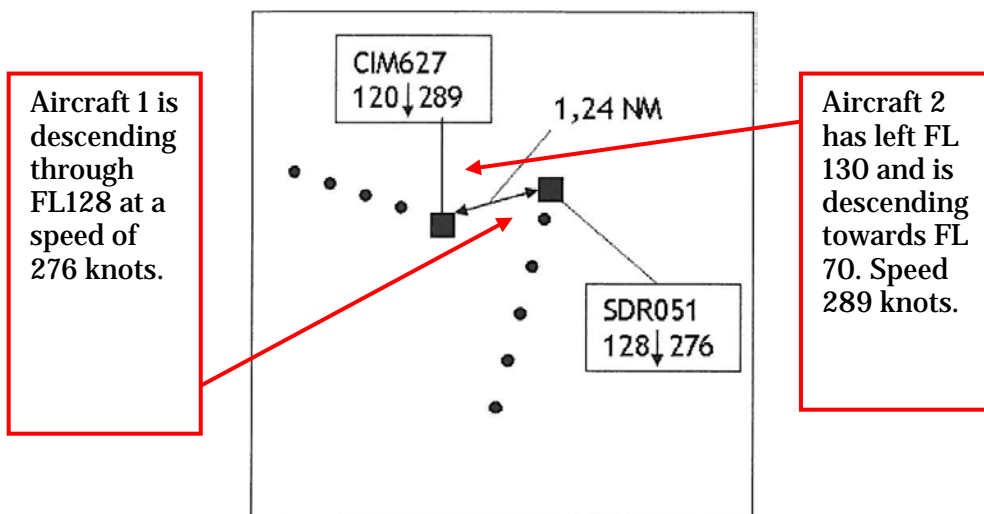
Fig.4. Concluding phase of the sequence of events – the incident.

Aircraft 1 passed in front of aircraft 2 at a minimum distance of 1.24 nm and a minimum altitude difference of 800 feet. At FL126 aircraft 1 requested a new vector to Sturup and was then cleared to descend to 3,000 feet. Aircraft 2 was instructed to stop descending and was at the same time given further information about aircraft 1. Aircraft 2 then replied: "We got him in sight at all time so no big deal for us".

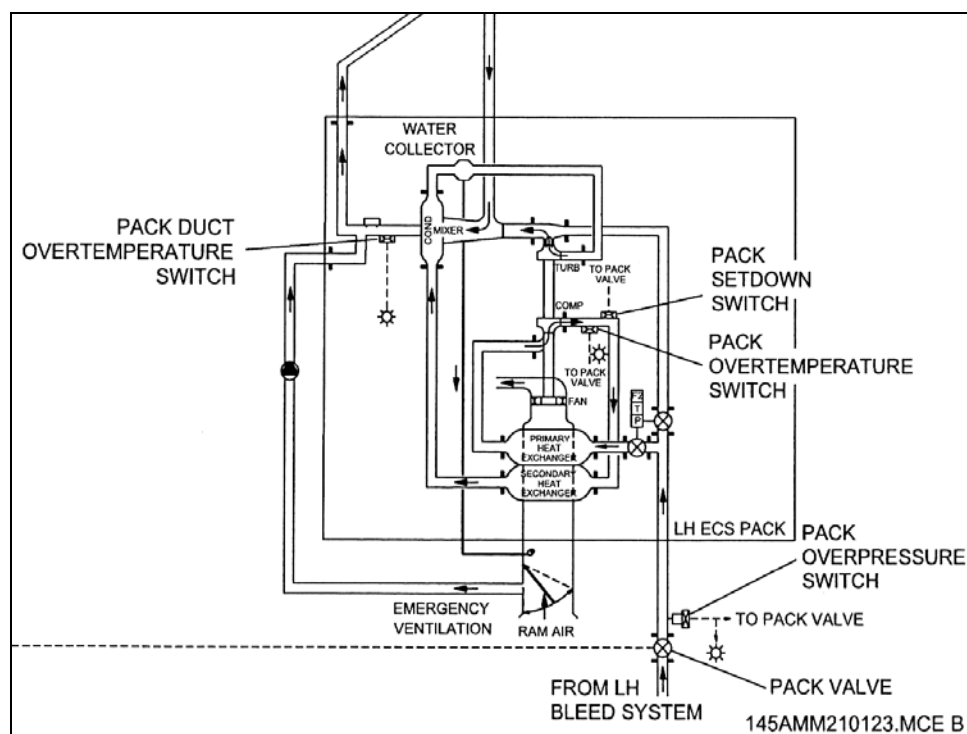
Fig. 6. CPS.

Each air conditioning system includes a cooling system, called the Cooling Pack System (CPS), which contains a cooling module called the Air Control Module (ACM). The ACM is driven by bleed air from the respective engine. The CPS and its associated components are controlled via a computerised control unit called the Digital Temperature Control (DTC), which receives control signals from, among other sources, a number of temperature sensors in the system. One of these is called the Pack Temp Sensor and is located in the inlet duct from the CPS to the cabin (Pack Duct).

In the CPS is a warning system which is activated if the temperature or the pressure in the system becomes too high. This system is controlled by a temperature sensor, the Pack Overtemp Switch (243°C), and a pressure sensor, the Pack Overpressure Switch (55 PSI) which are located in the part of

The air conditioning system on this type of aircraft has a generally high failure rate. The problems often consist of temperature fluctuations, false warnings and uncommanded shutdowns. At times the faults are intermittent and therefore difficult to trace and repair.

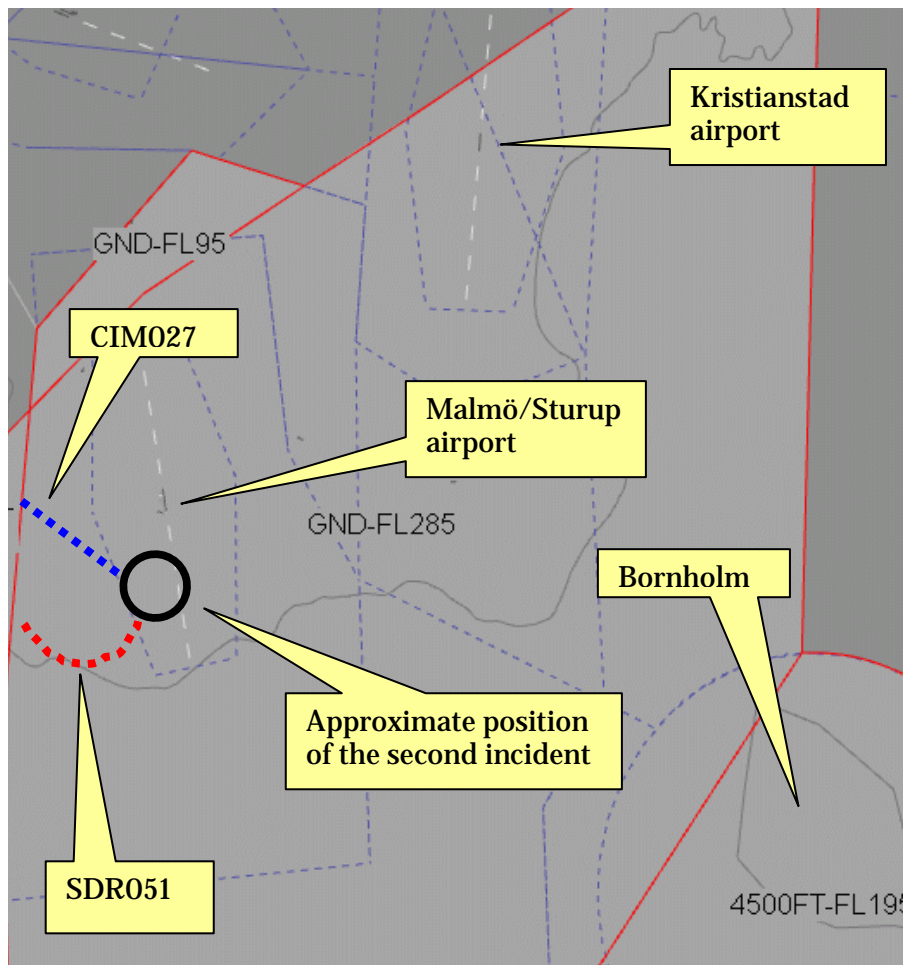
Fig. 10. Sector L.

The above map shows a part of Sector L, indicating the tracks of both aircraft during the events and the approximate position where the reduced aircraft separation occurred.

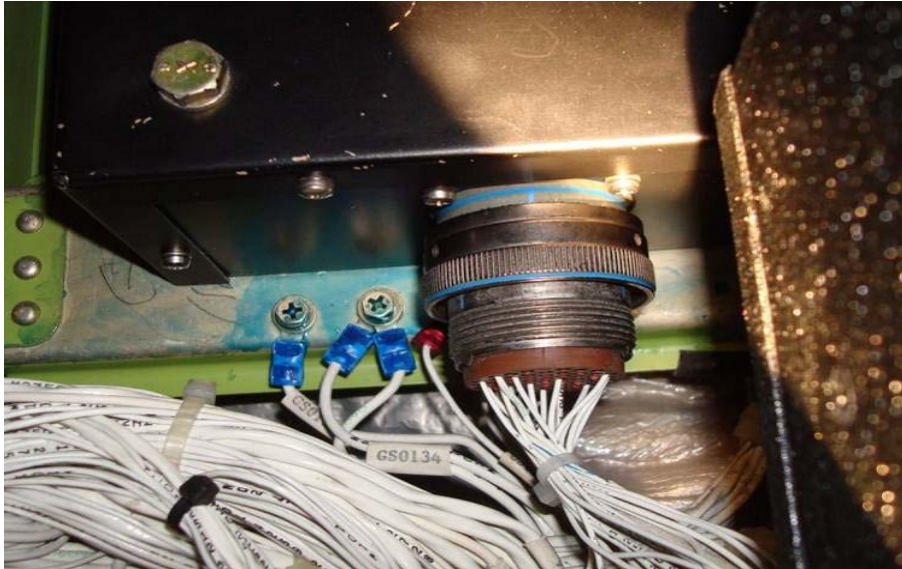
Fig.12. Electrical connector P0082.

In connection with fault tracing on this second failure, it was noted that two pins in two electrical connectors, P0082 and P0083, part of the left side air conditioning system, were incorrectly located. All indications were that the incorrect mounting was done in connection with the implementation of SB No. 145-21-0014. According to the operator, it was easy to misinterpret the modification instructions.

Incorrect location of the connector pins could, according to the manufacturer, have led to the temperature signals to the DTC being incorrect, and that a warning concerning overheating in the system was generated falsely.

Whether the warning and system shutdown was caused by a fault in the unit that had been replaced has not been verified, but is entirely possible. The warning and shutdown could also, according to the manufacturer's analysis, have been caused by incorrect connections in two electrical units, P0082 and P0083.

After the electrical connectors had been corrected, both air conditioning systems were checked while flying up to an altitude of FL370, and were found to operate normally.

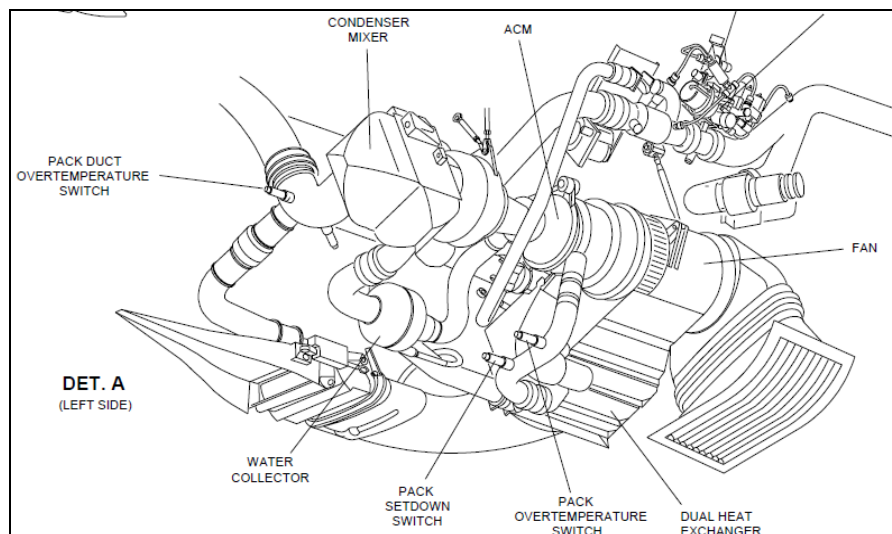
Fig. 13. The right hand CPS.

The air temperature in the Pack Duct is measured, among other things, by the Pack Duct Overtemperature Switch (93°C). This sensor is physically located immediately after a unit in the CPS called the Condenser Mixer, in which, among other things, hot air is mixed with cold air.

Practical tests carried out by the operator showed that the air temperature at the sensor's position was not homogeneous and stable. Small changes in the sensor body position inside the outlet duct resulted in large changes in the temperature being sensed. The temperature profile in the duct was also affected by how heavily the CPS was being loaded.

The rapidity of the sequence, which took place in less than one minute, can indicate that the shutdown of the right side CPU was caused by an incorrect activation of the Pack Duct Overtemperature Switch (93°C).

There are therefore reasons for the regulatory authorities and the aircraft manufacturer to take the necessary measures to minimise the risk of unjustified shutdown of the CPU, and to ensure that the two air conditioning systems operate independently of each other.
