Statens haverikommission
Swedish Accident Investigation Board

Report RL 2010:06e

**Accident to aircraft SE-GBL at
Gothenburg City Airport (Säve),
Västra Götaland County, on 6 July 2009**

Case L-09/09

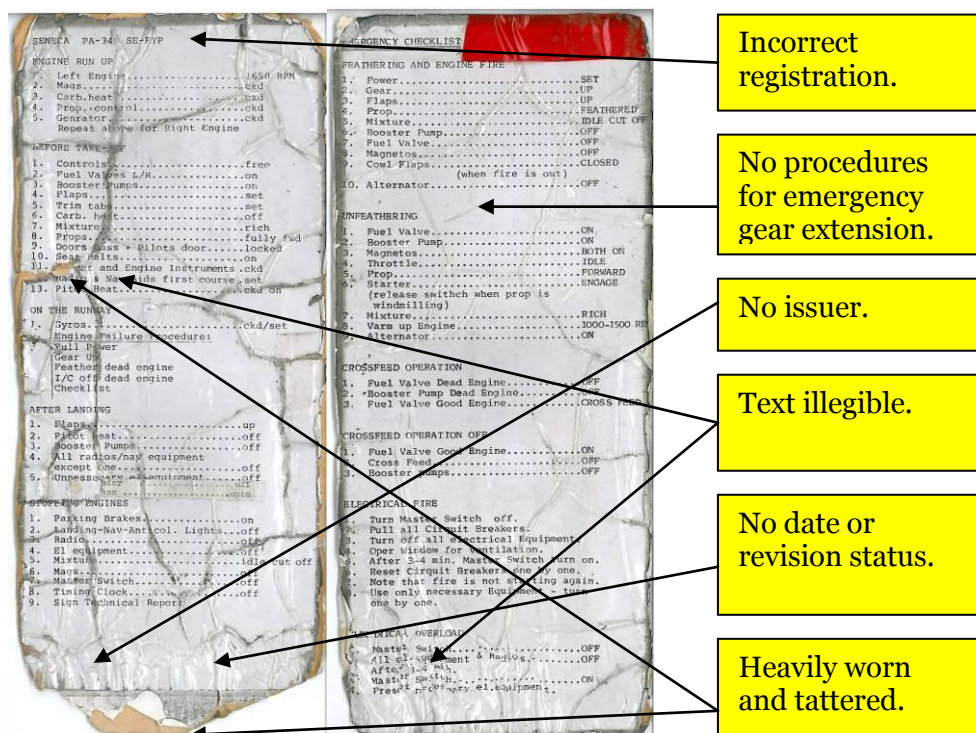
Fig. 3. Normal checklist and emergency checklist.

The checklists in this particular aircraft consisted of two plastic laminated paper sheets, one of which was headed “EMERGENCY CHECKLIST” and was distinguished by a strip of red tape. On the rear of each checklist was written: “Seneca PA 34 SE-FYP”. Both the normal and emergency checklists were very worn, and in places illegible. Neither of the checklists were dated, nor did they show the issuer or revision status.

The actual checklists in SE-GBL were found – apart from their generally unacceptable status – to not contain actions in the case of faulty operation of the landing gear system. SHK is of the opinion that no more detailed explanation is required as to why emergency instructions in the case of landing gear problems must be present on emergency checklists, when operating aircraft with retractable landing gear.

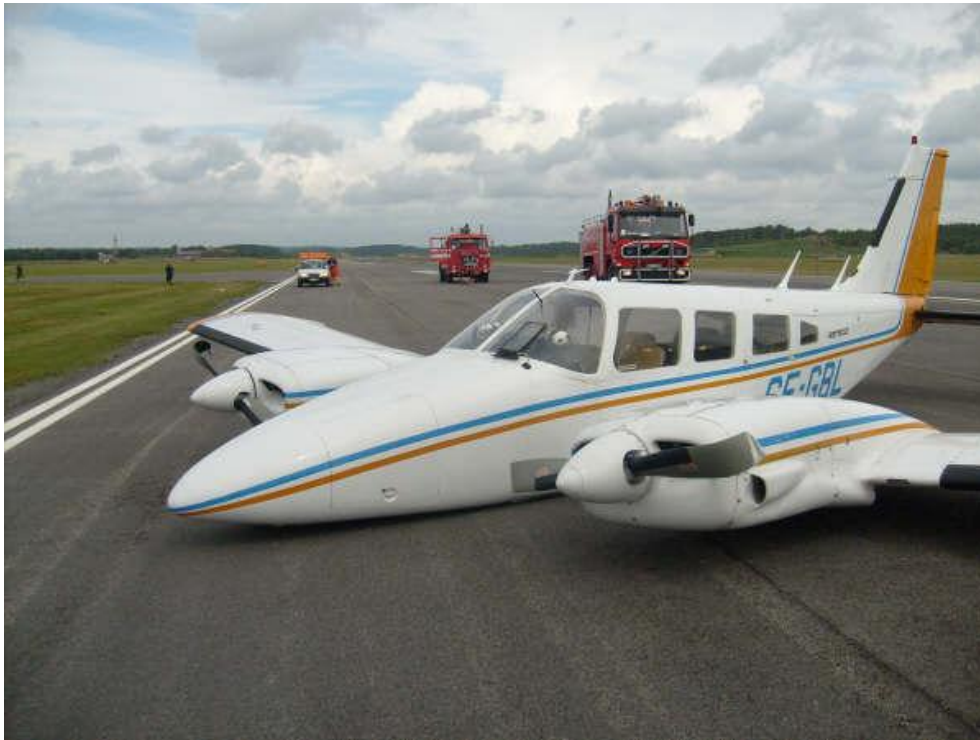
Fig. 5. The aircraft after the emergency landing.
Photograph: Säve Rescue Services.

As a result of the accident, the following damage to the aircraft was initially found:

- Damage to the landing gear and the landing gear doors
- Damage to both propellers
- Secondary damage to both engines
- Damage to the wing flaps
- Scraping damage to the underside of the aircraft
- Possible structural damage to an unknown extent

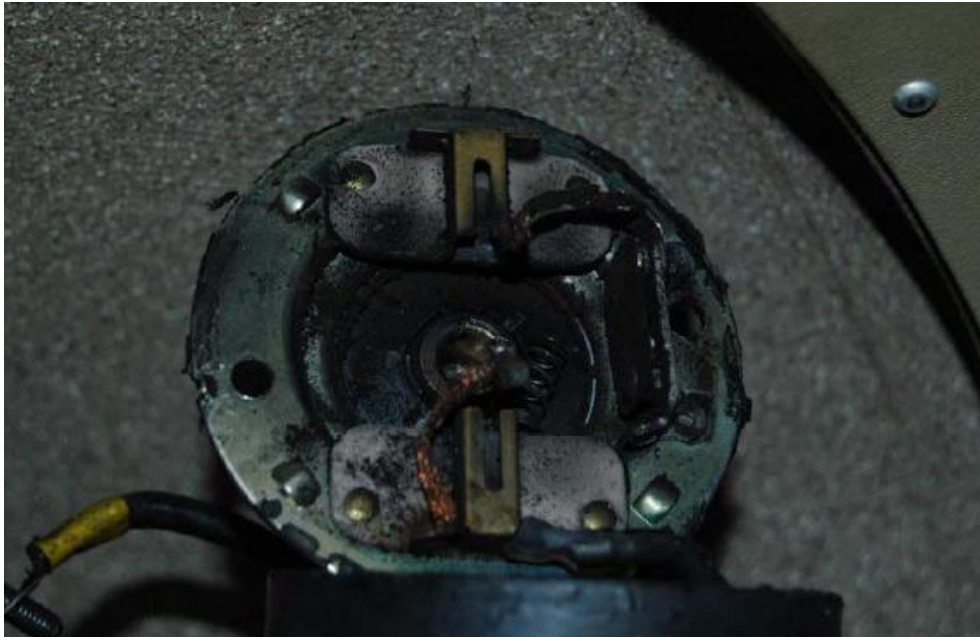
Fig. 6. The electric motor after dismantling. Photo: EMS AB.

The electric motor cover was removed so that the unit could be examined. It could then be seen that the internal moving parts, the commutator and the carbon brushes, were completely worn out.

Analysis of the technical fault that caused incorrect operation showed that the carbon brushes were worn out in the electric motor that drives the hydraulic pump. This fault was of a type that the pilot could not take any action that would extend the landing gear by using the normal aircraft system.

The inspection interval in respect of the electric motor was in the higher category, since this particular aircraft was not used for flight training purposes. However the components in the electric motor became worn and caused faulty operation of the unit long before the next inspection was due. SHK cannot however express an opinion on the length of the interval since it not known what the status of the electric motor was at the time of the previous inspection.
