**Statens haverikommission**  
Swedish Accident Investigation Board

***Report RL 2010:08e***

**Aircraft incident to LN-RRX in airspace  
over Östergötland county, Sweden  
on 5 October 2009**

Case L-17/09

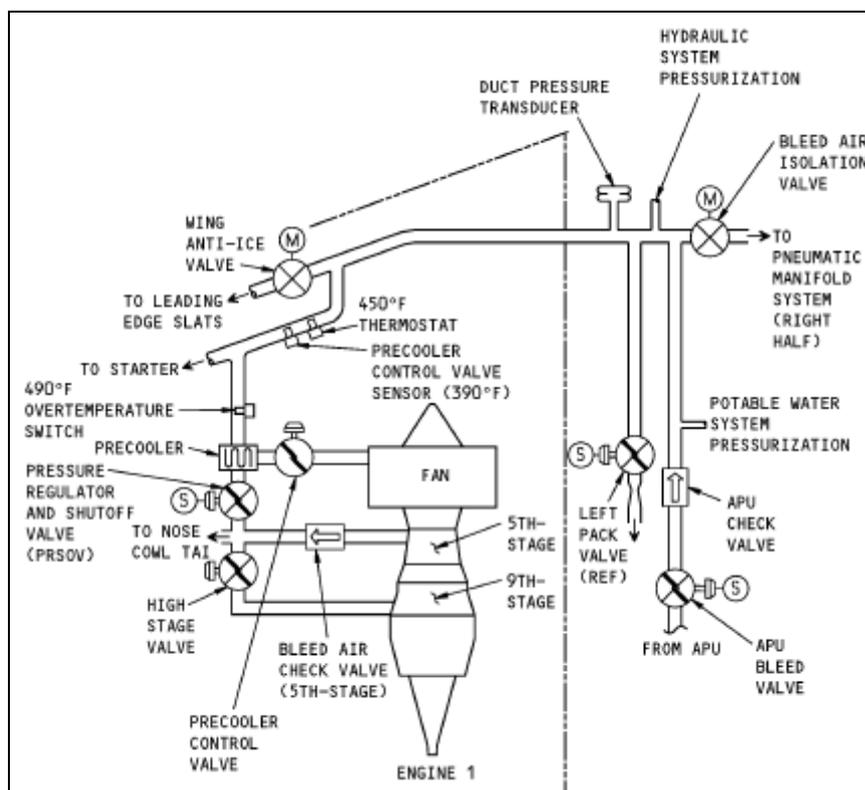
Fig. 1. Air bleed system (left engine)

The engine air bleed control system, Fig. 1, in this particular type of aircraft is an older design and consists of a number of pneumatic and electrical components which to a certain extent work together in an “analogue” fashion. The system is located in the space between the engine compressor casing and the engine cowl. The engine air bleed system operates in a demanding environment, with large pressure and temperature variations, both within the system and its surroundings.

Each engine has a Bleed Air System, which among other things supplies the air conditioning system with bleed air. Air is bled from the engine compressor via two Bleed Valves located on the compressor casing at compressor stages 5 and 9. The air bleed valve at stage 9 is called the High Stage Valve (HSV).

Before bleed air is pumped into the air conditioning system it must be cooled and have its pressure regulated. The pressure is regulated by a Pressure Regulating and Shutoff Valve, which is controlled by an electro-pneumatic control unit, the Bleed Air Regulator. The Bleed Air Regulator receives its information from a number of pressure and temperature sensors in the system.

After the incident the engine air bleed system was once again inspected in accordance with the “Health Check” whereupon it was found that the valve flap in the HSV for the right engine was not operating properly. When this unit was changed, the system operated without remarks and the aircraft was returned to service without any limitations.

On inspecting the removed HSV in a specialist workshop, it could be verified that as a result of jammed piston rings the unit would leak in its closed position.

It appears that both the disturbance suffered by the air bleed system several days before this particular incident and the incident itself were caused by a jammed flap in the HSV. After this valve had been changed the system worked without remarks and a component fault was verified after the change.

Leakage through the valve probably resulted in an excessive flow of hot bleed air from the engine entering the system, which thus overheated and was automatically switched off. It is not unusual for this type of fault to be of an intermittent nature, which can explain why the system operated normally in between the complaints. The components are subjected to harsh internal and external environments in the form of such stresses as vibration and large temperature variations, which could explain the disturbances.
