**Statens haverikommission**  
Swedish Accident Investigation Board

***Report RL 2010:15e***

**Accident to aircraft SE-LYK at Vinsta,  
Stockholm County, Sweden,  
on 8 August 2008**

Case L-20/08

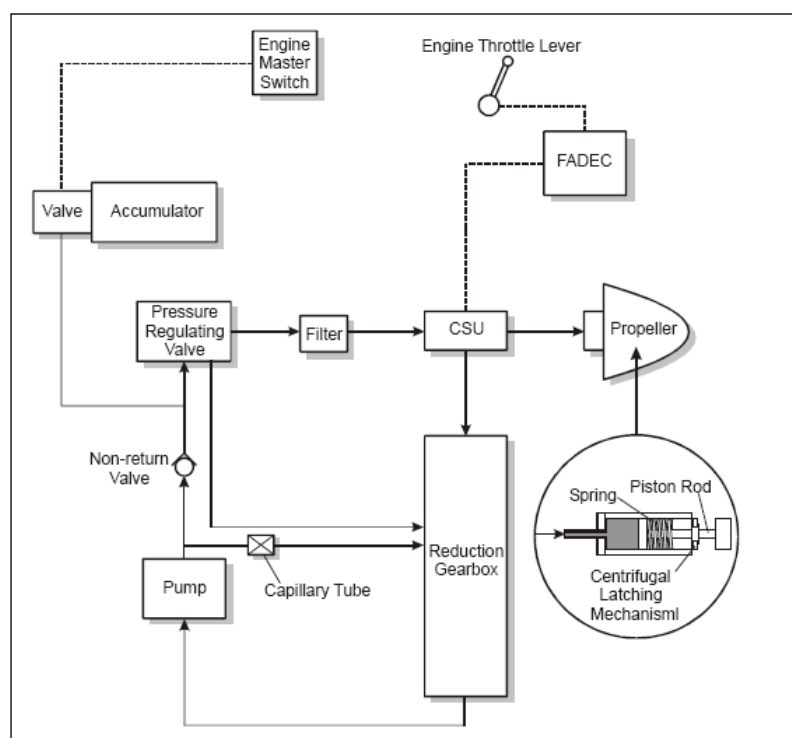
Figure 2. Propeller pitch change mechanism

Hydraulic oil from the engine hydraulic pump is pumped to the pitch change mechanism in the propeller hub. An electrically-operated valve called the Proportional Pressure Reducing Valve (PPRV), included in the CSU, regulates the flow of oil from the propeller hub. This enables the hydraulic pressure in the system to be regulated. The valve is a solenoid valve, which consists of a simple magnetic coil with a movable soft iron core connected to a valve piston.

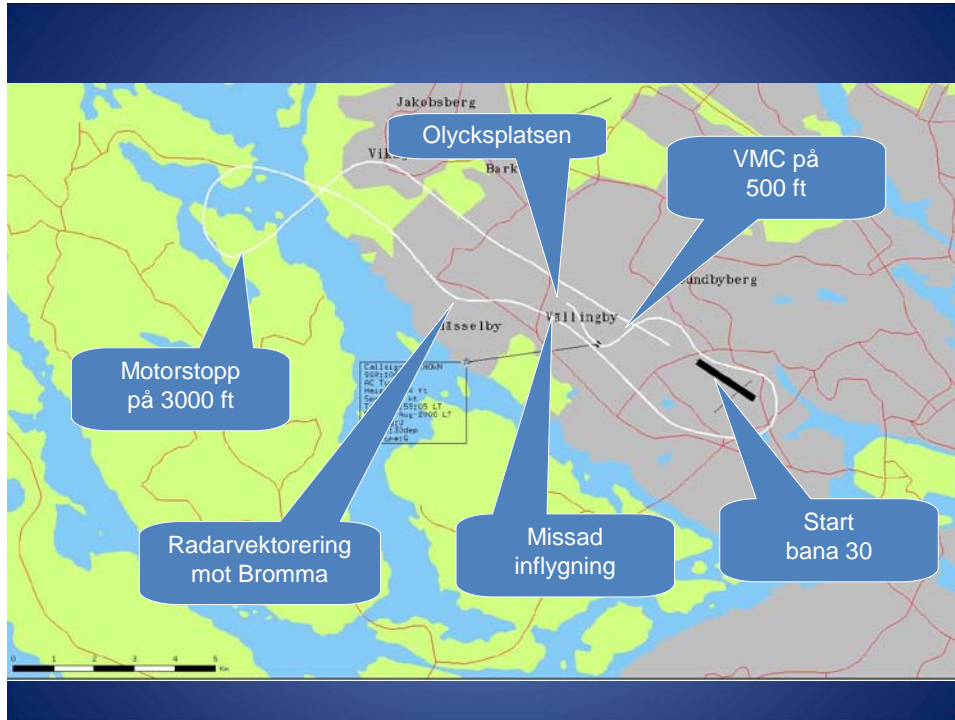
Figure 5. Radar plot

Olycksplatsen	Accident site
VMC på 500 ft	VMC at 500 ft
Start bana 30	Take-off from runway 30
Missad inflygning	Missed approach
Radarvektorer mot Bromma	Radar vectoring towards Bromma
Motorstopp på 3000 ft	Engine stopped at 3,000 ft

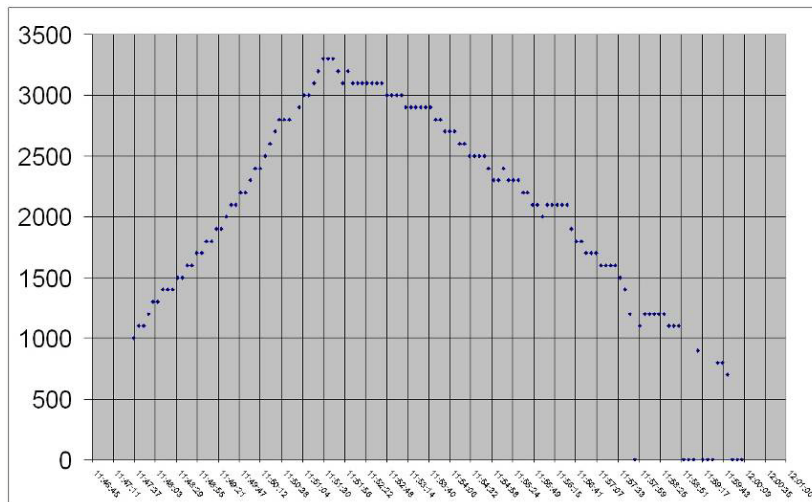
Figure 6. Altitude profile of the flight

The altitudes are stated with reference to the pressure level of 1013 hPa. Taking into account the air pressure at the time and the height of the airport above sea level, the stated altitudes must be reduced by approximately 500 feet to obtain the height above the airport. The engine stoppage occurred at the highest altitude on the curve, after which the altitude reduced relatively smoothly at about 300 ft/min.

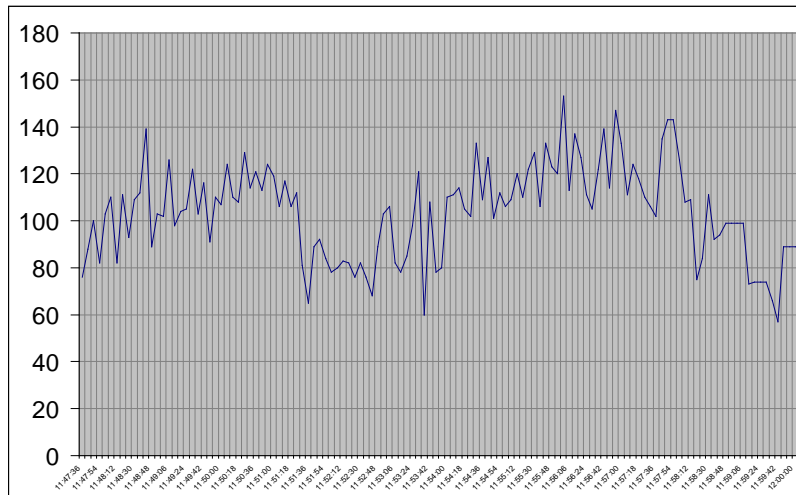
Figure 7. Ground speed of the flight

The radar recording shows that the speed relative to the ground was high during much of the flight. Even if the ground speed is corrected by wind speed, it is probable that the air speed was higher than that recommended for single-engine flying, i.e. 82 knots.

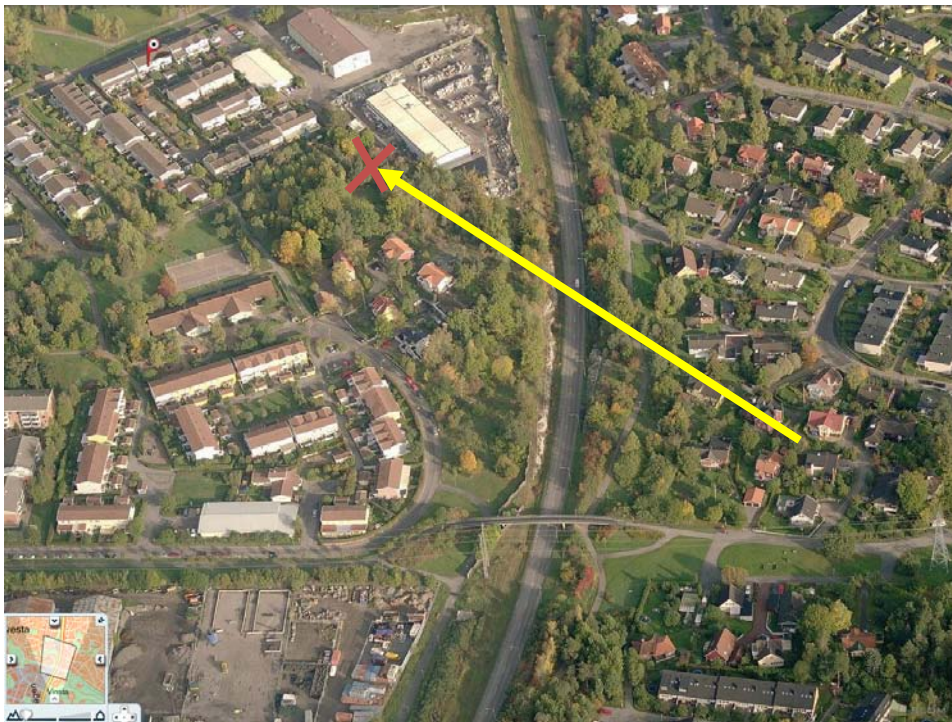
Figure 8. Photograph of the accident site

The accident site was a wooded area located between an industrial area and a residential area.

The yellow arrow indicates the direction of approach and the red cross indicates the accident site.

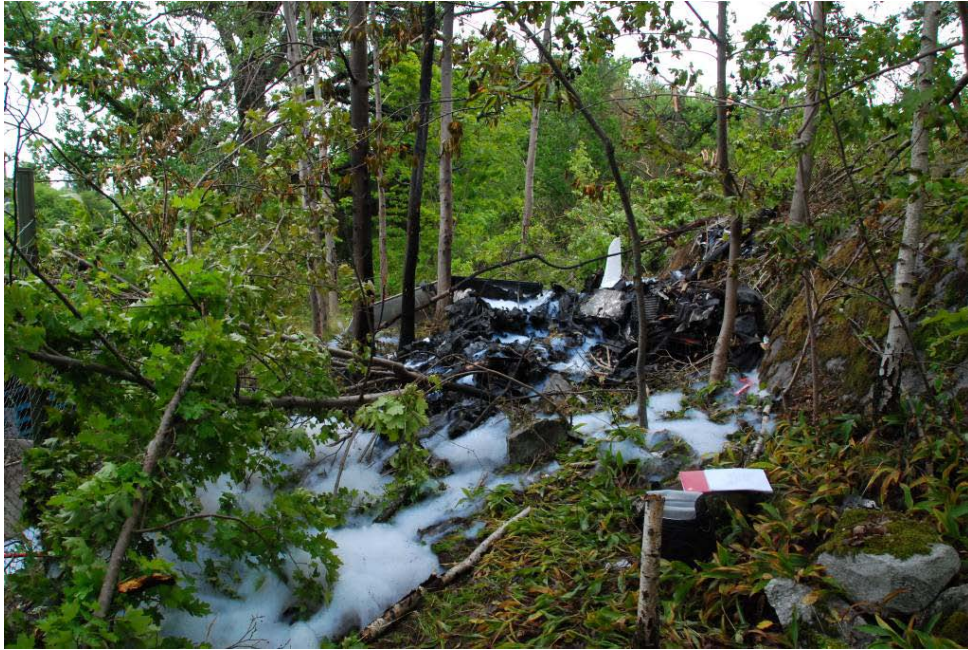
Figure 9. The aircraft wreckage

The aircraft burned out almost completely. Only the two engines and propellers, some metal parts and small composite pieces remained.

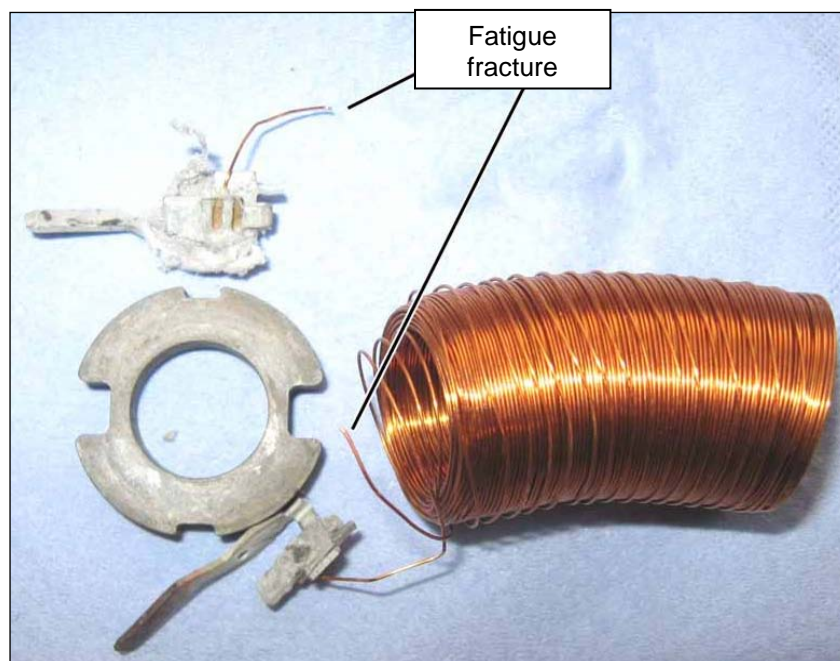
Figure 10. Solenoid winding of the PPRV valve

During the examination of the propeller pitch change mechanism it was found that the PPRV was not working and was in its fully open position.

During fault tracing on the PPRV it was found that faulty operation of the valve was caused by an electrical open circuit in its solenoid winding. The copper wire of the winding had broken at the soldered junction to one of the two connection pins of the valve, due to a fatigue crack. (See the photograph below.)

According to the engine manufacturer seven previous cases had been documented where there had been serious engine malfunctions caused by faulty operation of the PPRV. In all these cases it had been found that the copper wire forming the solenoid winding had broken. It was suspected that the breaks were due to metal fatigue resulting from vibration of the gearbox.

No technical faults were found in the right hand engine, except for the fault that was found in the PPRV in the propeller pitch change system. The faulty operation of the valve, which meant that it suddenly opened completely, meant that the hydraulic pressure in the pitch change mechanism immediately fell. Since the engine stoppage occurred during normal flight, the propeller rotation speed was greater than 1,300 rpm. The loss of pressure meant that the balance weights in the pitch change mechanism could without hindrance alter the blade angle to the maximum, i.e. 81°, which is equivalent to “fully feathered”.

Because faults have occurred in the propeller pitch change mechanism, the engine manufacturer published Service Bulletin (SB) TM TAE 125-0018 on 19 June 2008. This prescribes that PPRV units which have been installed on gearboxes and have accumulated between 300 and 400 flying hours must be replaced within 10 flying hours or during the next periodic maintenance inspection, whichever occurs first. If a PPRV unit has accumulated more than 400 flying hours it must be replaced within 50 flying hours or during the next periodic maintenance inspection, whichever occurs first. The valve must thereafter be replaced by a newly reconditioned unit at every 300 hours.

The modification to the CSU installation on the propeller gearbox that was initiated by the manufacturer after the accident, and that was prescribed in the Thielert SB TAE 125-0020, was, in the SHK view, relevant to solving the problem and ensuring flight safety. This measure was also prescribed in the EASA AD No.: 2009-0193, and SHK sees therefore no reason to issue any recommendation in this respect.

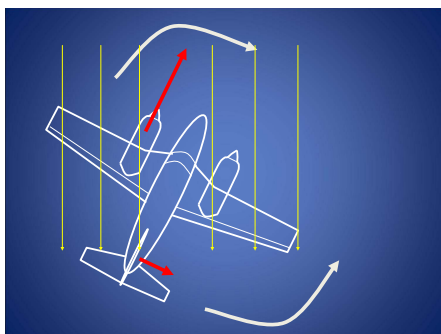
If there is no or too little rudder applied, the aircraft can become stabilised in a yawed state, with side-slip. The tail fin will then act as a weather vane and generate a side force that compensates for the asymmetric drag. In that case the longitudinal axis of the aircraft will not be parallel with the direction of movement, meaning that the wind speed from ahead will push on the aircraft from one side (side slip). This in turn means that there will be an increase in drag due partly to the fuselage and engine nacelles “crabbing” through the air, and partly because the efficiency of the wings reduces, so that their ability to produce a lifting force falls as the drag increases. This in turn results in an increase in the lowest possible flying speed. The aerodynamic vibrations that indicate too low a speed can then be felt at a higher speed than normal. See also the following Figures.

The above Figure shows the forces that arise if insufficient rudder is applied.
