Statens haverikommission
Swedish Accident Investigation Board

Report RL 2010:14e

**Aeroplane incident to OE-GVA on approach to
Stockholm/Bromma airport in Stockholm
County, Sweden on the 26th of November 2008**

Case L-28/08

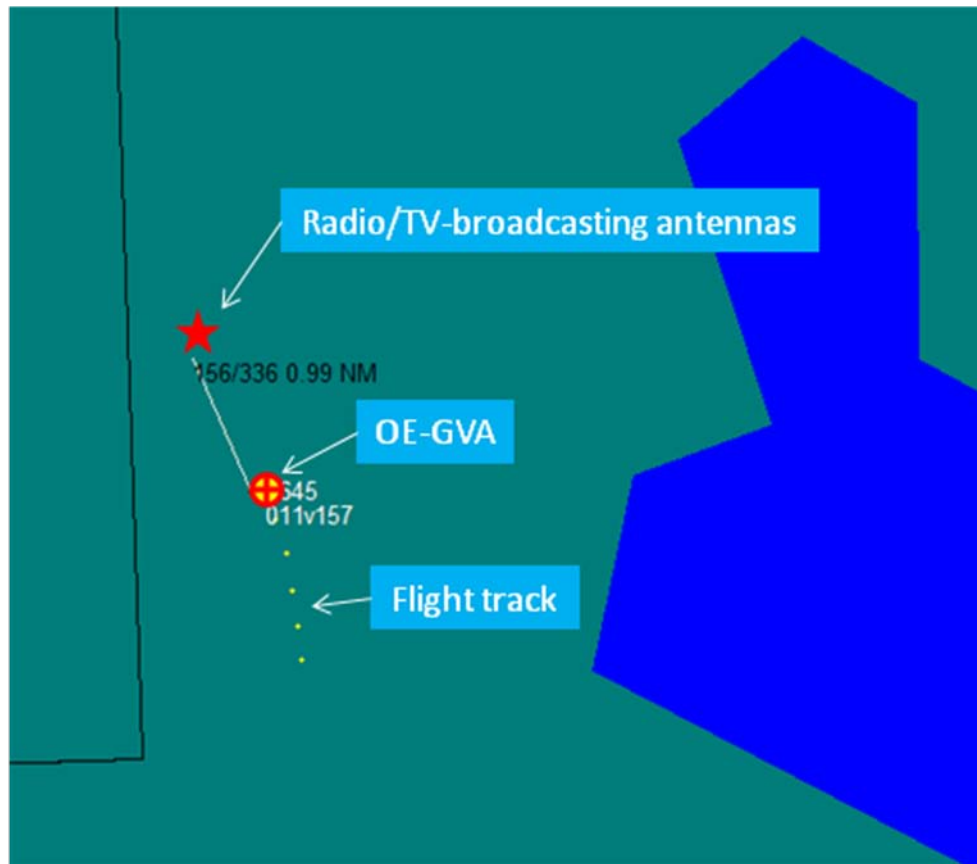
Fig. 5. Zoomed radar image showing the position of the aeroplane at the lowest recorded altitude.

The numbers in Fig. 5: 156/336 0.99 NM, represent: bearing in degrees to and from the antennas, and the distance to the aeroplane in Nautical Miles – 0.99, this corresponds to about 1.83 km.

The altitude of the aeroplane is 1 100 feet, according to Fig.4. At the incident the air pressure was 996 hPa, i.e. 17 hPa lower than the standard air pressure of 1013.2 hPa, STD²⁰. 1 hPa corresponds to an altitude difference of about 30 feet. The current pressure corresponds to an altitude difference of about 510 feet ($17 * 30 = 510$ feet), i.e. about 155 m. Since the reference pressure surface in this case is below the surface of current QNH, the altitude of the aeroplane was $1\ 100 - 510 = 590$ feet, corresponding to about 180 m above the ground.

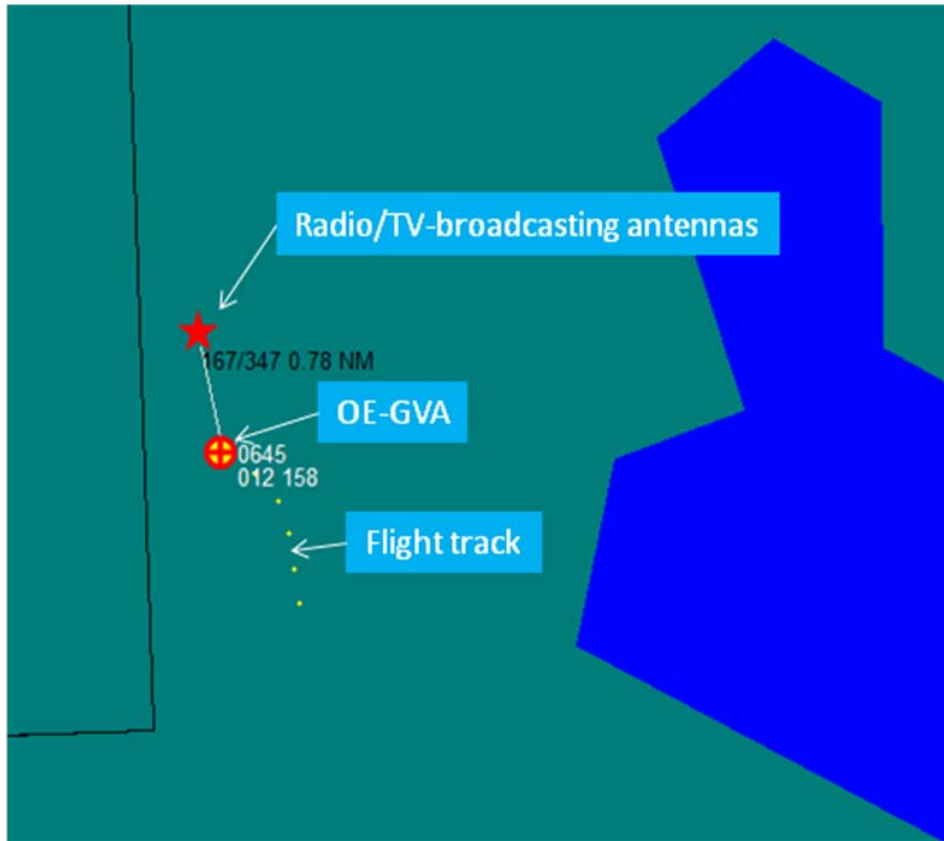
Fig. 6. Zoomed radar image showing the position of the aeroplane at the minimum recorded distance to the radio/TV broadcasting antennas.

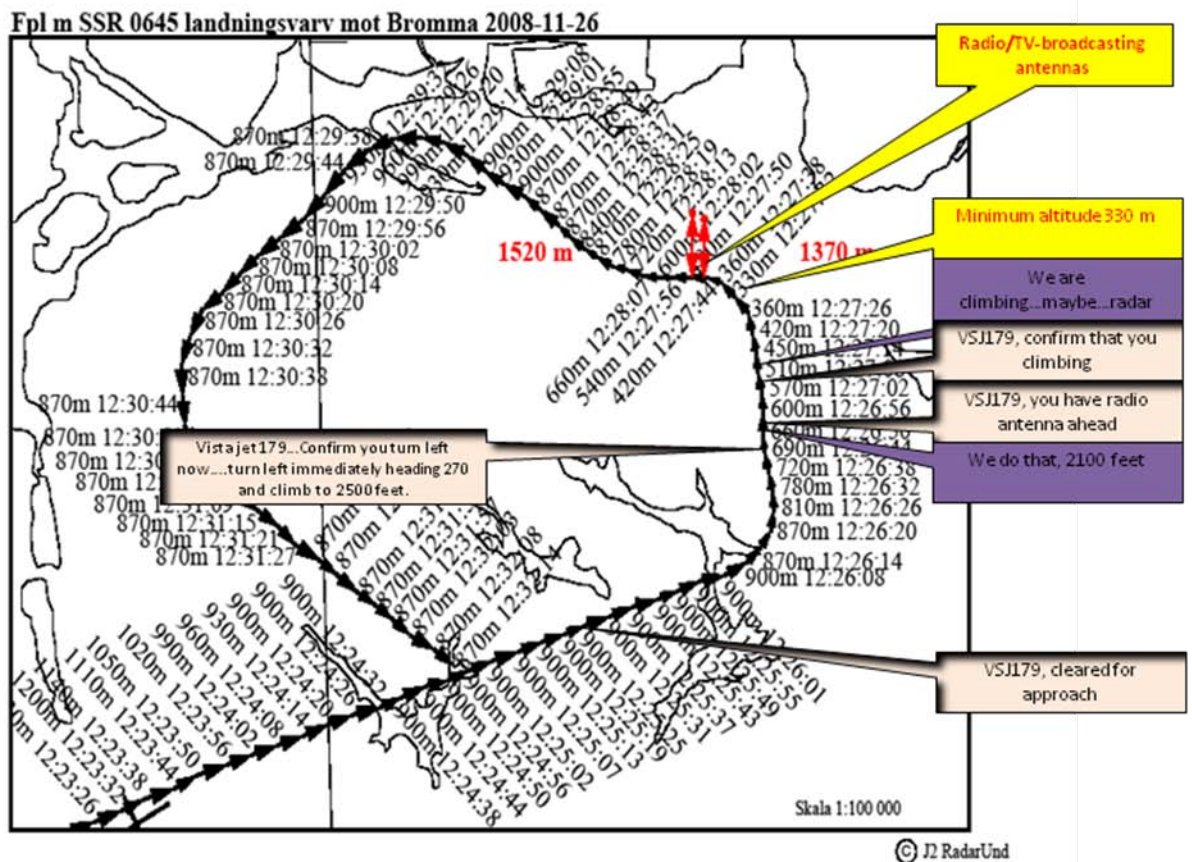
Fig. 7. The MUST-radar recorded altitude of the aeroplane at different times during the incident, with the radio communication between ATC and the aeroplane superposed. The ATC-transmissions are shown within shaded frames.

Fig. 7 shows that the aeroplane was maintaining the cleared altitude (900 m STD – 2 500 feet QNH) until the left turn was initiated at about 12:26:08 hrs. The aeroplane turned to a northerly heading and continued to descend on this heading during about 80 seconds. During this time the aeroplane was instructed to turn left to 270 degrees and climb to 2 500 feet (QNH), and confirm that the climb was initiated.

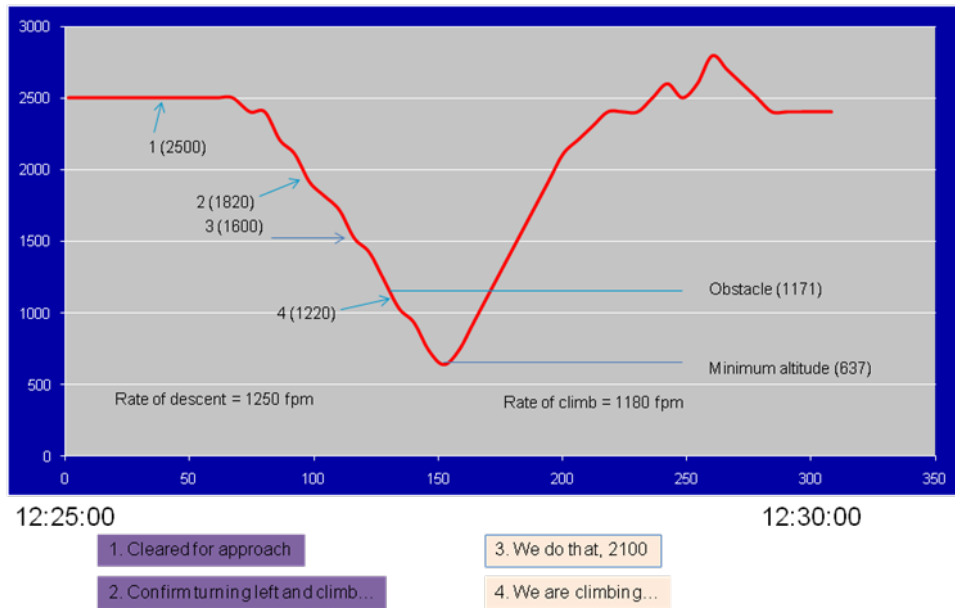
The altitudes in parenthesis in Fig. 8 indicate the altitude over the sea of the aeroplane corrected for actual air pressure. The numbers 1 – 4 indicate the radio communication between the aeroplane and the ATC.

Fig. 8. Diagram of the aeroplane's altitude in feet QNH, with some of the radio communications, numbers 1 - 4. The time sequence is shown on the horizontal axis.

After the Commander at 1 220 feet reported "We are climbing", the airplane continued to descend for another 24 seconds, see Fig. 8, to the lowest recorded altitude of about 650 feet. SHK could not find any obvious reason to this. However, there was probably a very high level of stress amongst the pilots at this point of the flight. The ATC had repeatedly instructed the pilot to turn and warned about obstacles in the direction of the flight, while the pilots probably still were busy with finding the reason to the failed turn. In this phase the GPWS-warning was also triggered. This warning is a loud voice and light signal that continues until the airplane is heading away from the obstacle and climbing. The pilot's stress level was probably further increased by the warning and ultimately triggered the Commander to regain the controls, turn and climb away from the obstacle.

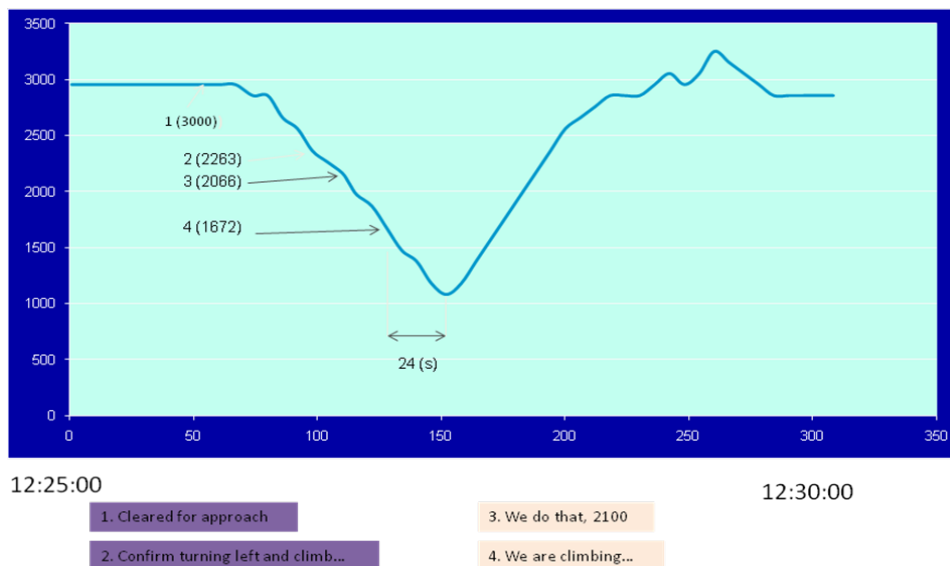
Fig. 9 shows the same time sequence with the altitudes in feet on an altimeter adjusted to STD air pressure.

Fig. 9. Diagram showing the aeroplane's altitude in feet STD, with some of the radio communications, numbers 1 -4.
