Statens haverikommission
Swedish Accident Investigation Board

Report RL 2010:05e

**Incident involving aircraft D-ACPE
and OH-SAK at Göteborg/Landvetter
airport, Västra Götalands county,
on 7 December 2007.**

Case L-32/07

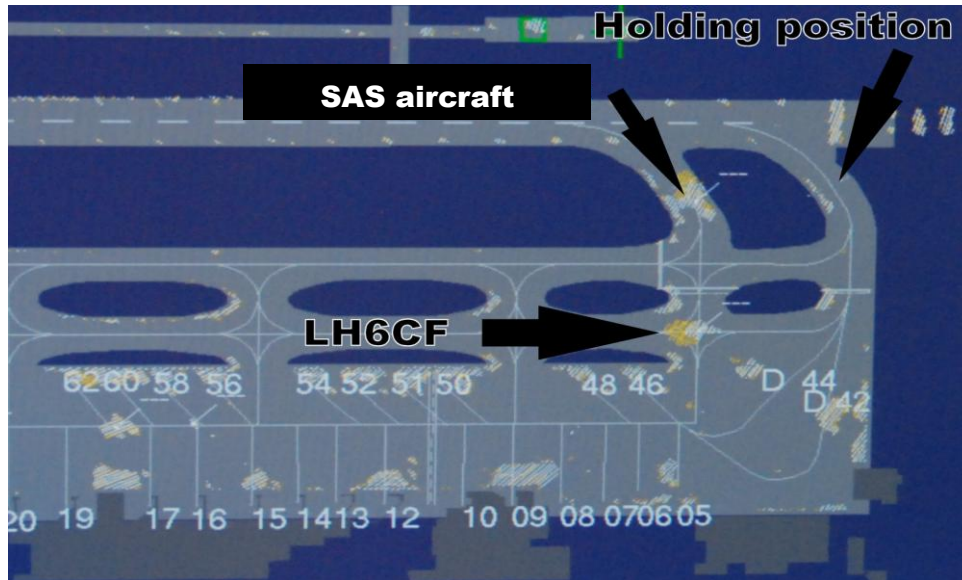
The illustration at Figure 1 shows the positions of the aircraft, where LH is taxiing on taxiway Z and the SAS aircraft is about to taxi in via taxiway Y. The illustration also shows the holding position, to which the air traffic controller had given LH clearance. At the time the aircraft were at the positions shown in the illustration, LH was instructed to contact the control tower on a new frequency, which was acknowledged correctly by the first officer, who was managing the radio communication during taxiing.

Fig.1. Ground surveillance radar image showing the positions of the aircraft.

The LH crew did however not contact the control tower on the new frequency, but continued to taxi past the holding position for runway 21 and lined up on the runway. At the time it was dark and visibility was reduced due to light rain that had begun to fall.

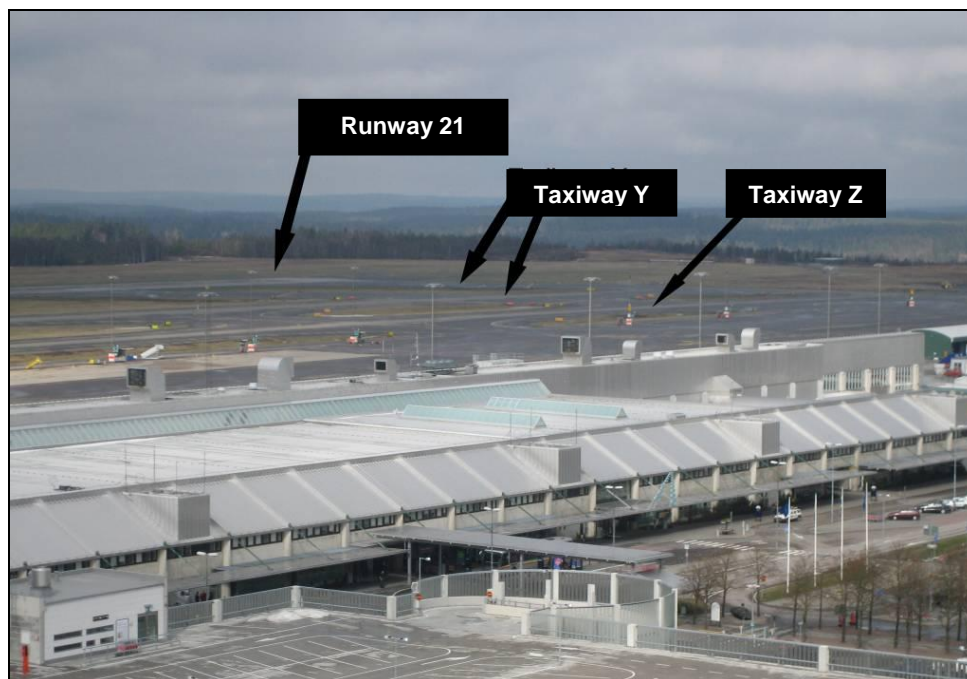
The reason that “full length” was stated, and that the taxiway was not given its name, was that the air traffic controller considered that the whole of the long taxiway was called Yankee, (Y), including the entrances after 90 degree turns. According to the air traffic controller, the taxiway was called Y at three different places and this could lead to misunderstandings (compare with Figure 2).

Fig.2. View from the air traffic control tower.

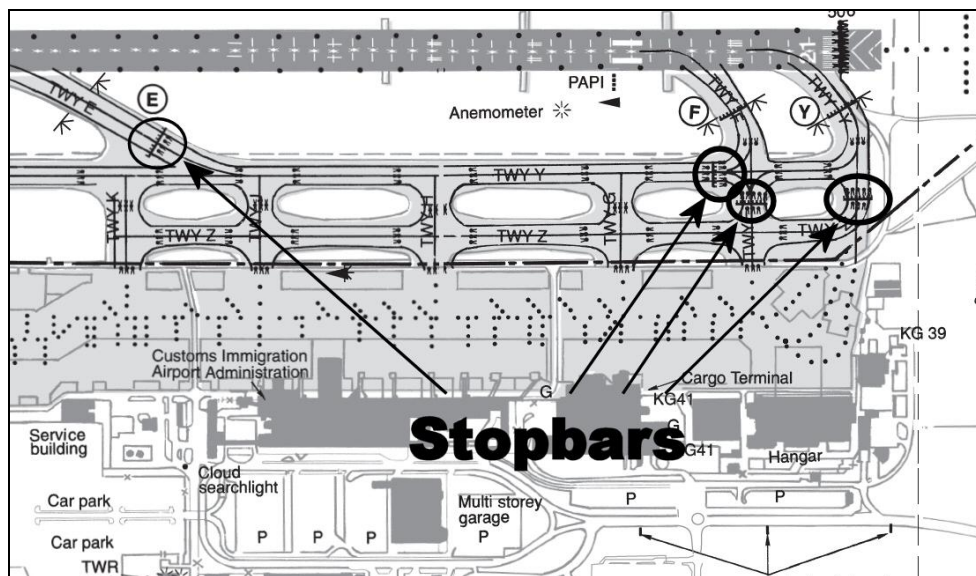
The airport status was in accordance with AIP³-Sverige/Sweden. The runway entrances are equipped with stop bars, i.e. a row of red lights submerged in the taxiway asphalt. Stop bars are however only located at the holding positions that are called CAT II holdings, i.e. places to wait further away from the runway, and are used in very poor visibility. At this particular time these holding positions were not in use.

Fig.3. Runway 21 showing the stop bar locations.
