Final report RL 2013:12e

**Serious incident on 1 July 2012 involving
the aircraft TC-SNM and TC-SUO at
Stockholm/Arlanda Airport, Stockholm county.**

Ref no L-59/12

2013-07-01

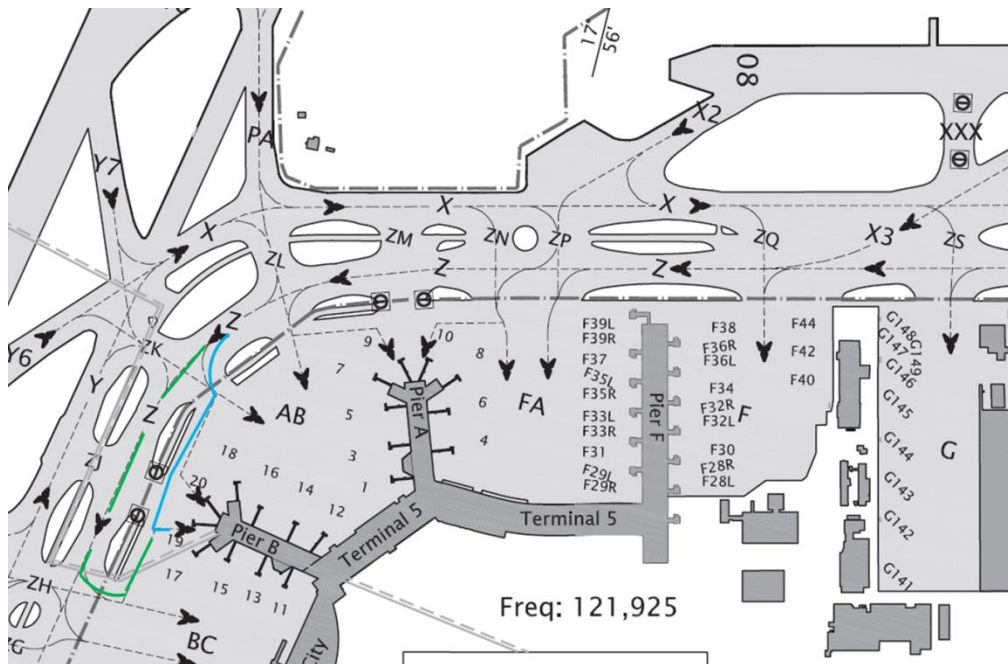
After landing on runway 26, the aircraft was cleared by air traffic control to “*taxi to stand 19*”. According to AIP⁸-Sweden's published taxiing instructions for arriving aircraft to stand 19, entry ZH to apron BC must be used (Fig. 2). However, after taxiing on taxiway Z, the aircraft performed a left turn at entry ZK in order to arrive at apron AB.

Fig. 2. AIP Sweden with a map of ground movements for arriving aircraft. The route taken by TC-SNM is marked in blue. The published taxi route has been marked in green.

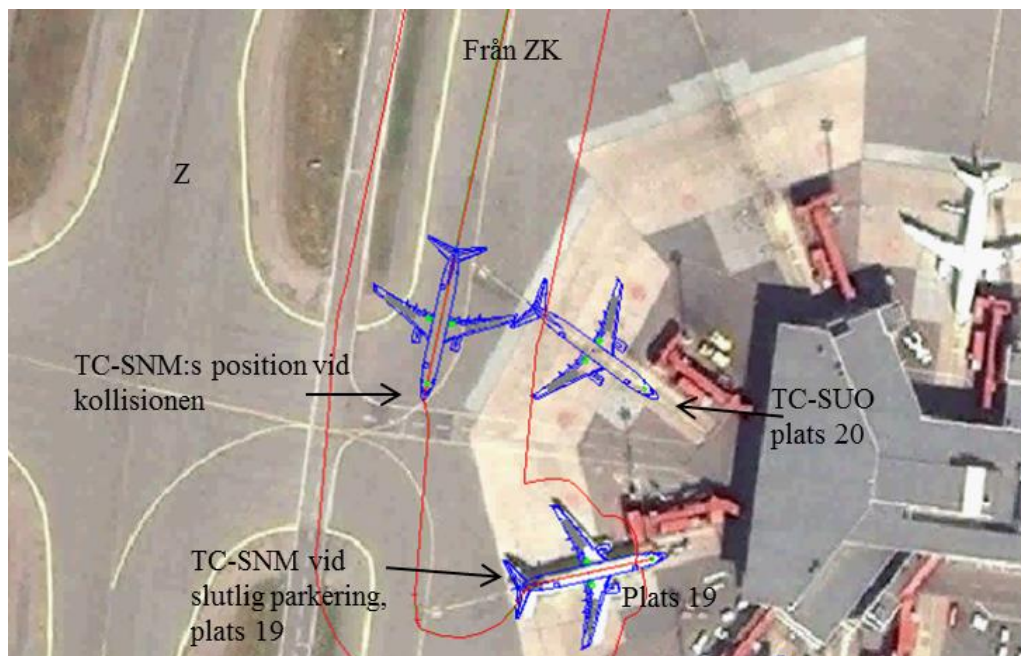
TC-SNM then turned right, whereby the aircraft's left wingtip later collided with the right elevator of an aircraft of the same type and operator with registration TC-SUO, parked at stand 20 (Fig. 3).

Figure 3 has been taken from a video sequence from a simulation of the situation based on data from the A-SMGCS⁹ recording. The sequence has been provided by Swedavia¹⁰ and shows, among other things, markings for the relevant taxiways and apron. The figure shows TC-SNM's route via entry ZK to stand 19. The image shows TC-SNM's position in relation to the centre line and the parked aircraft TC-SUO.

Fig. 3. TC-SNM's position at the time of collision.

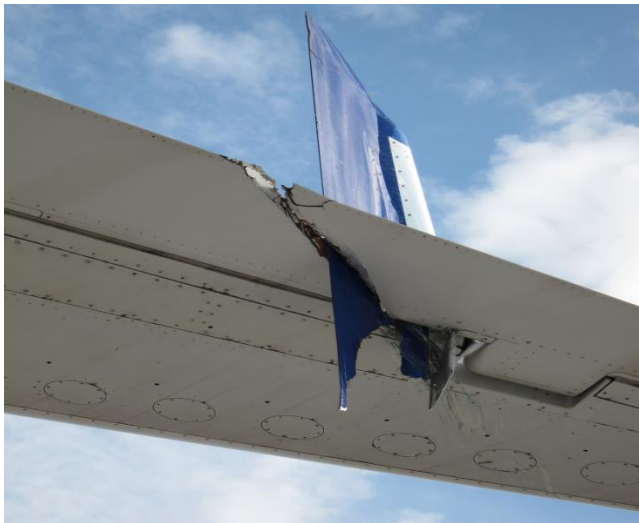
The upper part of the left winglet¹³ of aircraft TC-SNM was torn off and became lodged in the right elevator of the parked aircraft TC-SUO (Fig. 4).

Fig. 4. TC-SNM's winglet and TC-SUO's elevator. Photo: SHK.

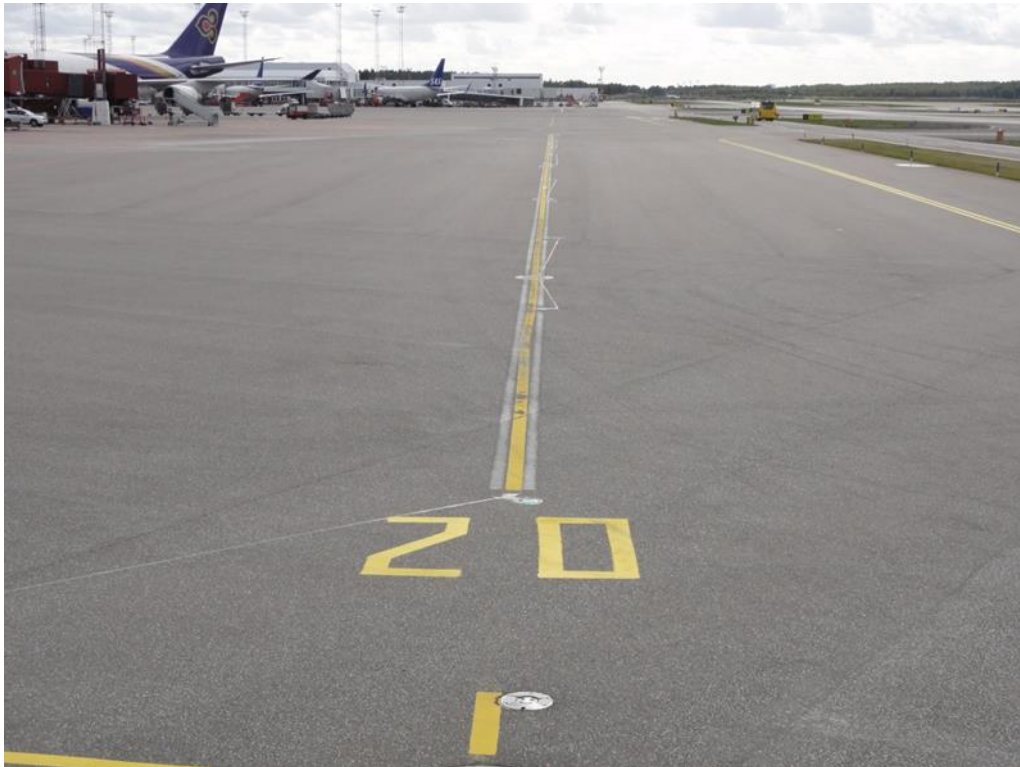
Fig. 6. South-facing view from cockpit height. Photo: SHK.

The co-pilot was of the understanding that the yellow marking that led from ZK past stand 20 also continued to stand 19 (see Fig. 6). He stated that the transponder was active and that there were ground crew at stand 19 who he expected would react if there was no obstacle clearance for passage.

Just after performing the turn at ZK and towards the yellow marking (see Fig. 6), the co-pilot expressed concern on two occasions over whether the correct route had been chosen. He pointed this out to the commander, as well as his opinion that passage might not be possible. In this situation, the commander had probably not considered that their choice of route could be incorrect, given his understanding and expectations. This conviction was not broken during the continued taxiing. Pilots, like everyone, are prone to the unconscious tendency to continue with an original plan despite the fact that conditions may have changed. This is known as plan continuation bias²¹.
