Statens haverikommission
Swedish Accident Investigation Board

Report RL 2011:02e

**Accident to helicopter SE-JME
in Flatruet Härjedalen, Z County,
on 28 October 2009**

Case L-18/09

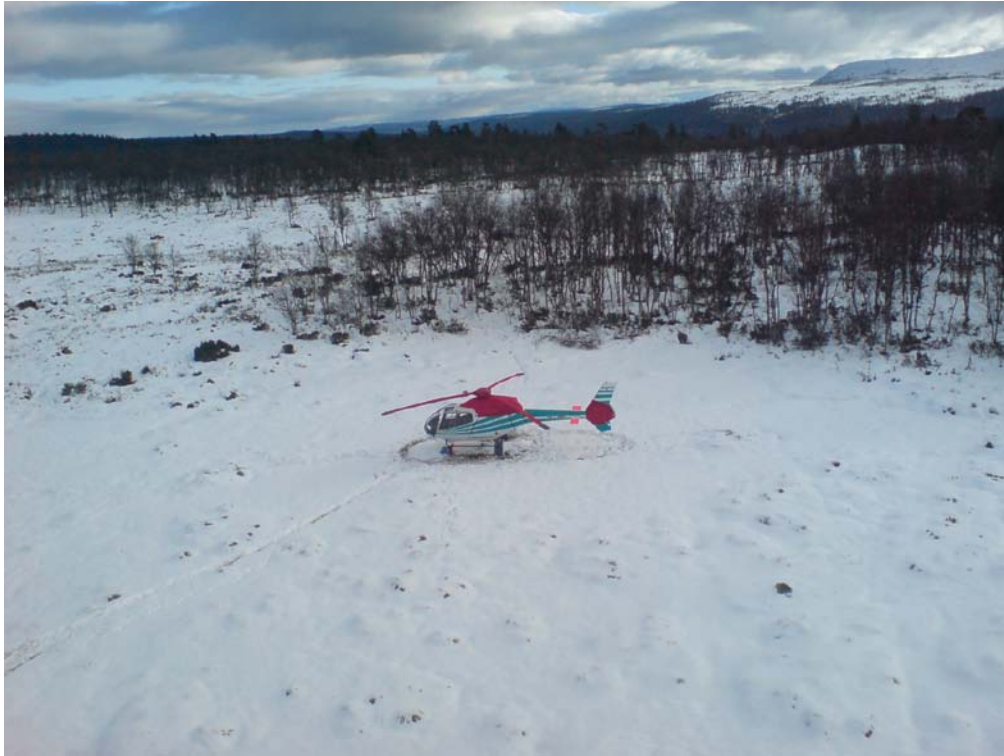
After examination of the helicopter, a large open crack in the main rotor hub was discovered along with several cracks in the tail section and the tail boom. The accident occurred during daylight and the helicopter landed at position N 62°41' 60 E 012°41' 46, 801 m above sea level.

Fig. 1 Landing site, the helicopter's nose is facing north.

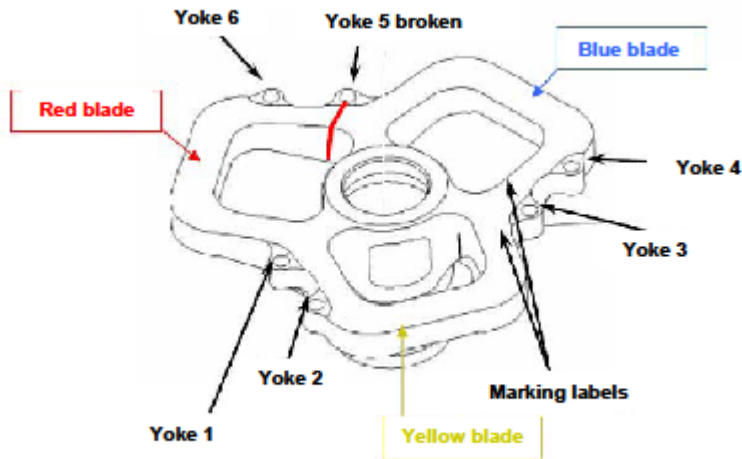
Fig. 5 The main rotor hub with a marked crack (broken) on the ear (yoke).

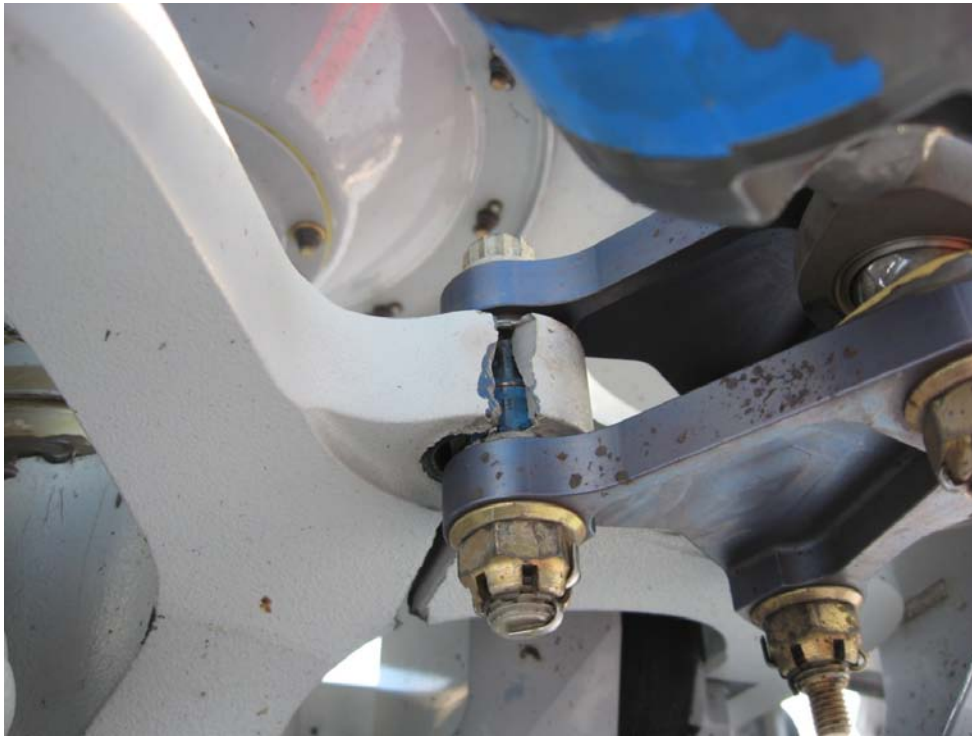
After the accident, the crack in the main rotor hub was discovered and was easily visible from the underside, when the observer stands on the helicopter foot step assembly, see fig. 7.

Fig. 7 The main rotor hub with a visible crack.

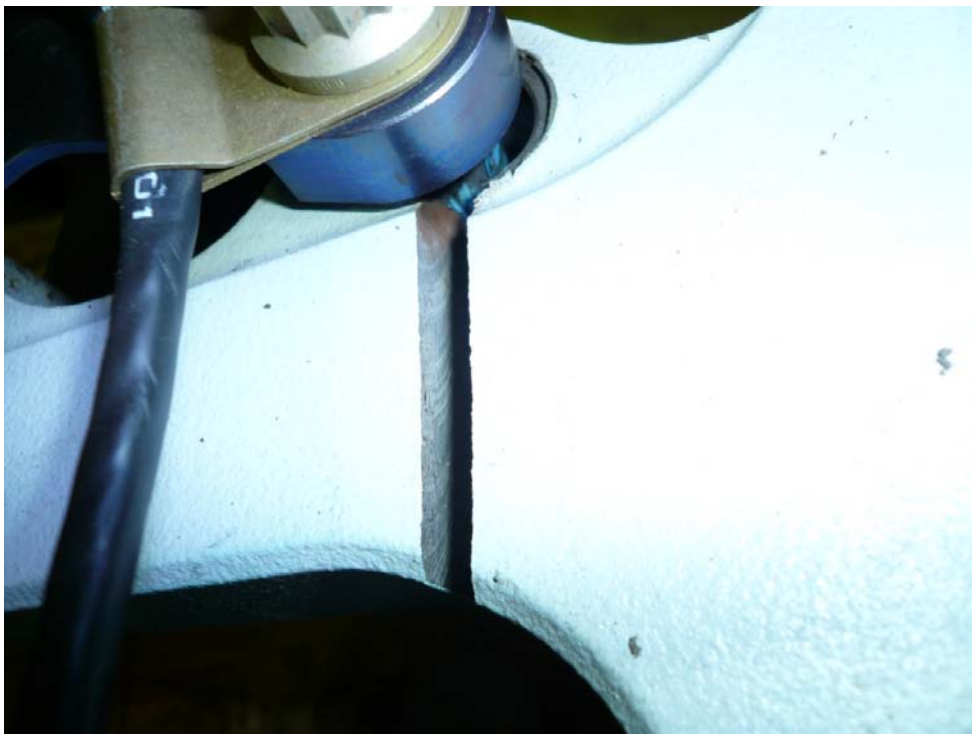
When not under load, the crack was open approximately 5 mm. The discoloration (brown) shows the area where the crack started under the blue-coloured bracket for the vibration damper, see Fig 8.

Fig. 8 Main rotor hub with fatigue crack, as seen from above.

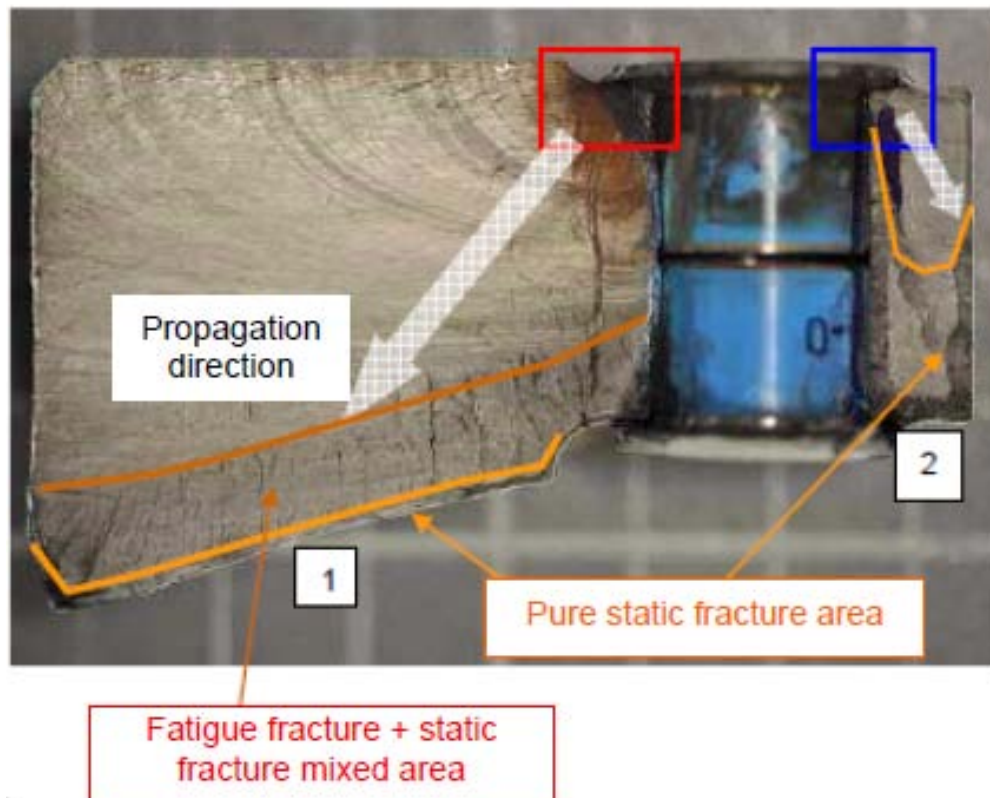
The fractured areas can be clearly seen from figure 9. Crack initiation first occurred in the red (inner) and then in the blue (outer) area of the ear, number 5 (yoke). The final fracture is highlighted in yellow and is the area under the yellow line out to the free boundary curve. The fractured surface area relative to the entire area of fracture is on the inside (red area= area 1) 70%/ 25%/ 5%; the first figure applies to the area with a pure fatigue crack. On the outer (blue area= area 2) the corresponding figures are 40%/ 60%. Area 2 has no zones with mixed fatigue failure and final failure. It can clearly be seen how little of the fracture area that remains once the final fracture occurred.

The striations (Macro Marks MM) are clearly visible on the images of the fracture surface, both primary MM1 and secondary MM2 can be identified.

Fig. 9 A cross-section through the main rotor hub ear (yoke) number 5 with marked fatigue zone, mixed zone and the zone final fracture (static fracture zone).

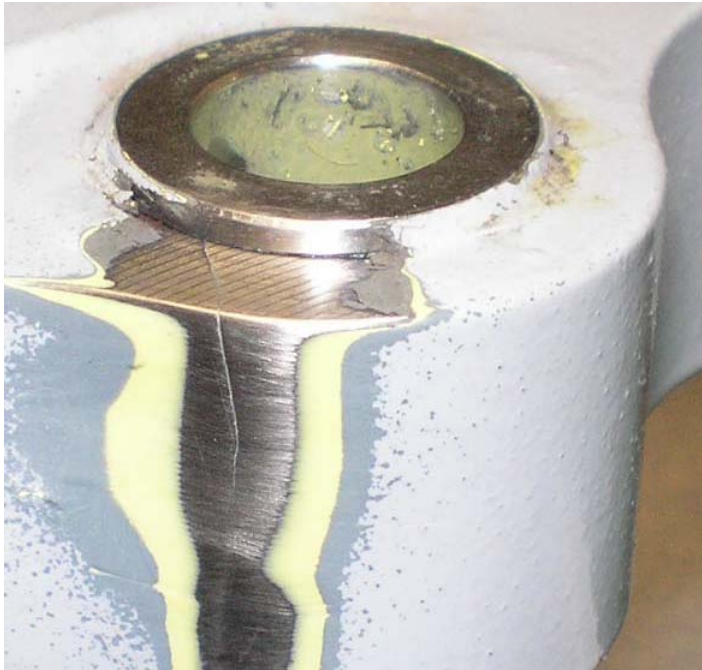
The time between crack initiation and visual detection was relatively short. The cracks were located in the same area of the main rotor hub, toward the outside of the ear on the hub and they were therefore relatively easy to detect, see fig. 10.

Fig. 10 Ear on the damaged rotor hub with exposed crack, item S/N 1070.

Helicopter S/N:	1070
Total flying hours rotor hub (Fh):	5031
Time since installation (Fh):	866

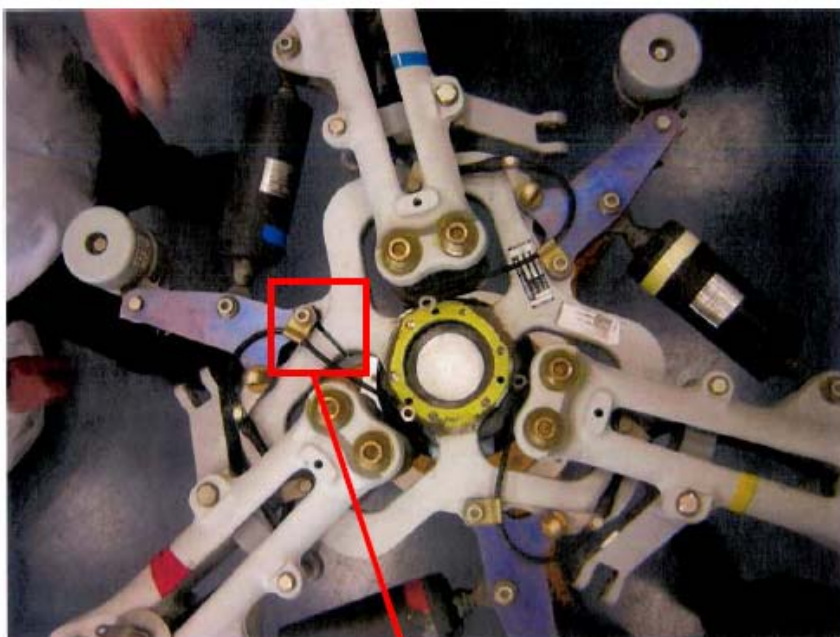
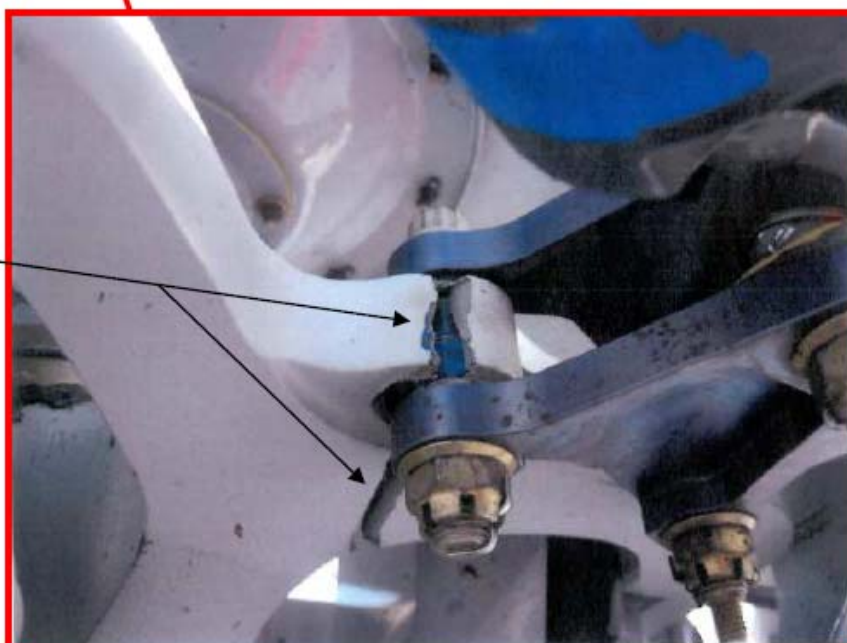
Before removal, the fracture could be observed at one of the yokes used for attachment of the drag dampers.

Detail of the total failure of the hub strap

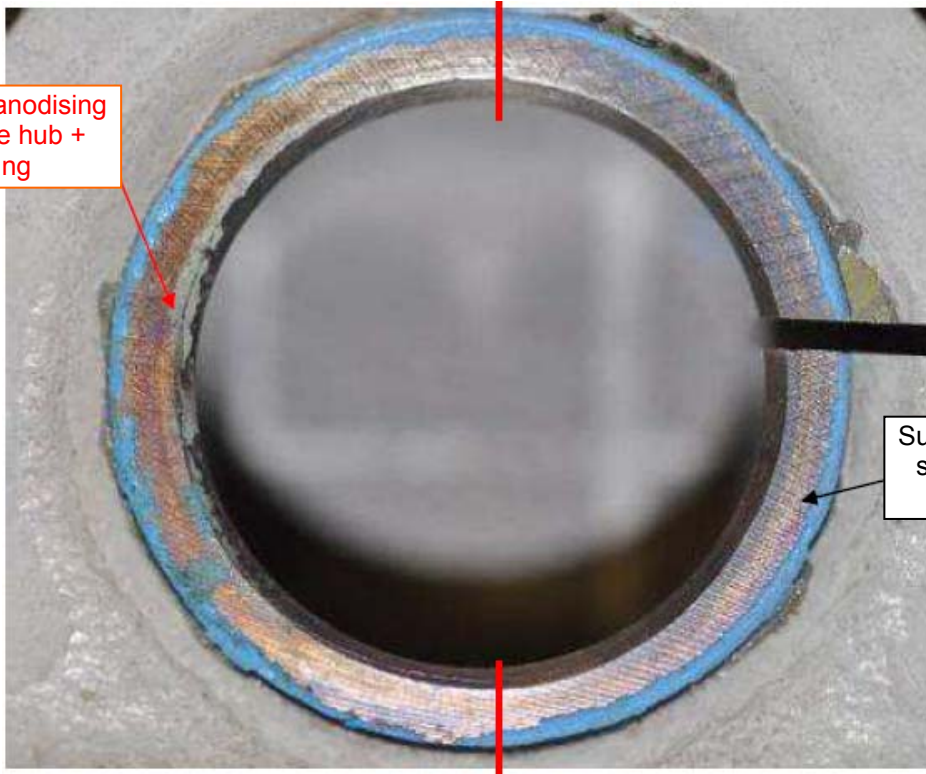
Sulphuric acid anodising slightly removed from the hub

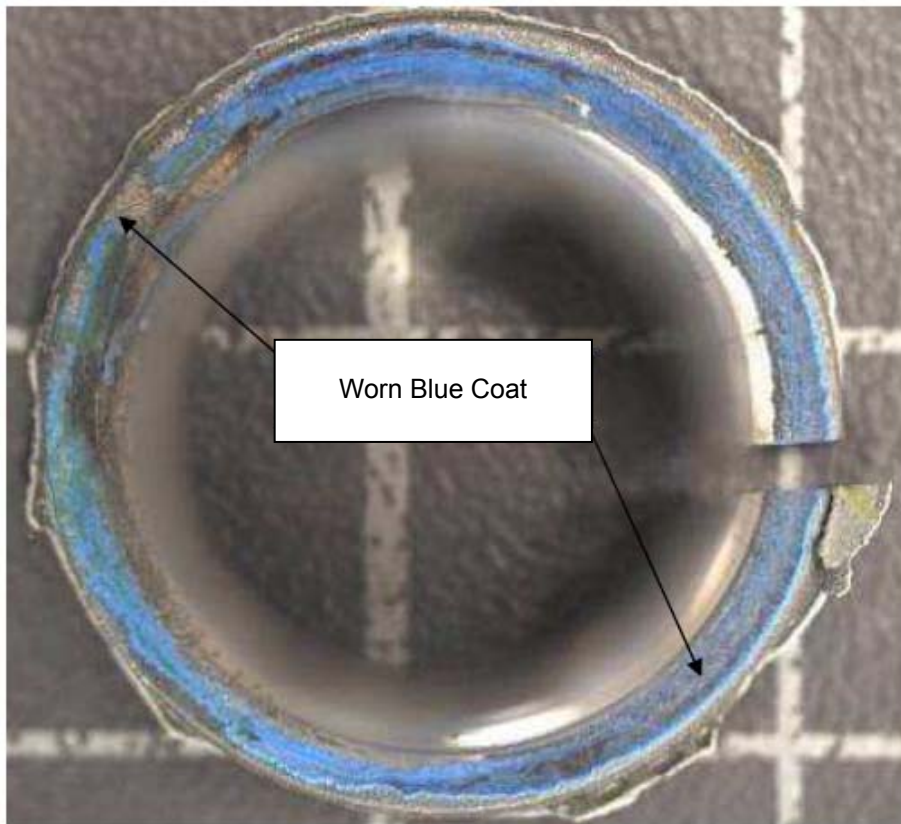
- FTi bush No. 2

Worn Blue Coat

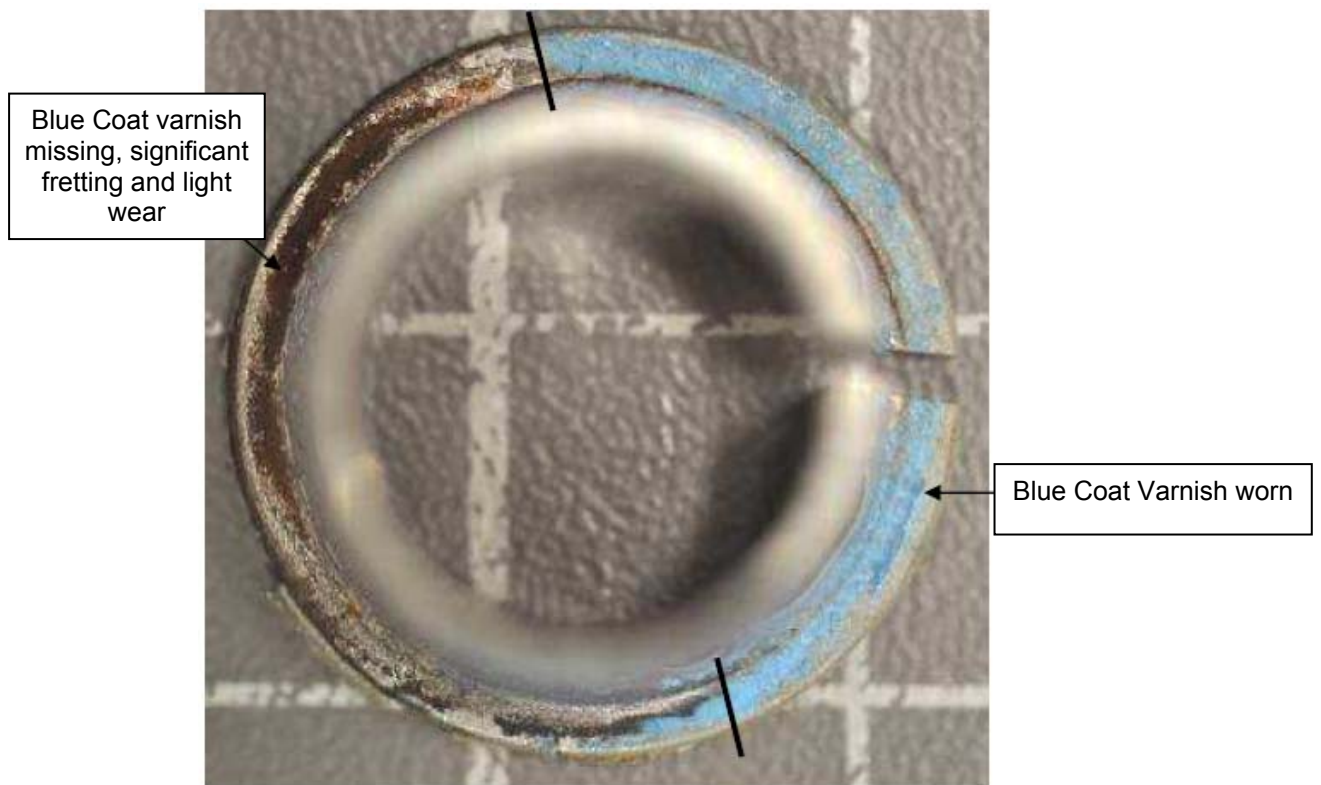
- Broken yoke No. 5

The crack found on "yoke 5" located between the red blade and the blue blade of hub body S/N M282 resulted from the initiation then growth of a gradual fatigue cracking phenomenon. The initiation area is located on the upper face of the titanium hub, under the shoulder of the FTi bush, in an area which resulted heavily damaged by fretting corrosion. As a matter of fact, under the shoulder, we noticed that the Blue Coat varnish was missing. The observations made under the FTi bushes of the other yokes revealed similar deteriorations, however in a less advanced stage. The number of main macroscopic marks was estimated to approximately 210 over the entire fracture surface. The examination with a field-emission scanning electron microscope revealed a striation whose Da/Dn varies from $2.63 \cdot 10^{-5}$ mm/cycle in the initiation area to $5.88 \cdot 10^{-5}$ mm/cycle at the end of the fatigue growth.

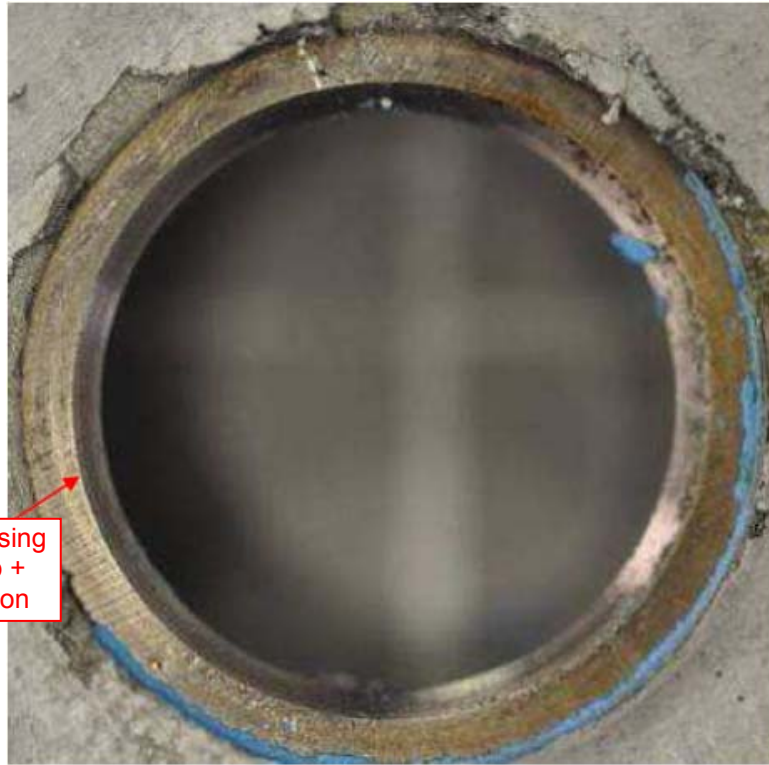
- Yoke No. 2

Sulphuric acid anodising missing on the hub + light fretting corrosion

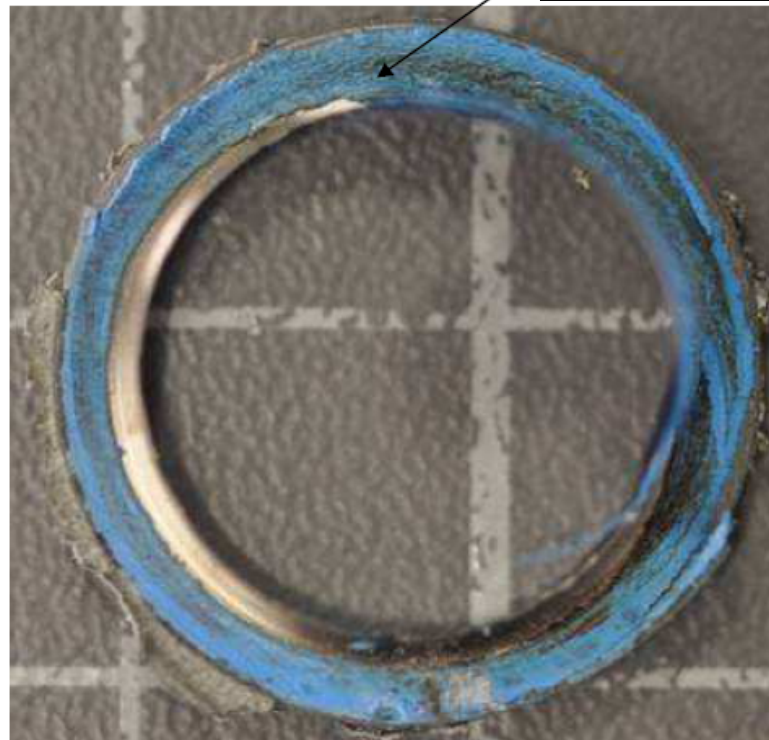
- FTi bush No. 2

Blue Coat varnish crept under the shoulder of the bush

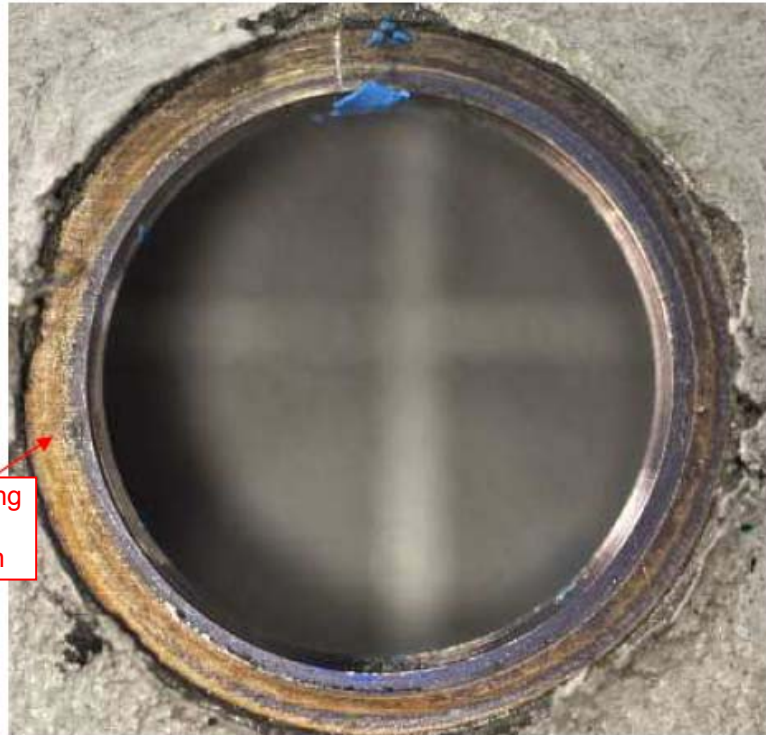
- Yoke No. 3

Sulphuric acid anodising missing on the hub + light fretting corrosion

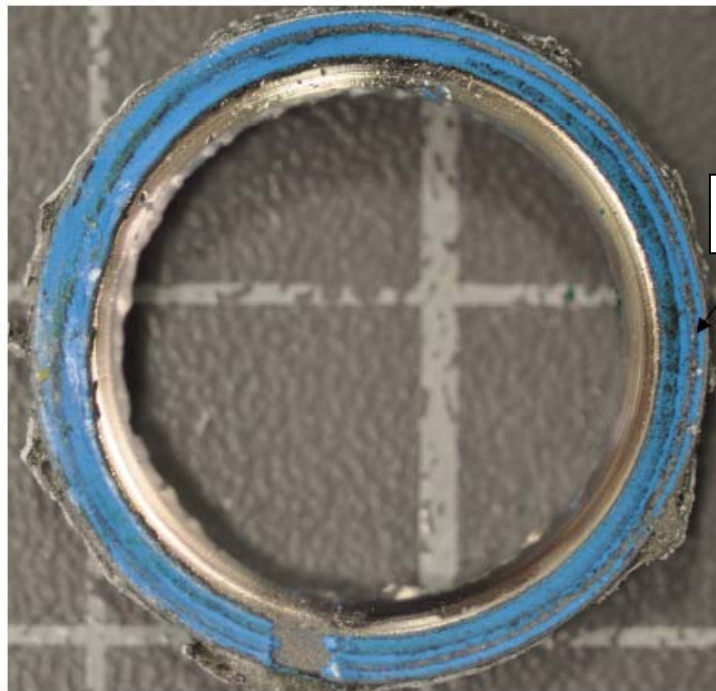
- FTi bush No. 3

Blue Coat varnish slightly worn

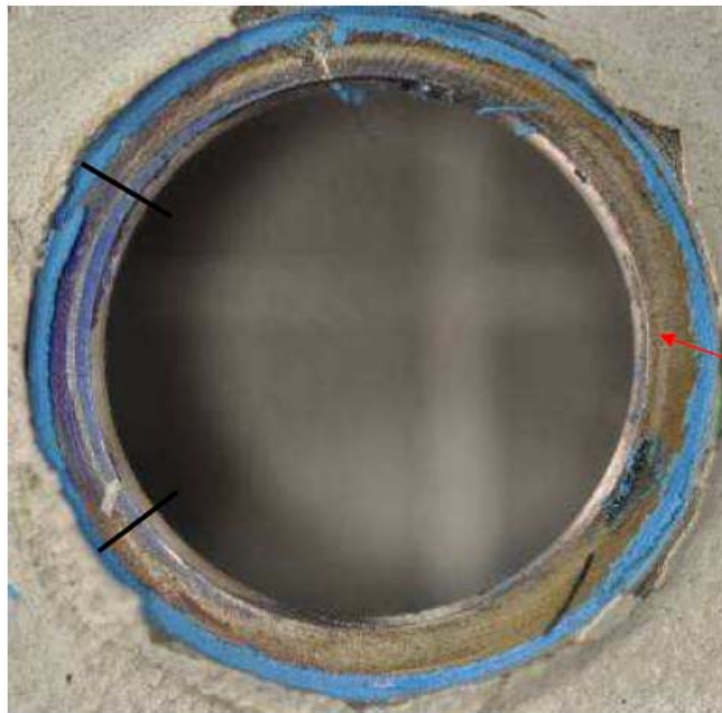
- Yoke No. 4

Sulphuric acid anodising missing on the hub

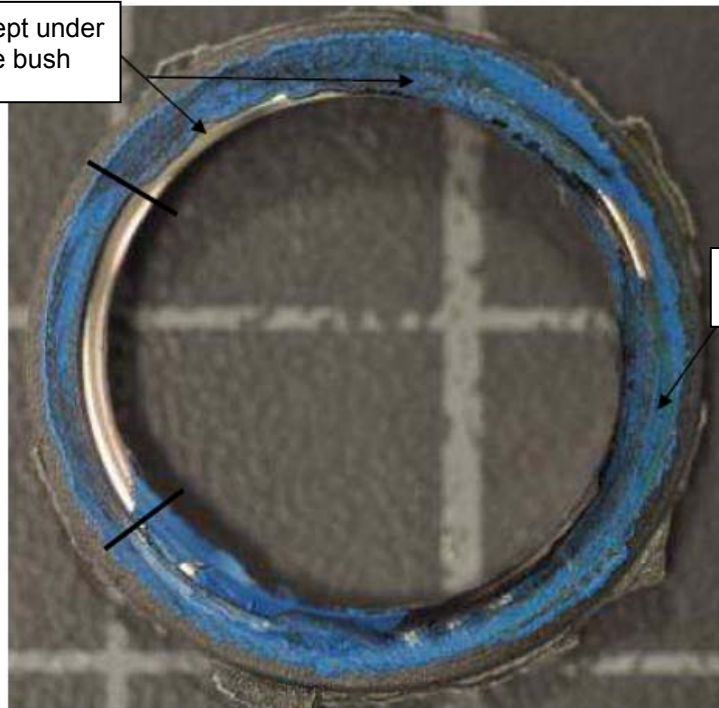
- FTi bush No. 4

Blue Coat varnish crept under the shoulder of the bush

Blue Coat varnish slightly worn

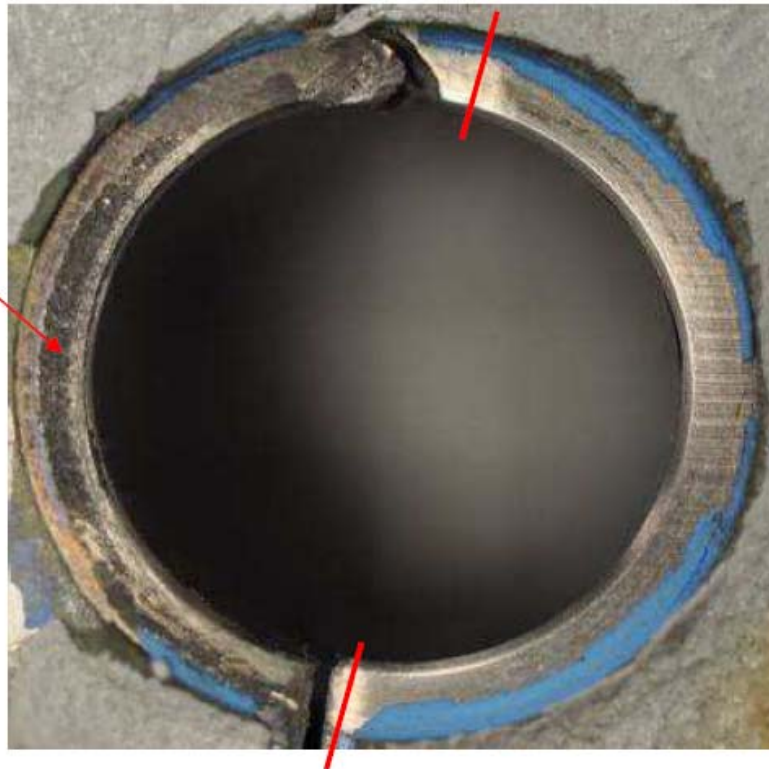
- Yoke No. 5

Significant
fretting + wear

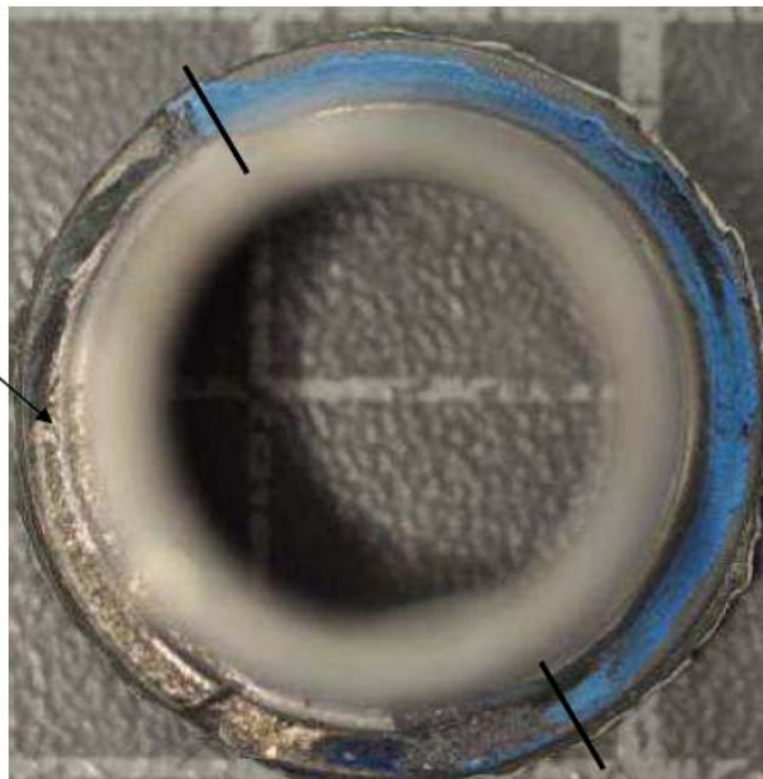
- FTi bush No. 5

Significant fretting with worn
Blue Coat varnish

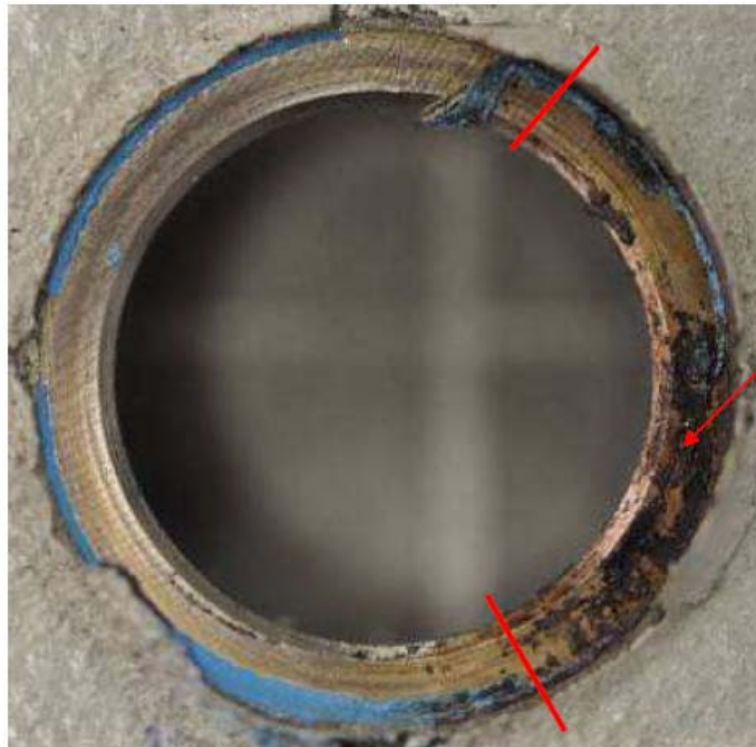
- Yoke No. 6

Significant fretting + wear

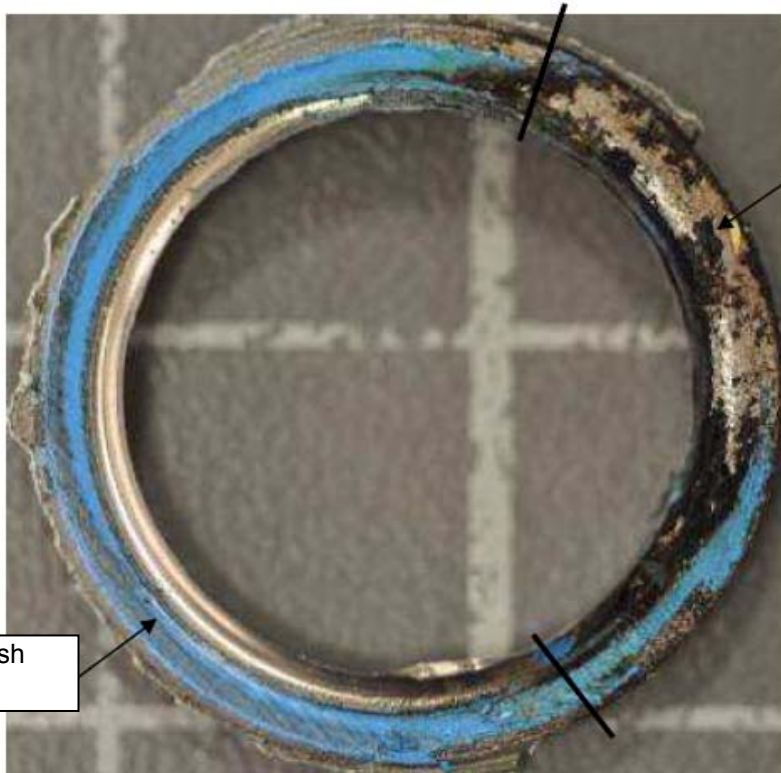
- FTi bush No. 6

Significant fretting + wear

Blue Coat varnish slightly worn

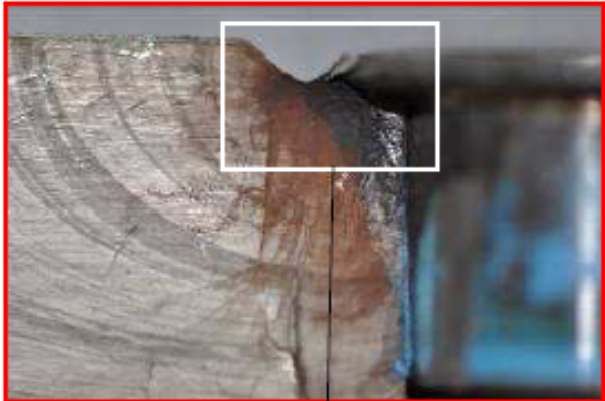
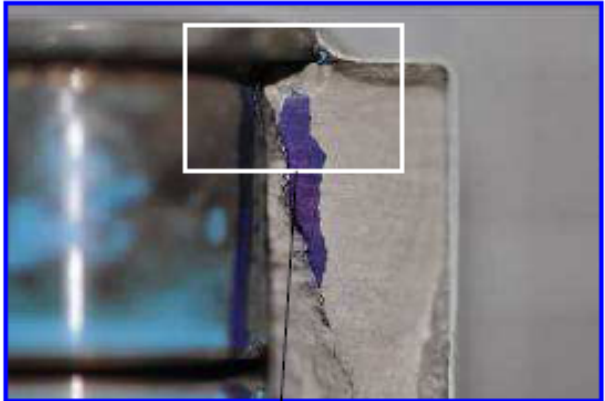
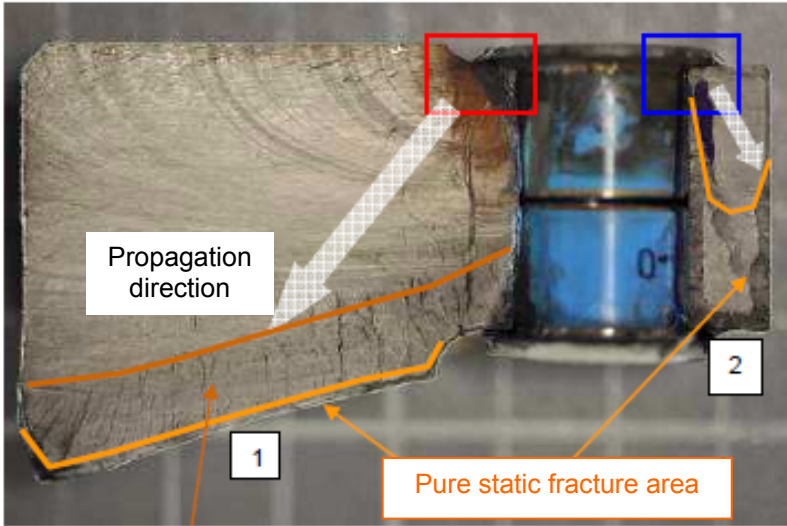
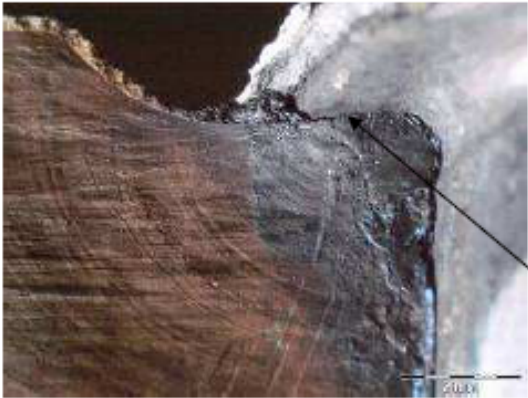
The failure of the hub initiated and propagated due to fatigue, under the bush shoulder on both sides of the FTi bush, in an area with significant fretting corrosion. The fatigue / mixed zone / static fracture proportion is approximately 70% / 25% / 5% for the crack which propagated towards the inside (1), and 40% / 60% for the crack which propagated towards the outside (2).

Fatigue fracture + static fracture mixed area

The crack initiated on both sides of the FTi bush, under the shoulder.

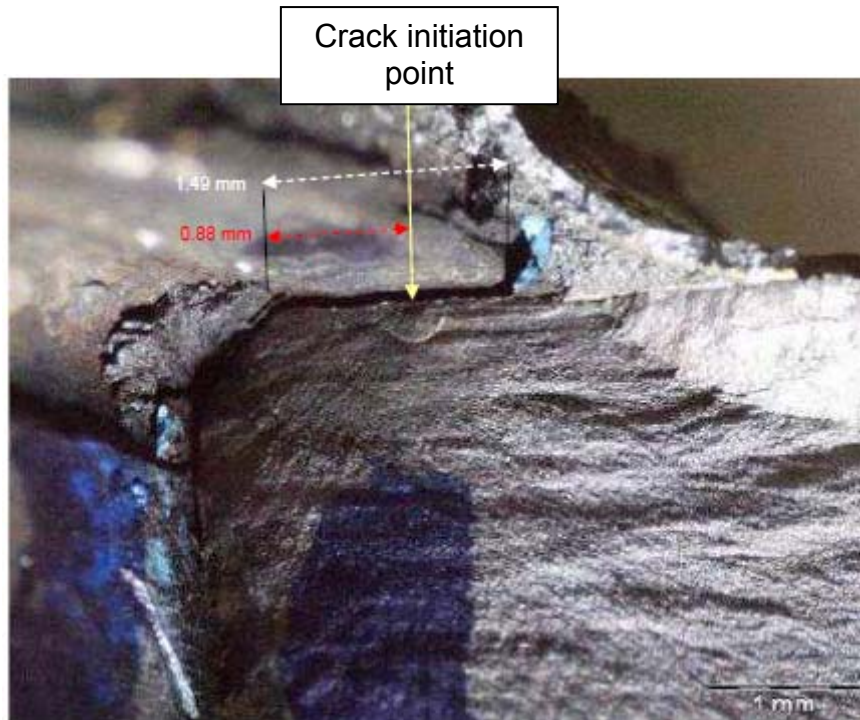
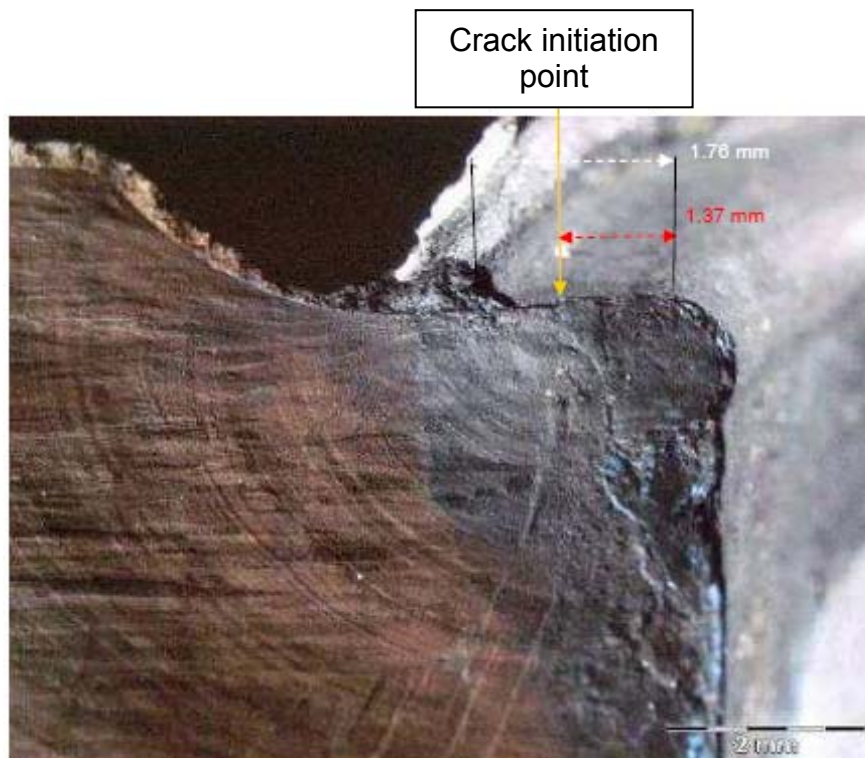
Decision on conformity	Not applicable
Estimation of uncertainty	Not applicable
Opinion and Interpretation	Not applicable
Observation	The crack initiation zone is centred over the hub / bush shoulder contact area.
