Final report RL 2012: 10e

**Serious incident on 3 June 2010
to aircraft SE-DFY
at Tarbes Pyrénées Airport, France.**

Case no: L-63/10
2012-03-22

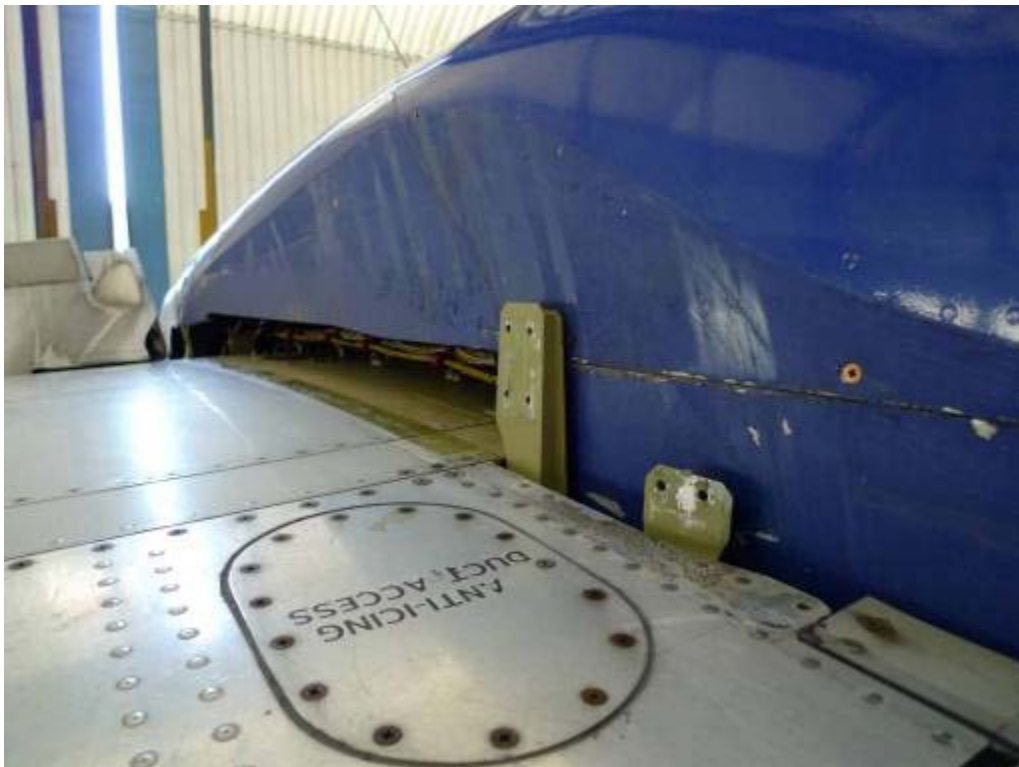
Panel number 3806A on the right upper side of the stabilizer, which was found next to the runway, was fitted with four screws NAS 1203 out of a total of sixteen intended (see fig. 1.). When the panel separated from the aircraft, one screw was pulled out of its anchor nut (fixed in one of four holes in mounting number two) and hit the elevator. In fastening number three there was two screws tightened, and here the nut part was pressed out of the fastening and stayed in the panel when it separated from the aircraft (see figure 2). The two rear screws on the panel were tightened and remained in place throughout the flight (see fig. 2.) The rear of the panel was broken off in front of these two screws. A clear fracture surface with plasticization was visible.

Fig. 1 The area where panel number 3806A should have been mounted, looking backwards

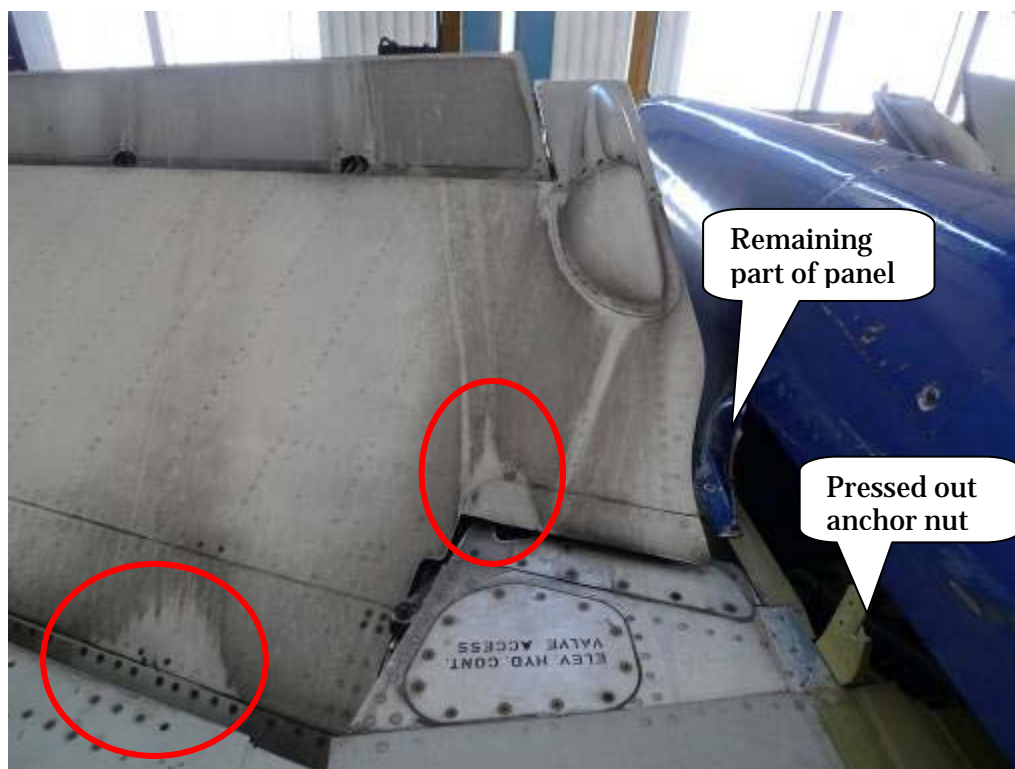
Fig. 2 Scratch marks on the right elevator from panel number 3806A as it separated from the aircraft (marked with red ellipses)

There was minor damage in the form of scratch marks and a dent from a screw head in the right elevator surface skin. Panel number 3806A was broken in front of the rear faster. There was also damage to the faster/faster element of panel number 3806A.

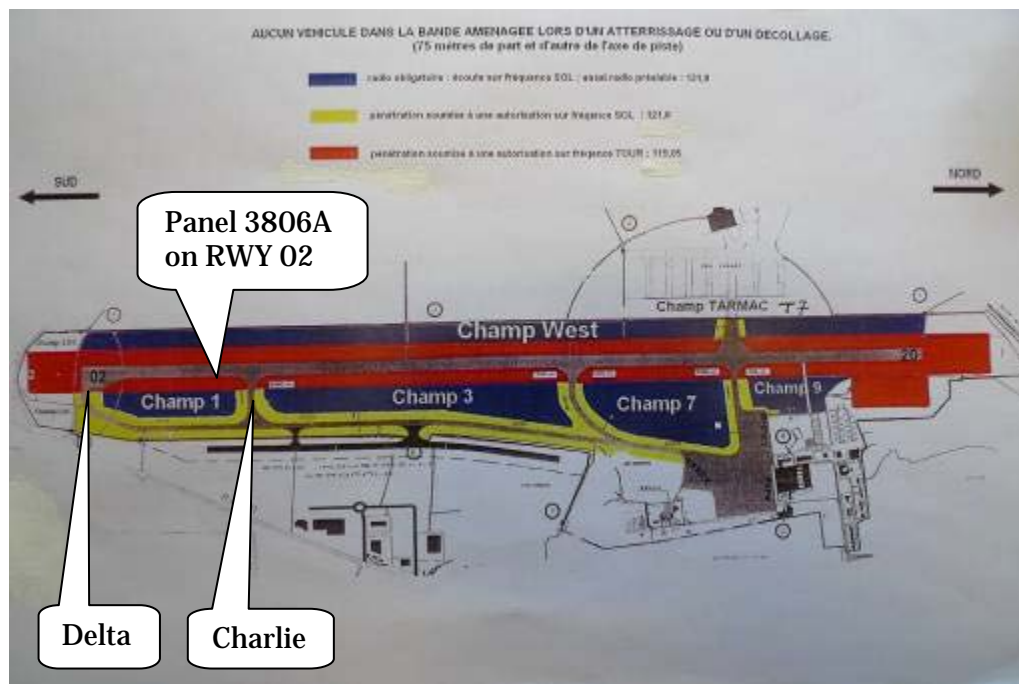
Fig. 5 Airport Tarbes Pyrénées, panel number 3806A lying on runway 02

Panel number 3806A separated from the aircraft in the early stages of takeoff and lay on runway 02 west of area Champ 1. The panel was found in a position equal to one-third of the aircraft's total ground roll distance (see fig. 5).

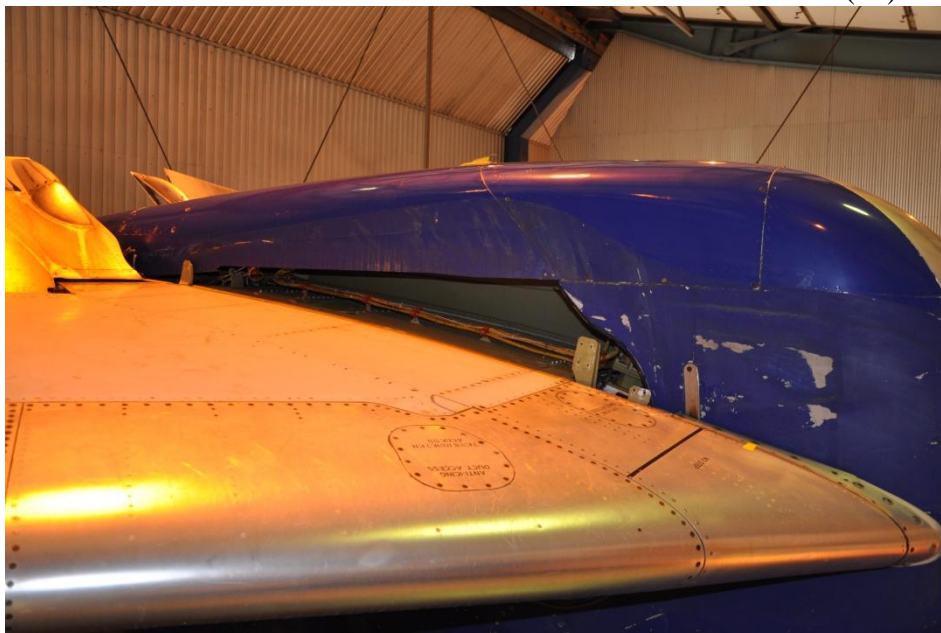
Photo 1: Area of RH horizontal stabilizer showing missing upper fairing.

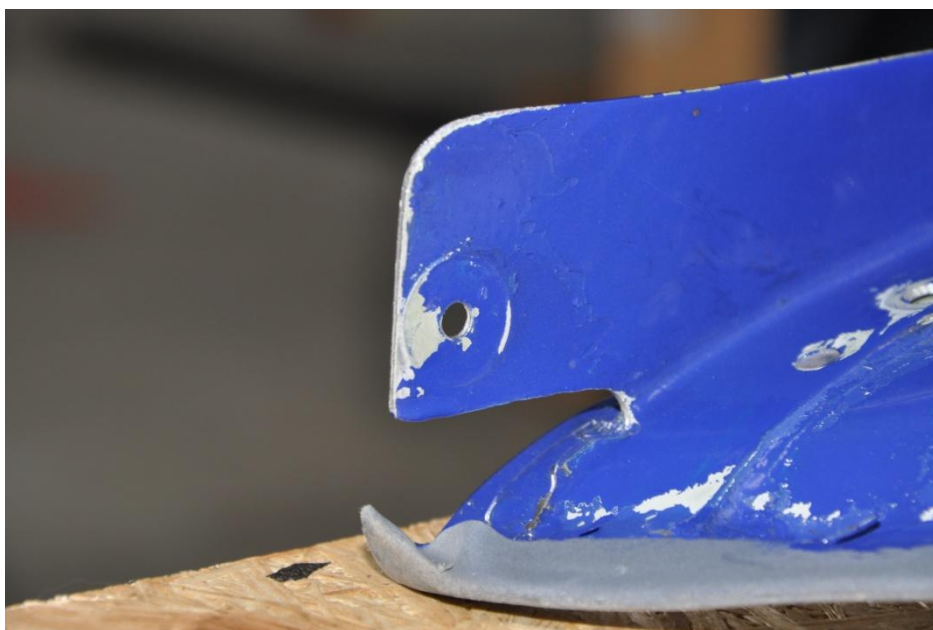
Forward screw hole on the horizontal surface (1-NAS1203-2 from fig2) was found to be undamaged.

Photo 2: 1-NAS1203-2 position, RH fairing.

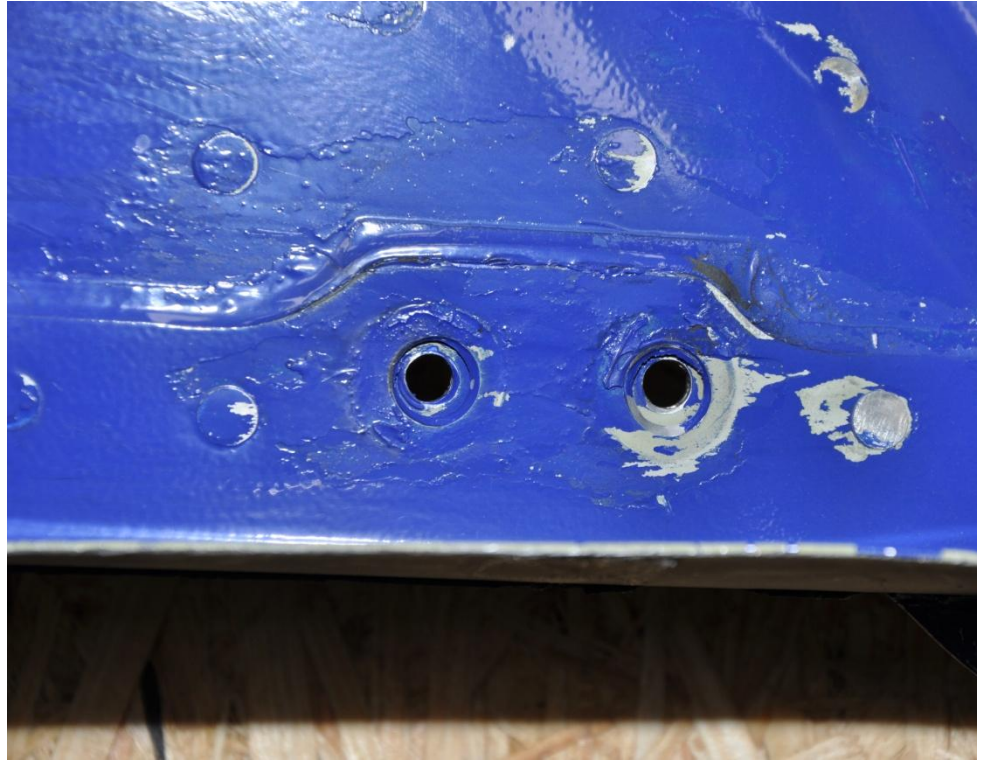
The 2 screw holes on the vertical surface (2-NAS1203-4) were found to be undamaged as was the mounting bracket for these.

Photo 3: 2-NAS1203-4 position, RH fairing.

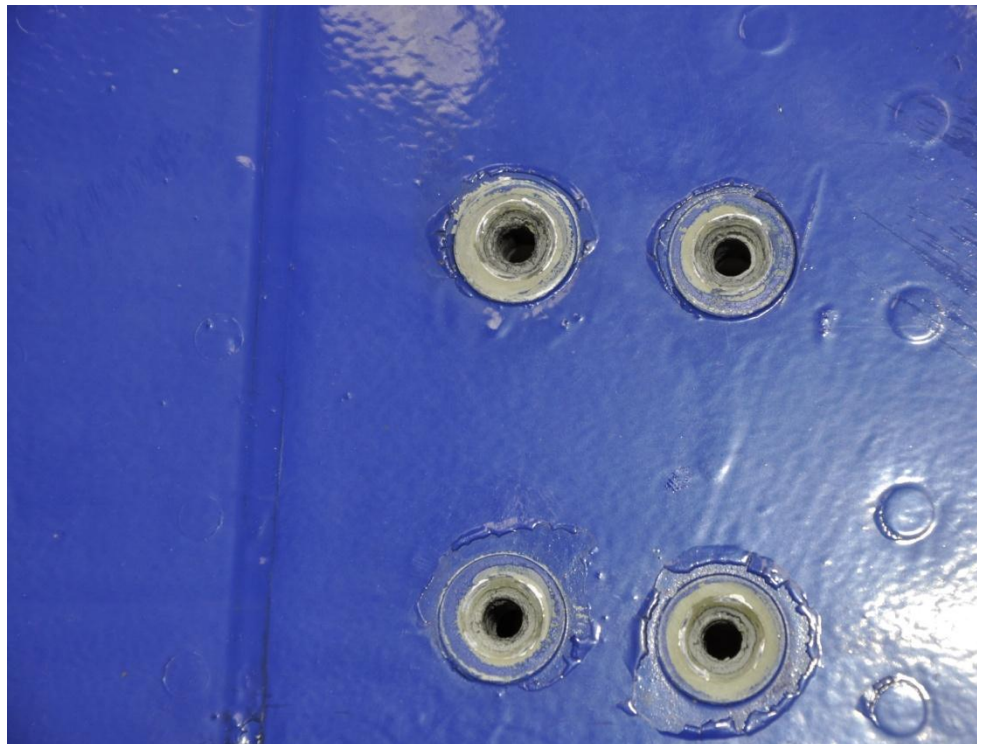
The 4 screw holes on the vertical surface (2-NAS1203-11 + 2-NAS1203-10) were found to be undamaged as was the mounting bracket for these.

Photo 4: 2-NAS1203-11 + 2-NAS1203-10 position, RH fairing.

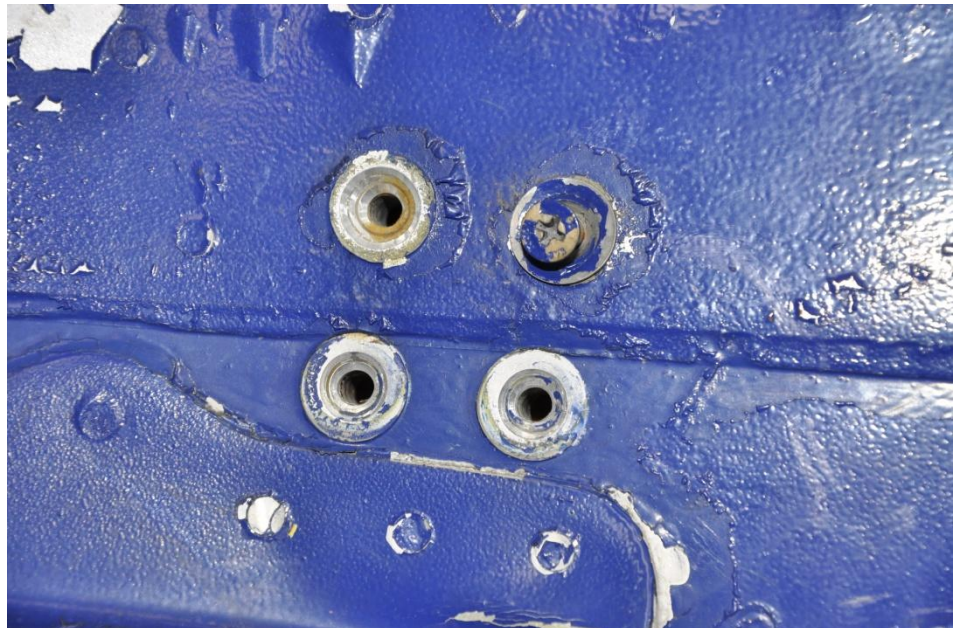
Where the 4 NAS1203-10 screws were mounted 3 holes showed no damage to the fairing or bracket. In the upper RH hole (looking inboard) the screw was protruding but still attached, with its fastener and part of the bracket still present on the inside. The bracket assembly received damage in the form of deformation as the attached fairing pulled away and then tearing as the metal failed and a piece remained attached to the screw as the fairing departed.

Photo 6: 4-NAS1203-10 location, RH fairing. Showing 1 remaining screw.

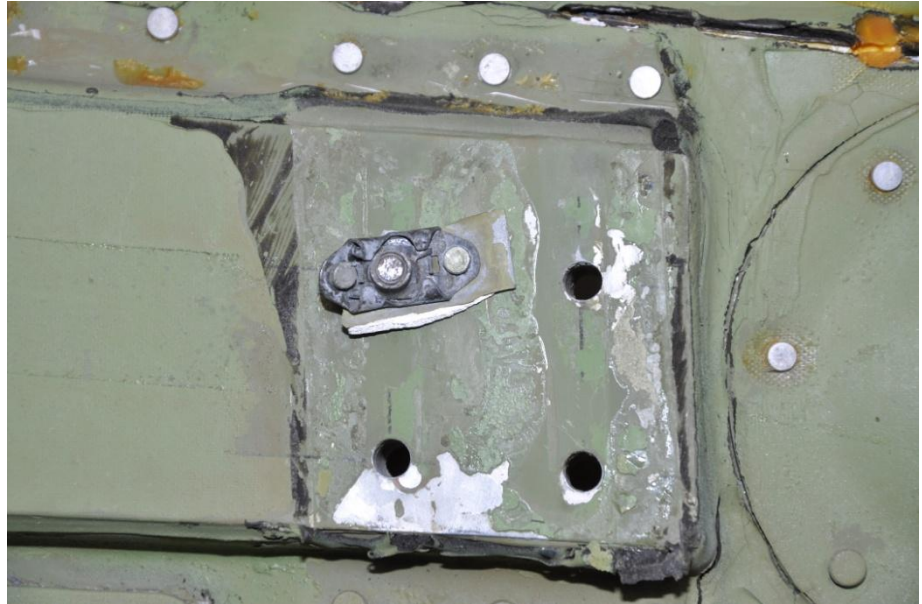
Photo 7: Internal view of the fairing showing the remaining screw, fastener and attached failed piece of bracket.

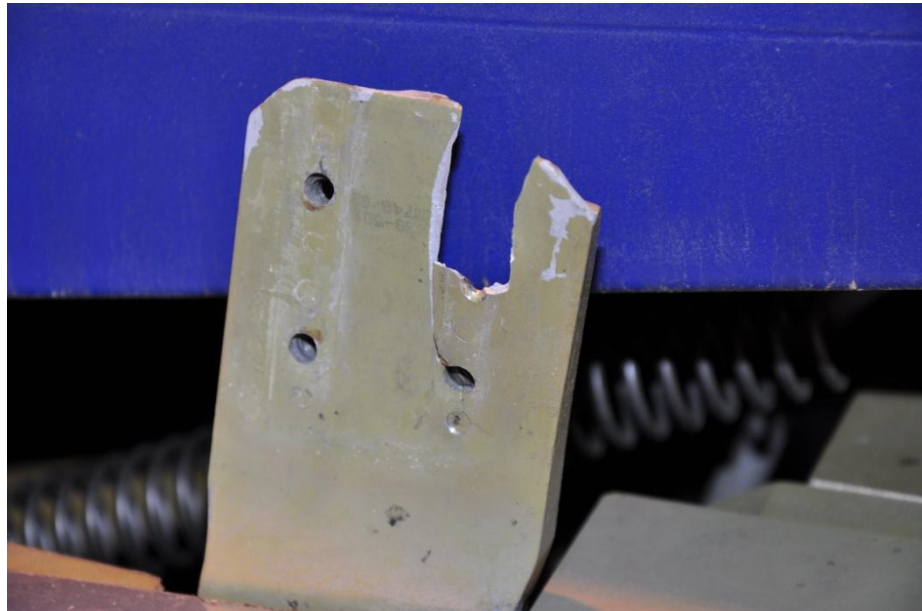
Photo 8: The failed bracket, showing outward bending and failure of the metal around the screw hole.

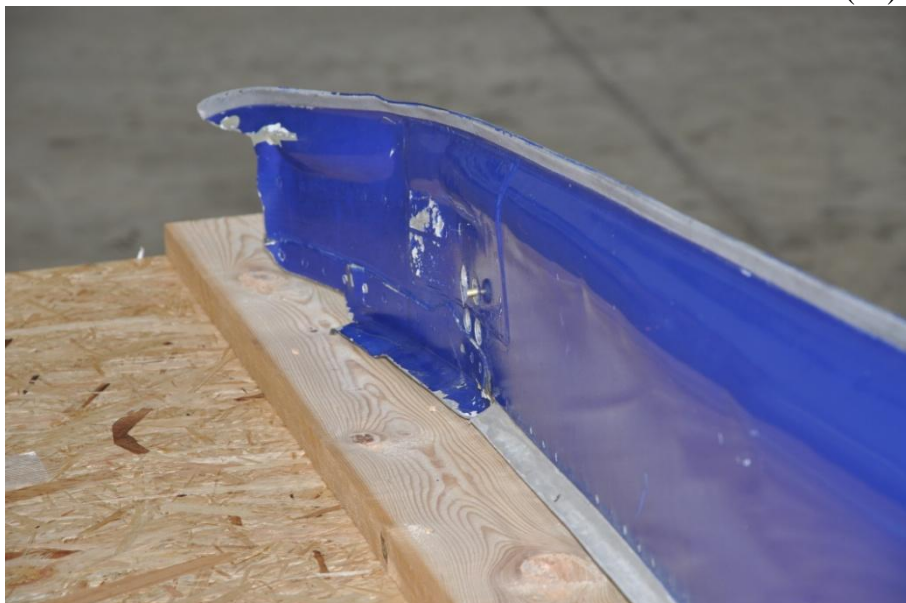
Photo 10: The rear end of the fairing showing bending, buckling and a tear failure.

Examining the detached fairing, seeing the bend in it and scratch marks, it appears that the fairing became caught in the airflow and was pulled outwards in a horizontal plane, while being secured at the rear, until about 60deg when the fairing and bracket failed and the fairing became detached, passing over the elevator and falling clear onto the runway behind the A/C. There is little evidence of any "flapping" of the fairing as there are no other witness marks to support this.

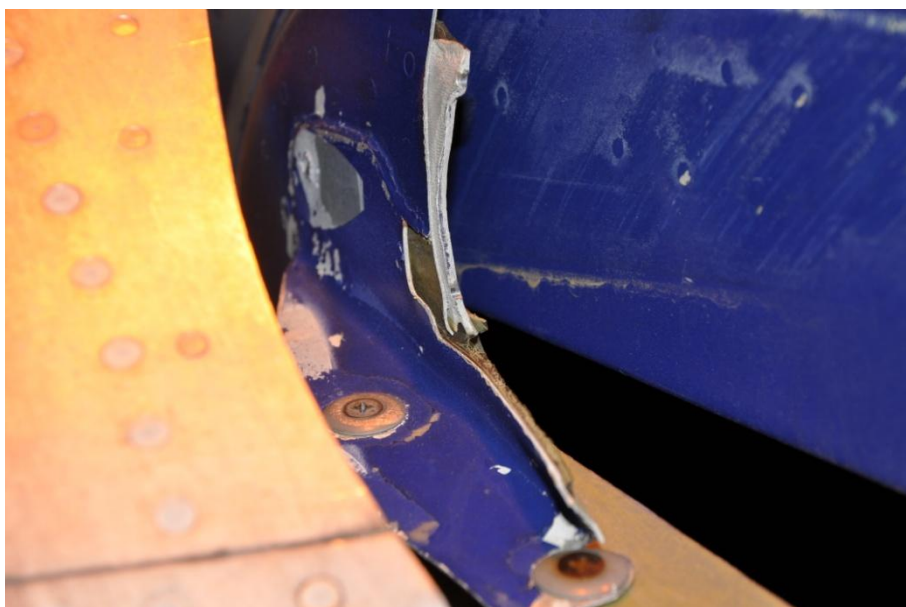
Photo 11: Failed part of fairing still attached to A/C with screws NAS1203-6 and (out of sight) bolt NAS1203-3

The screws in the horizontal surface NAS1203-6 were, in fact, just 2 in number and not 4 as shown in figure 2 taken from the AMM. Each fairing is individually drilled to match the holes / brackets on the aircraft and it is conceivable there are some differences.

It appears that the RH upper fairing was only secured in three locations, the rear bolt NAS1203-3, two rear screws NAS1203-6 and one of the four screw holes in the rearward vertical bracket, NAS1203-10. These were the only locations that remaining fasteners were found. All the other screw holes were empty, "clean" and showed no signs at all of being damaged by either a tight or loose screw working free or being pulled out.

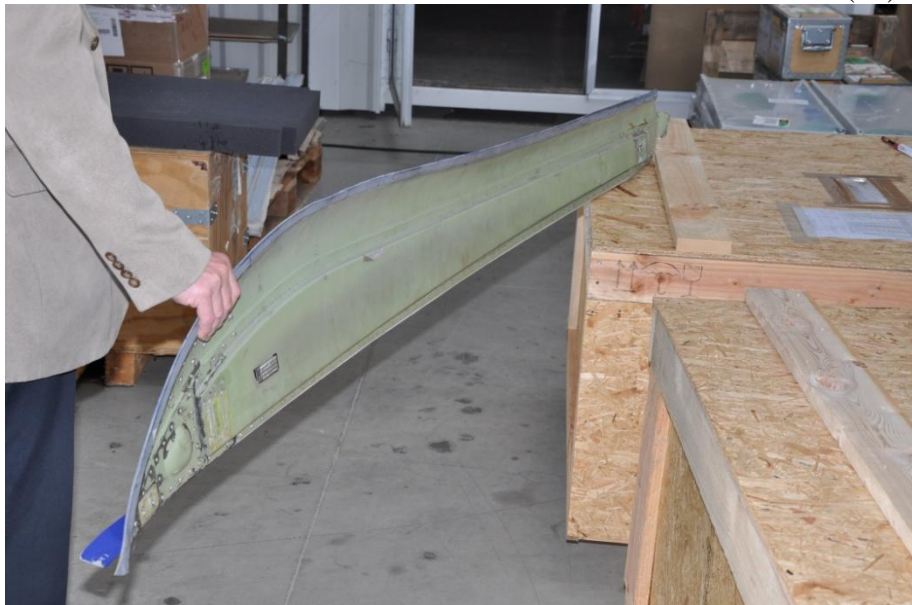
Photo 12: The rear of the fairing is in line with the wooden strip, this illustrates a bend in the fairing of approximately 60deg.

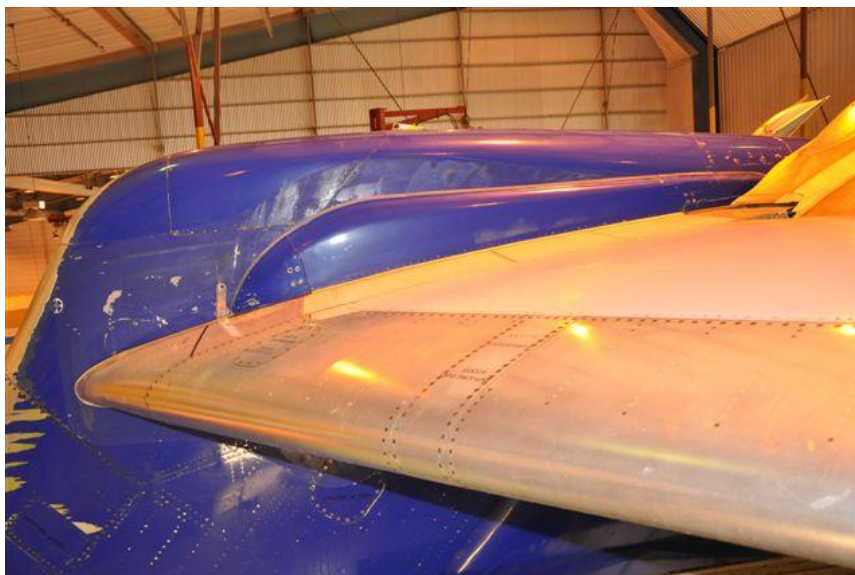
After landing at ARN the a/c was inspected and the LH upper fairing (item 170) was found to be intact but with some missing screws and some screws loose.

Photo 13: L/H upper fairing as found.

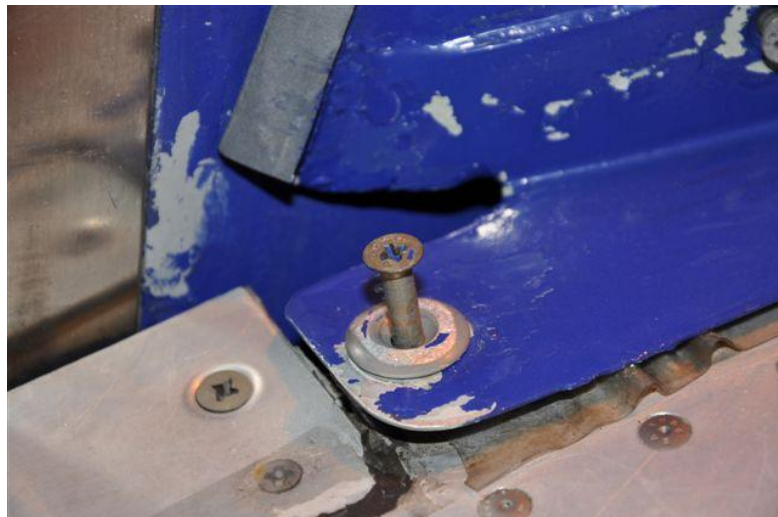
Bolt was loose and protruding.

Photo 14: Item 5 (from fig 3) bolt.

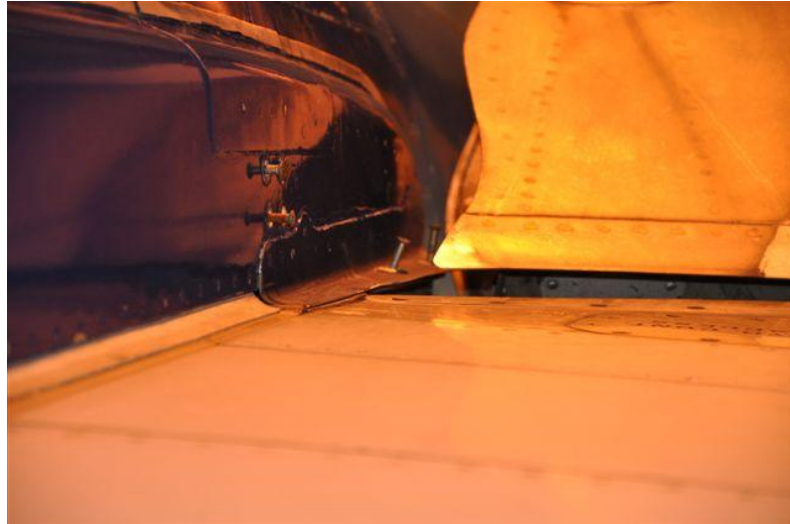
Bolts were loose and protruding.

Photo 15: Rear of Fairing.

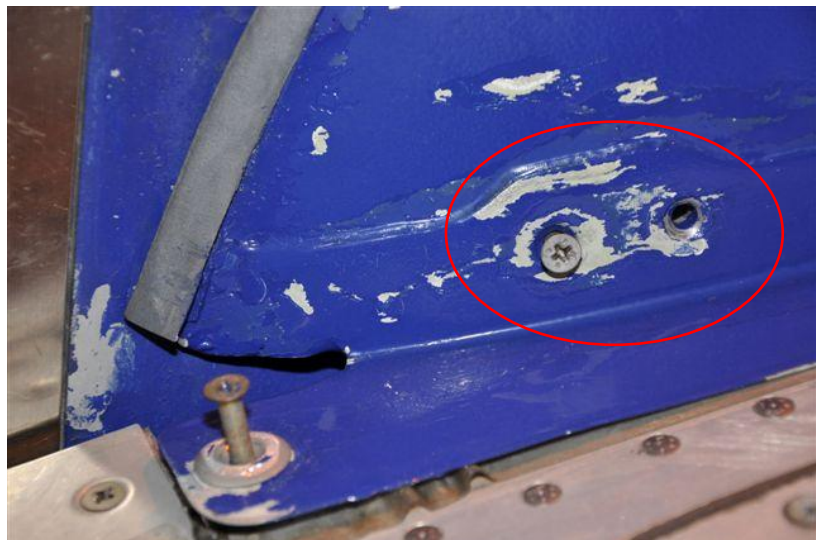
Fwd bolt loose and protruding, Aft bolt missing.

Photo 16: Area of view D.

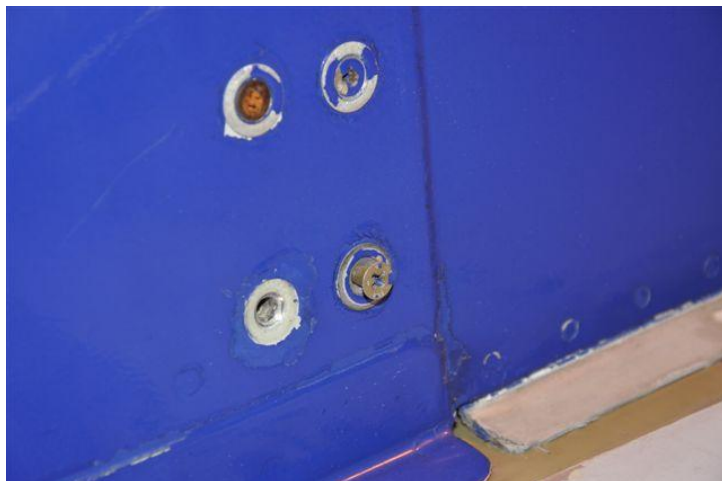
Screws on top tightened, lower fwd screw missing and lower aft screw loose and protruding.

Photo 17: Area of view C.

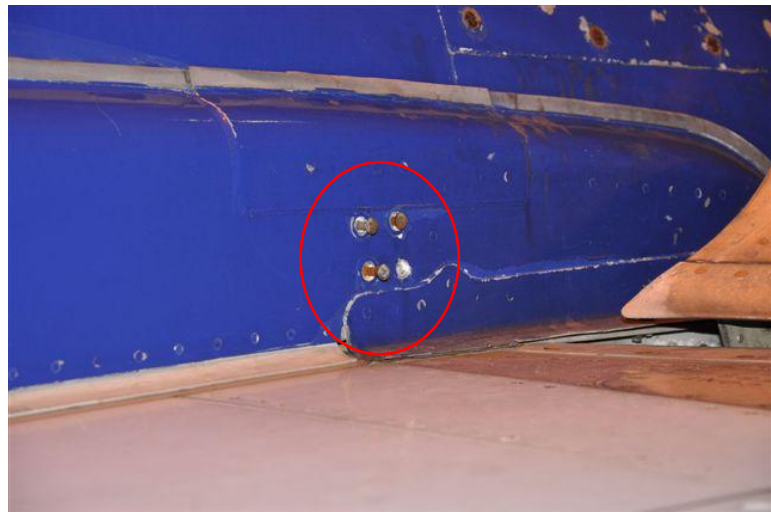
The 3 remaining screws were loose and protruding.

Photo 18: Area of view E.

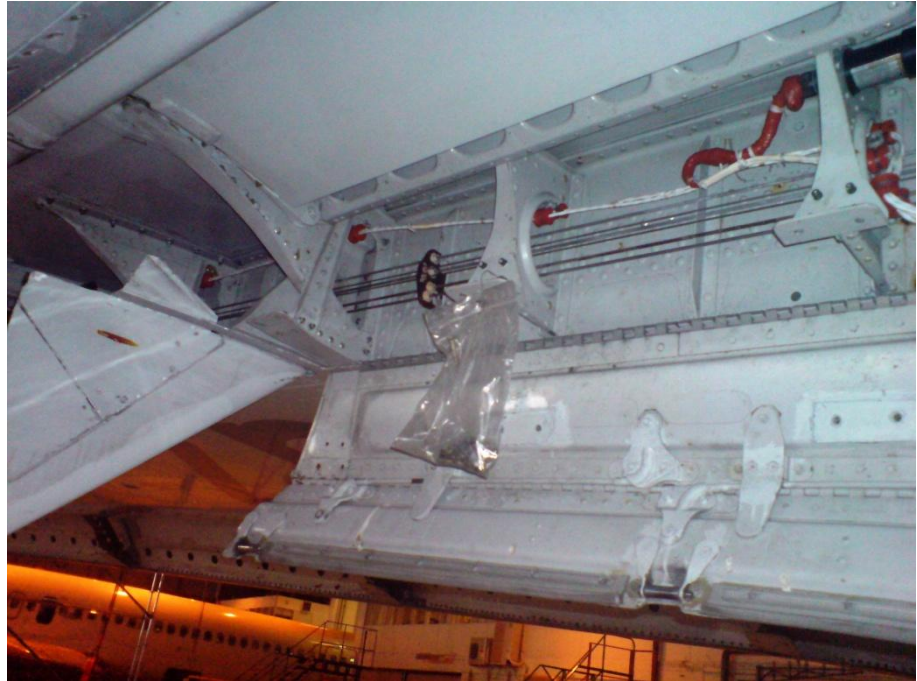
One of the aircraft previously stored with TARMAC, OY-KGZ, also suffered an incident, where on its return to SAS in May 2010, it was found that several screws were missing in the Bute doors on both the LH and RH wing. Each Bute door had only one or two screws installed but not tightened, the LH Bute door suffered slight damage. All the missing screws were subsequently found in plastic bags taped to the inside of each door. (reference SAS Tech report 18492). Upon further questioning of the TARMAC management it was ascertained that the same engineer that was responsible for signing off the work on this a/c was the same as the incident a/c SE-DFY. In response to SAS questions over the Bute door incident, TARMAC suspended the engineer in question, conducted a quality review and recommended a new procedure to document which panels had been open and a sign off that they were secure. This procedure was still not in place at the time of the CITs visit in June.

Photo 19: LH Bute door screws in bag, OY-KGZ.

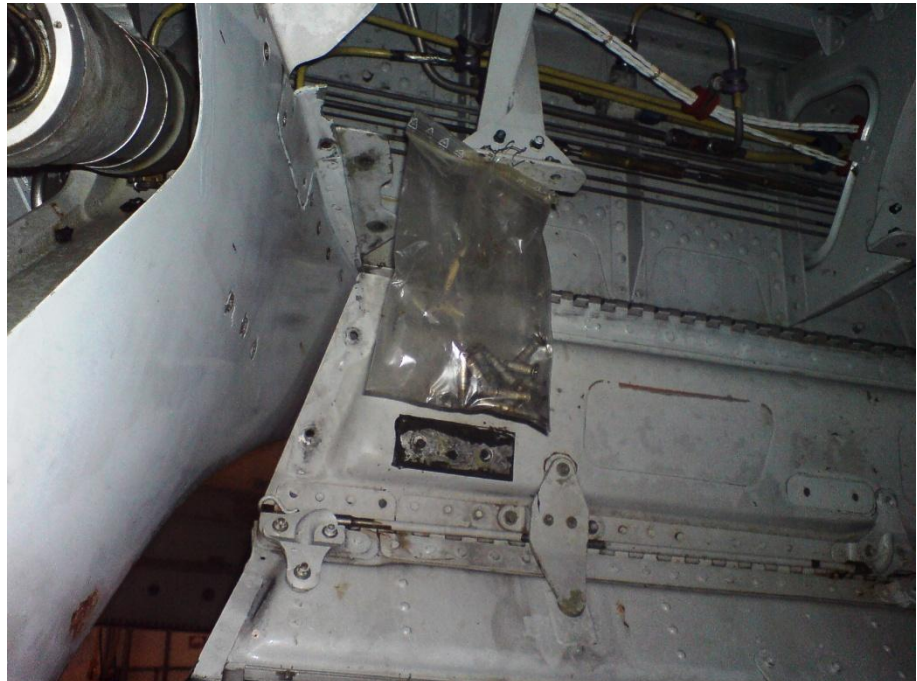
Photo 20: RH Bute door screws in bag, OY-KGZ.
