***Final report RL 2012: 12e***

**Incident on 18 August 2011 to aircraft HA-LPB at Skavsta airport, Södermanland County.**

Case no: L-85/11

2012-04-10

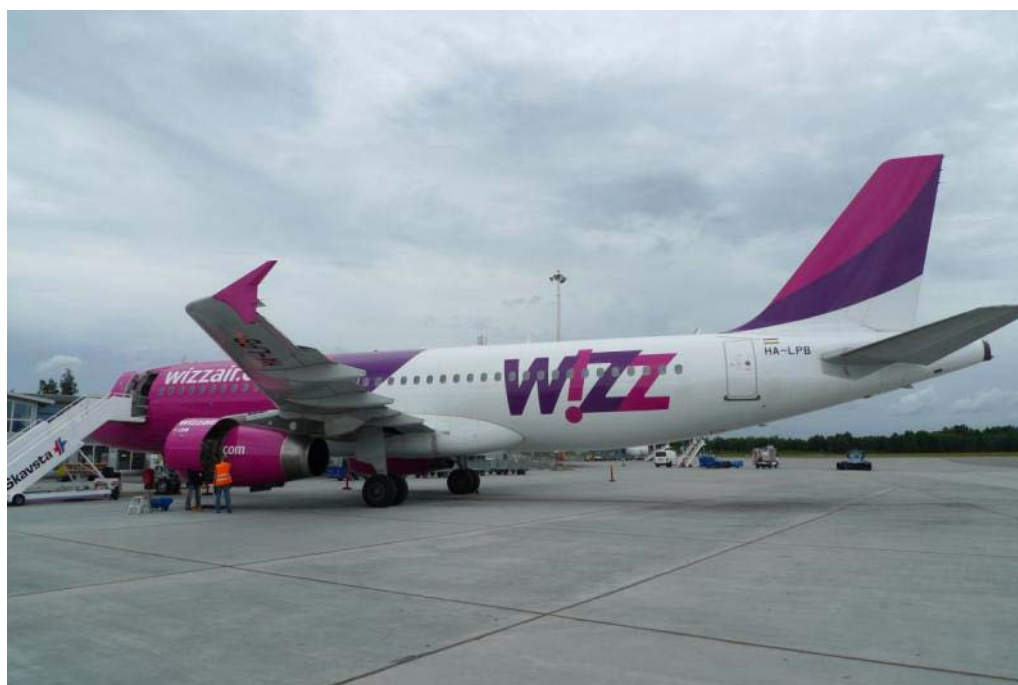
Fig.1. The aircraft after the incident. Photo: SHK

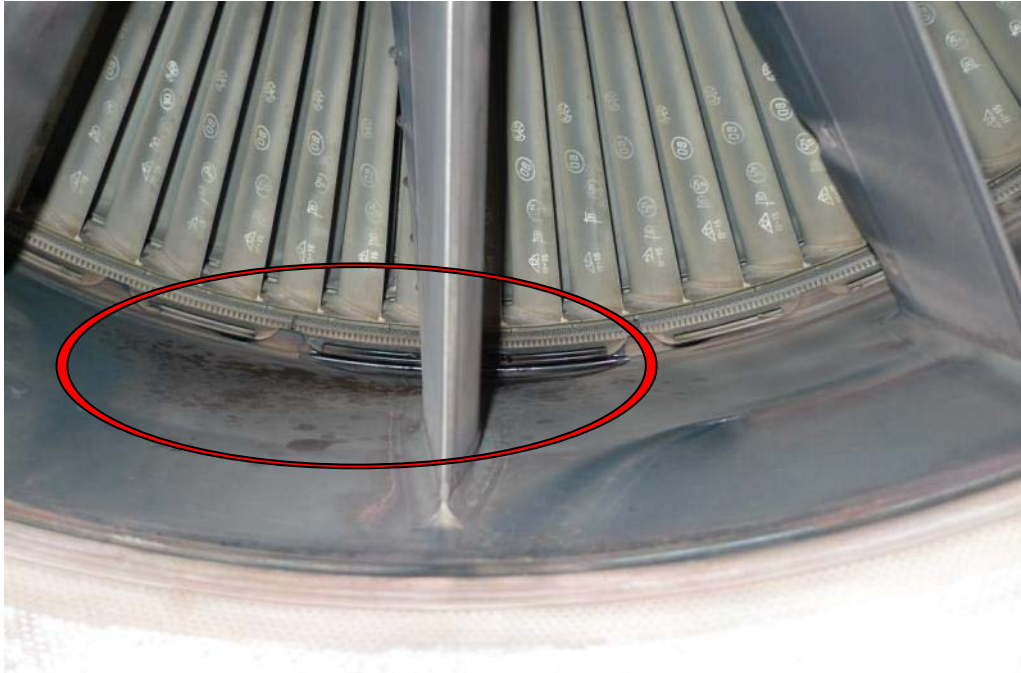
The only sign of oil or a fuel leak that could be identified was a small residue in the lower part of the rear outlet of engine number 1, see Figure 2. The other parts of the engine inspected at this time showed no visible signs of damage, discoloration of the outlet areas or traces of fire. Inspection was carried out in accordance with regulations 78-10-00-200 and 71-00-00-860-010 of the aircraft's AMM<sup>5</sup>.

Fig. 2. Engine no 1: Area at rear outlet with traces of burned oil or fuel residue. Photo: SHK

In this incident, the direct reason as to why open flames occurred could not be established. No damage or engine malfunctions were found. Taking into account the combustion residues found at the outlet from engine No. 1, it is most probable that an oil leakage caused the flames. Aviation fuel which is burned, normally leaves no trace in the form of combustion residues.
