Final report RL 2012:06e

**Incident with aircraft LN-RRR in the airspace
near Kristianstad, Skåne County, Sweden
on 20 October 2010**

Case L-141/10
2012-02-27

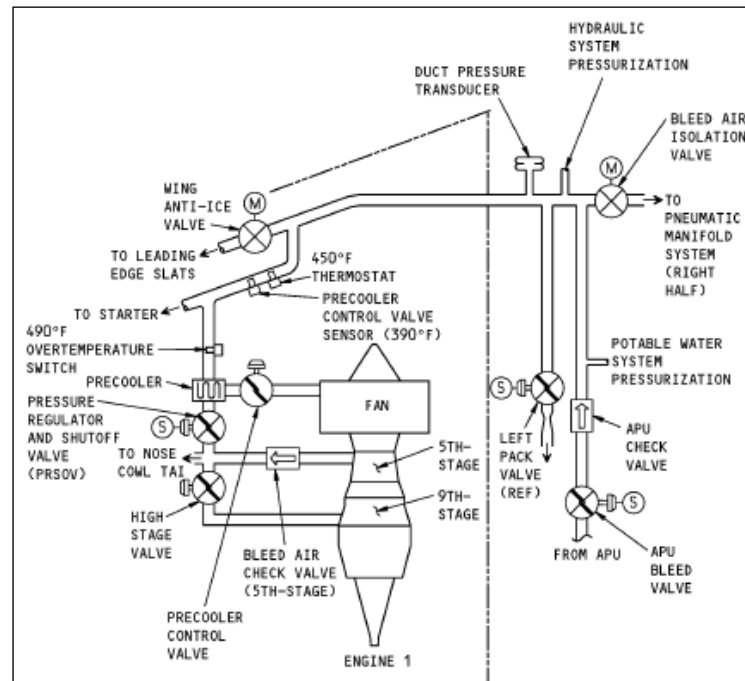
Fig. 1. Air bleed system (left engine)

During the physical inspection of the components the technicians who began examining the aircraft found that the High Stage Valve was in a half-open position, although it should have been closed. It was also noted that the PRSOV, which should have been closed, was stiff in its movement. Both of these units were replaced. For identification of the units, see fig. 1.

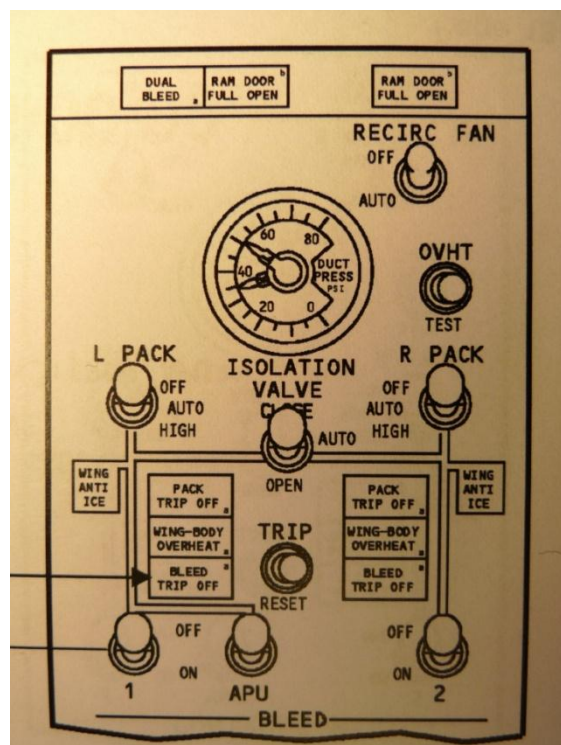
Fig. 2. Overhead control panel for air bleed systems, Bleed module

Additional checks were made on the bleed module (overhead panel) and it was found that the right switch's system (2) indicated that it was closed, although the valve was open (see fig. 2), and this unit was also replaced.
