Final report RL 2012:18e

**Serious incident involving the aircraft SE-KXJ on
24 November 2011 at Hemavan Tärnaby Airport,
Västerbotten County, Sweden**

Ref no L-123/11

2012-10-17

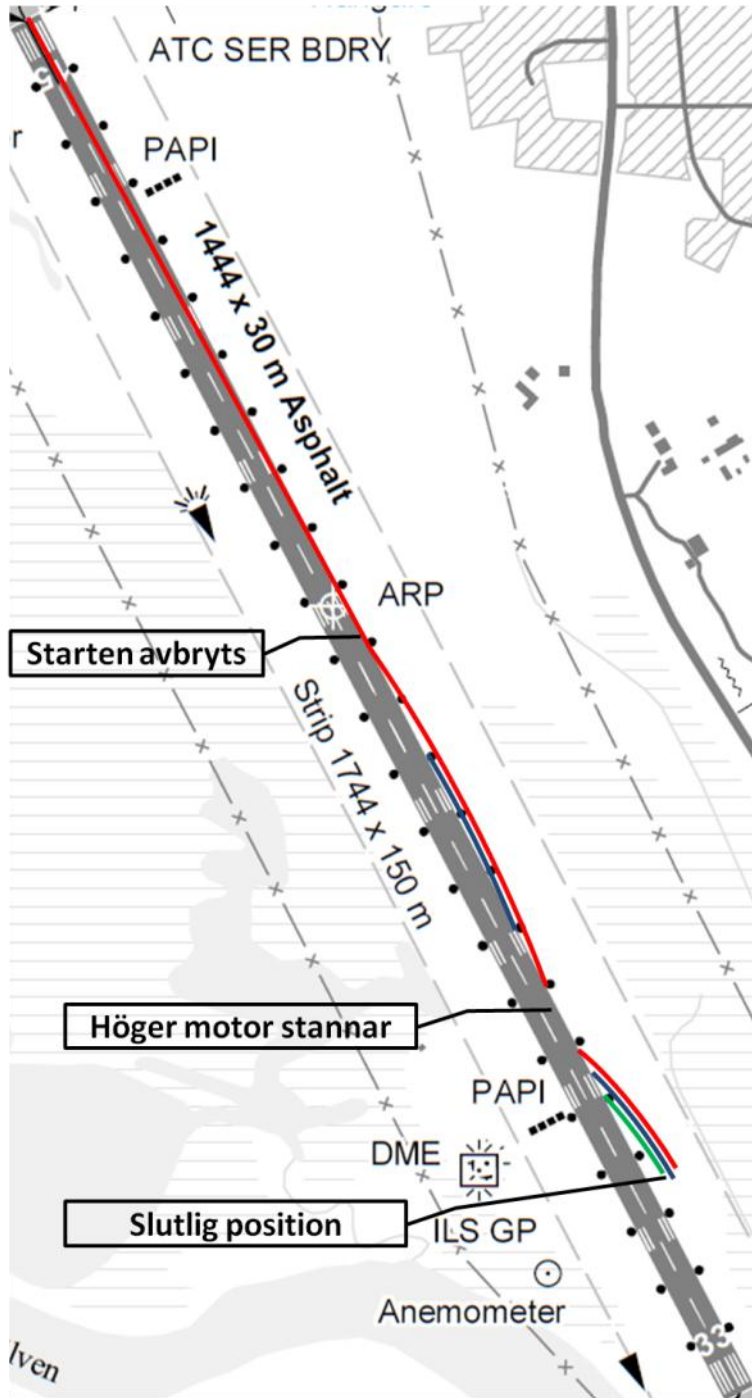
With the assistance of airport staff, SHK has documented the wheel tracks after the incident. The tracks show that the aircraft left the left edge of the runway after half the runway length and ran almost parallel with the same for 350 metres. After this, the aircraft came onto the runway to then once more leave the left edge of the runway, this time with a greater heading deviation. The aircraft stopped about 200 metres from the end of the runway, 15 metres to the left of the runway edge. See Figure 3 below.

Fig. 3. The red line shows the left wheel track; the blue line, the nose wheel track and the green line, the right wheel track.

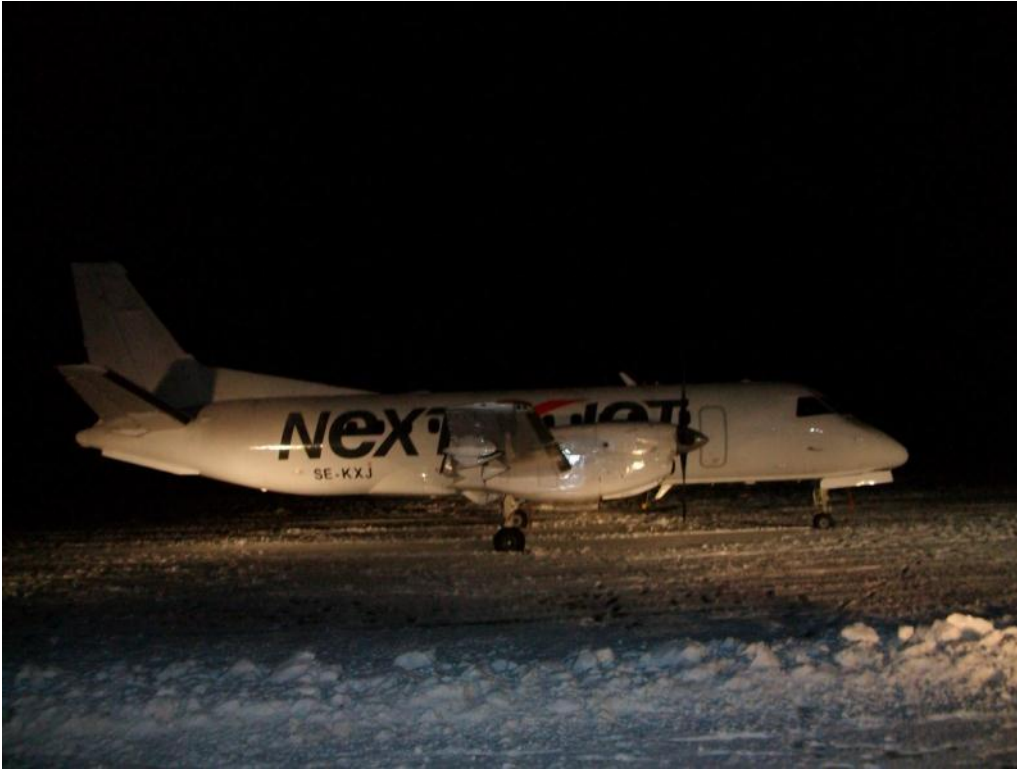
Damaged blade tips on the left propeller and damage to landing lights and cables on the nose gear.

The aircraft stopped on the left side of the runway, parallel to the runway direction, on the strip area, see Figure 4 below.

Fig. 4. The aircraft after the aborted take off. The ploughed snow bank outside the runway edge is visible in the foreground. Picture: SHK.
