Final report RL 2012:13e

**Accident on 20 June 2011 involving helicopter
D-HPHP in Salixbyn, Härjedalen municipality,
Jämtland county**

Ref no L-60/11

2012-05-30

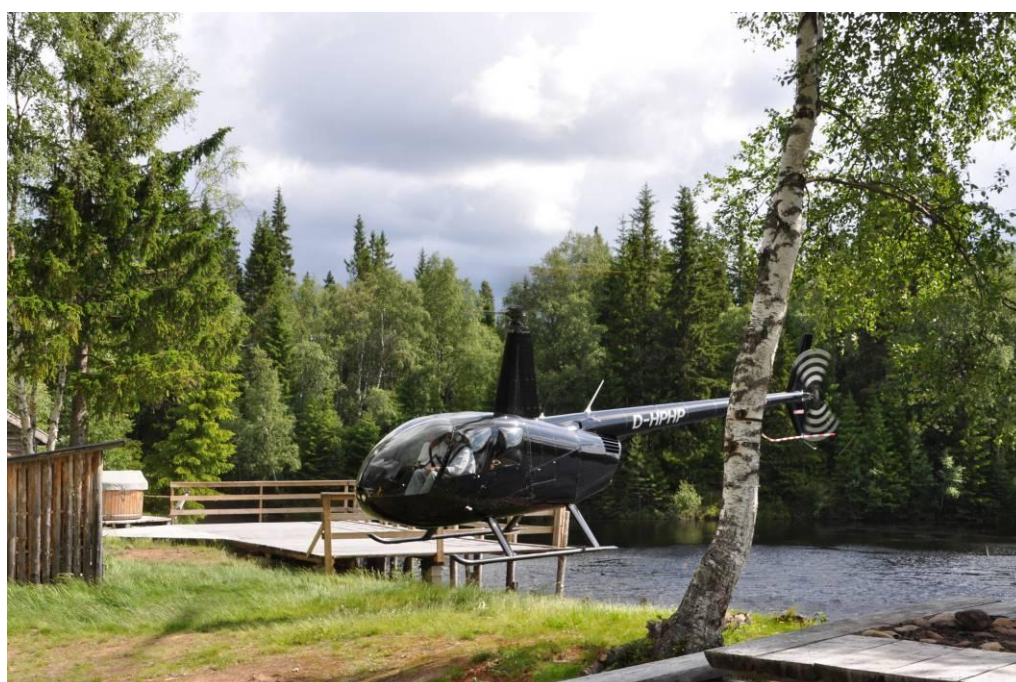
Picture 1: D-HPHP hovering before landing (Photo: Pilot of helicopter D-HALP)

The pilot of D-HPHP hovered over the lake towards the intended touchdown site. When the left landing skid had touched down and the right skid came into contact with the ground, the pilot offloaded by lowering the collective. The helicopter then tipped backwards, which the pilot corrected by quickly raising the collective and moving the cyclic forwards, after which the helicopter both tipped and moved forward, see Picture 2. The tip of one of the skids touched the ground at the same time as the helicopter yawed to the right, which resulted in the helicopter rotating to the right.

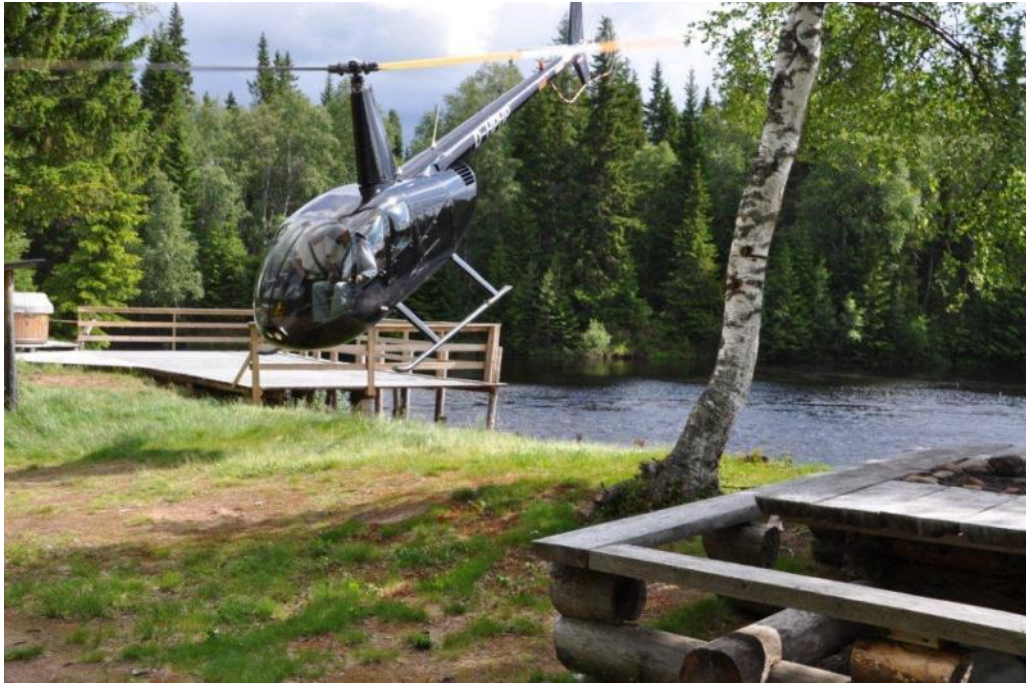
The passenger from D-HALP, who was standing in front of and facing D-HPHP when the pilot lost control of the helicopter, threw himself to the left and lay as close to the ground as possible. When the helicopter had swung round about half a turn the tail rotor of D-HPHP hit one of the blades of the main rotor on D-HALP. The main rotor blades on D-HPHP hit the ground and also a woodshed.

Picture 2: D-HPHP after initial first touchdown (Photo: Pilot of helicopter D-HALP)

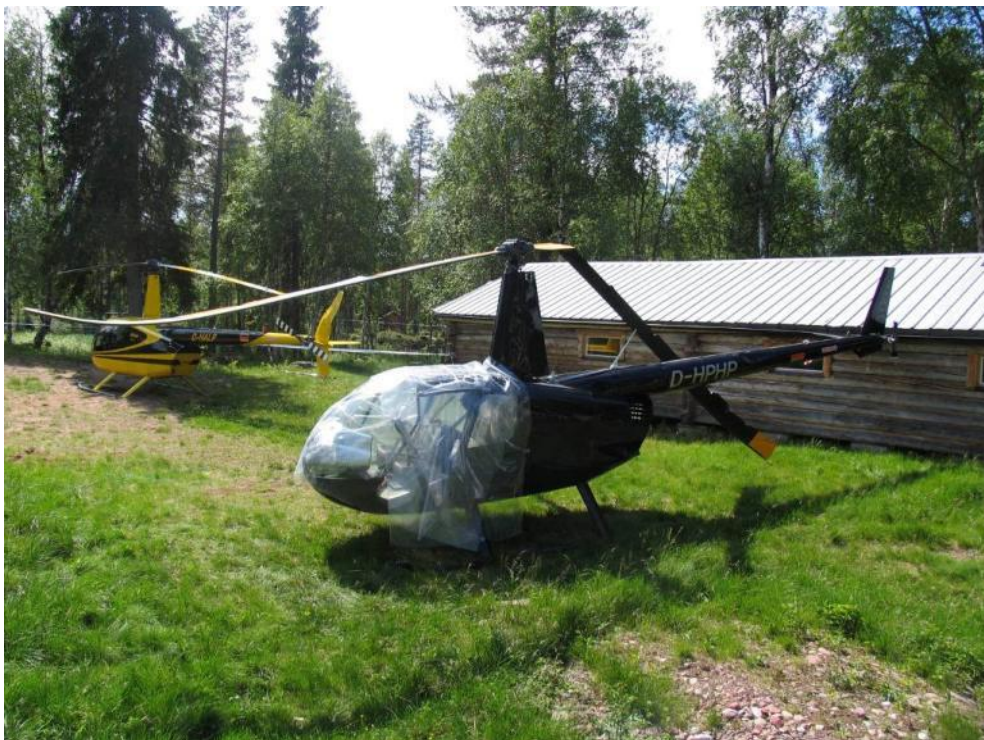
Picture 3: D-HPHP in final position with D-HALP in background (Photo: SHK)

The helicopter remained upright on the skids after the accident, but with significant damage. The pilot had noticed no technical faults on the helicopter. No fire broke out.

D-HPHP showed both structural damage and damage to the main and tail rotor. The helicopter fuselage sustained damage to its load-carrying, lower part and to the frames where the main rotor gearbox is attached. The main rotor gearbox with rotor mast had damaged attachment points and was slightly tilted forward. The tail boom had pressure damage to its upper surface and the top right side of the frame that connects to the fuselage. There were also indications of damage from impact of the main rotor blades. Both the tail skid and the tail boom's ventral fin were deformed and were almost horizontally bent to the right.

The main rotor blades were both severely swept backwards relative to the direction of movement; one of the blades had a pronounced buckle 0.7 metres from the mast and downwards approximately 30°. One blade tip was bent upwards and the other downwards. The oil in the blade bearing housings of the main rotor hub had leaked onto the dorsal side of the rear fuselage.

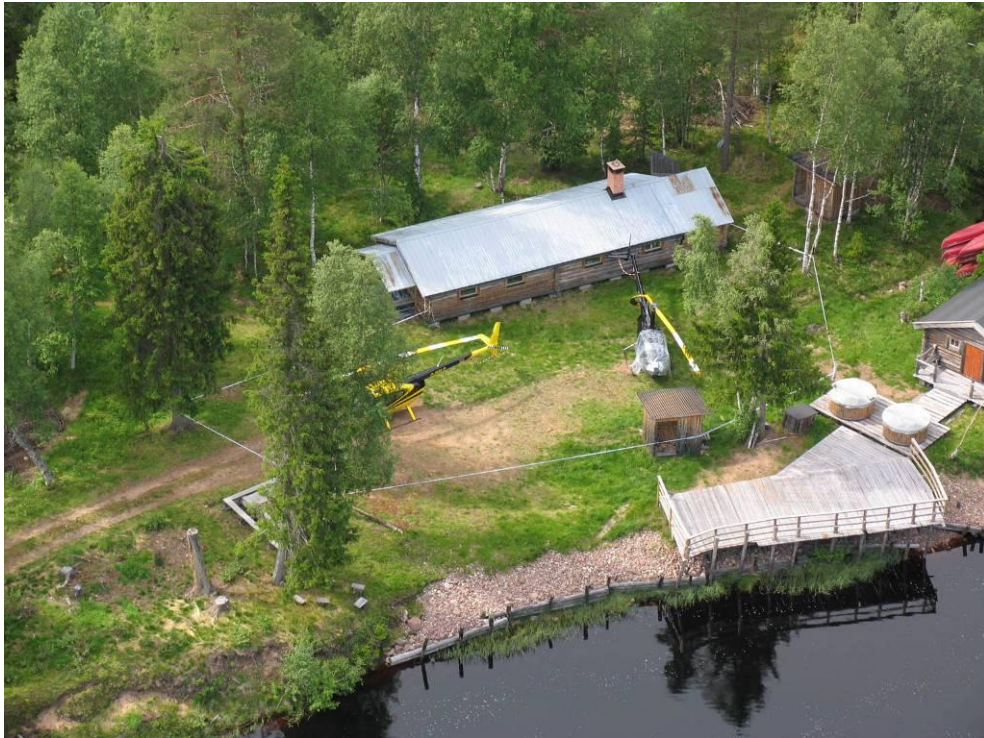
Picture 1: General view after the accident (Photo: Police authorities in Östersund).
