Report RL 2012:14e

**Aircraft accident to SE-FMU
at Kumla, Örebro county,
on 28 August 2011**

Case L-92/11

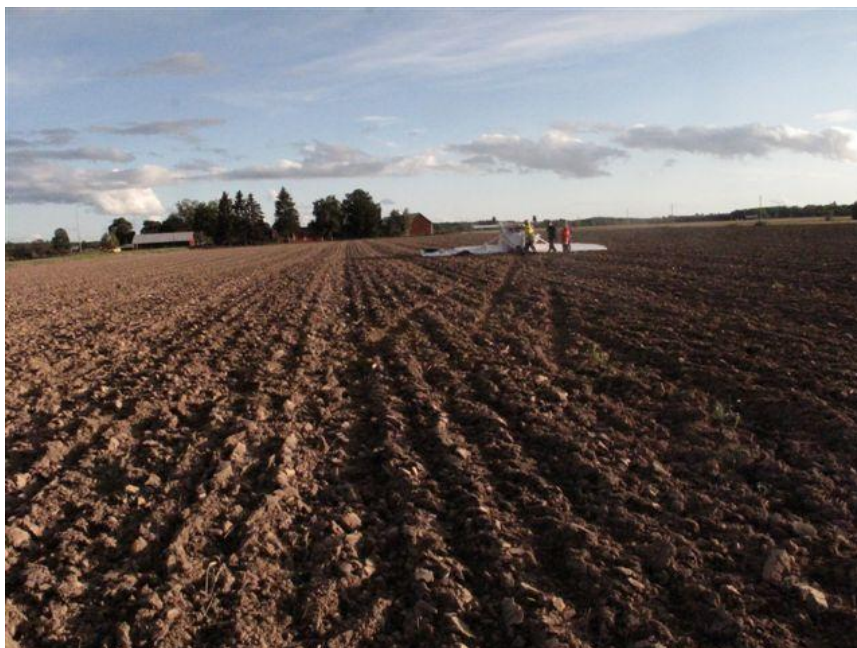
Figure 1. The aircraft, seen from the first touchdown point after the emergency landing.

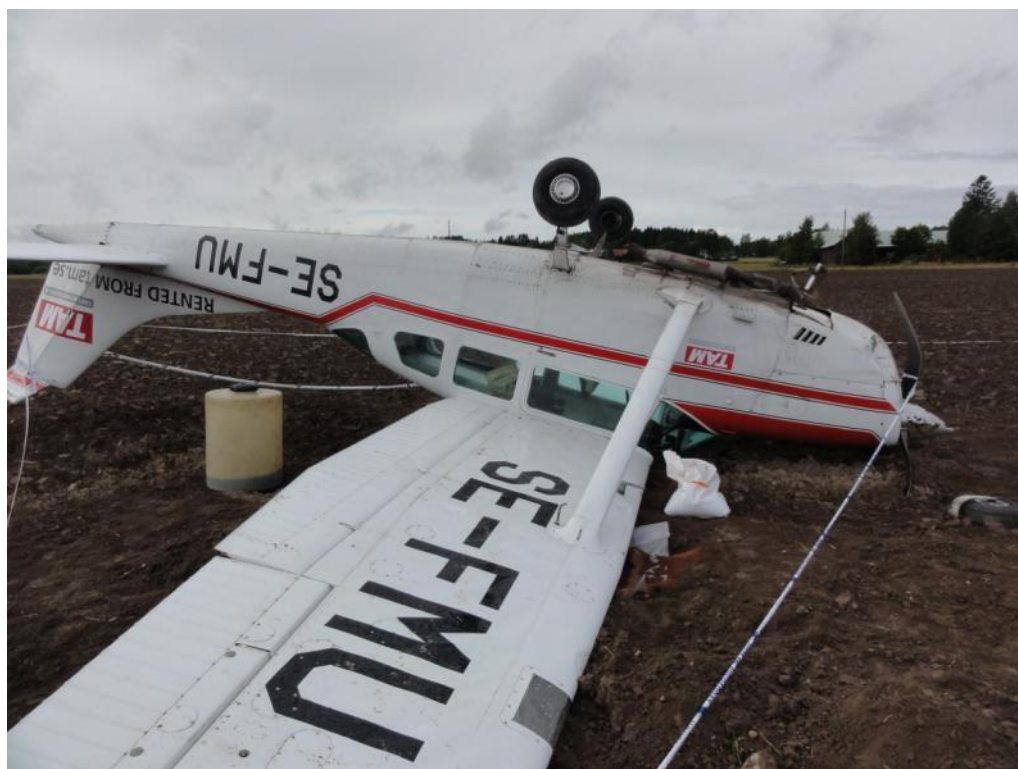
The aircraft ended up on its back, resulting in damage to the nose gear, wings and fin, as well as to propeller and engine. Some of the damage can be seen in Figure 2.

Figure 2. The aircraft after the emergency landing.

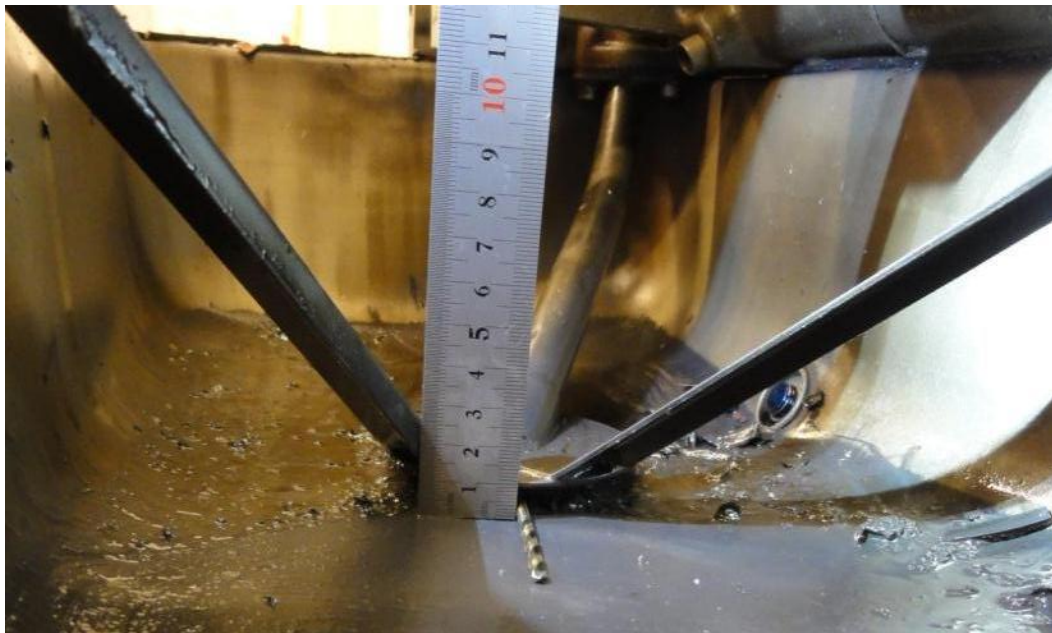
The oil is sucked up via a screen from the rear of the oil pan. The filter is positioned low (just 3.5 mm) over the bottom of the pan - see Fig.

Figure 7. Position of the oil filter. Note that the oil drain is positioned at the side, roughly 15 mm above the bottom of the pan. The drill bit in the image serves as a dimension reference and has a diameter of 3.5 mm.

The oil is drained off via an opening in the side of the oil pan. The bottom edge of the opening is positioned roughly 15 mm above the bottom of the pan.

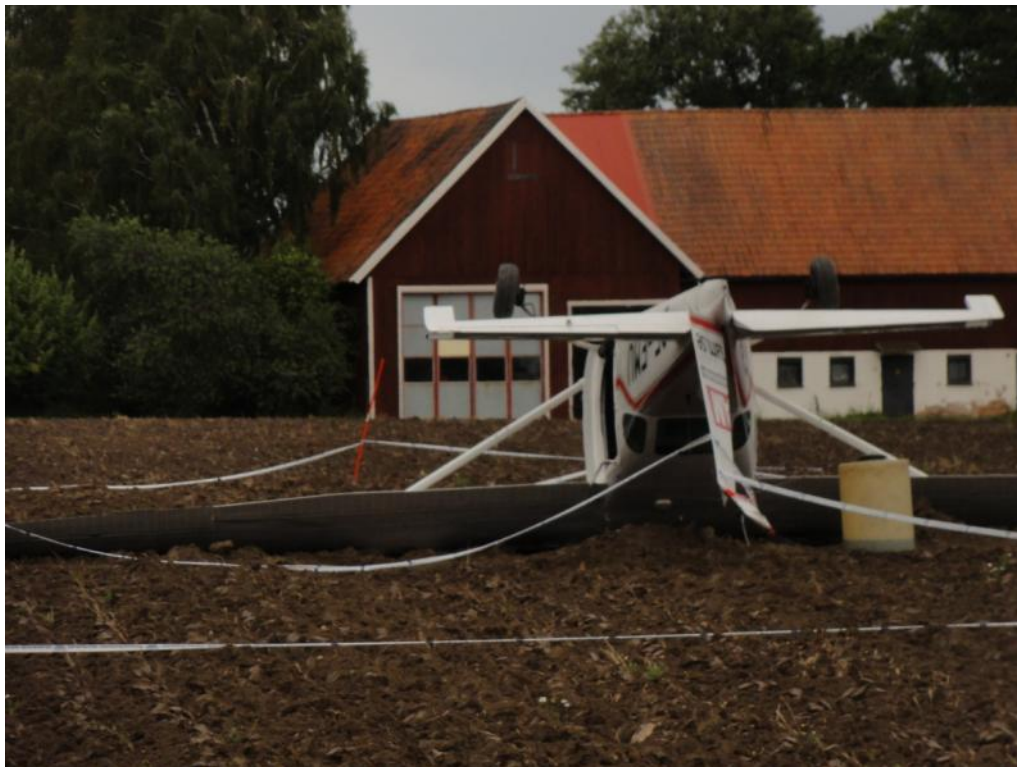
The nose wheel lay severed just before the point the aircraft began to overturn.

Figure 8. Picture taken facing the opposite direction of the flight path, showing, among other things, the cowshed that the aircraft flew over.

The approach and landing were problem-free until the aircraft had rolled around 30 metres along the ploughed field. The cause of the aircraft nosing over was probably the nose wheel fork snapping due to the heavy load in the soft ground, resulting in the aircraft's nose being pushed into the ground.

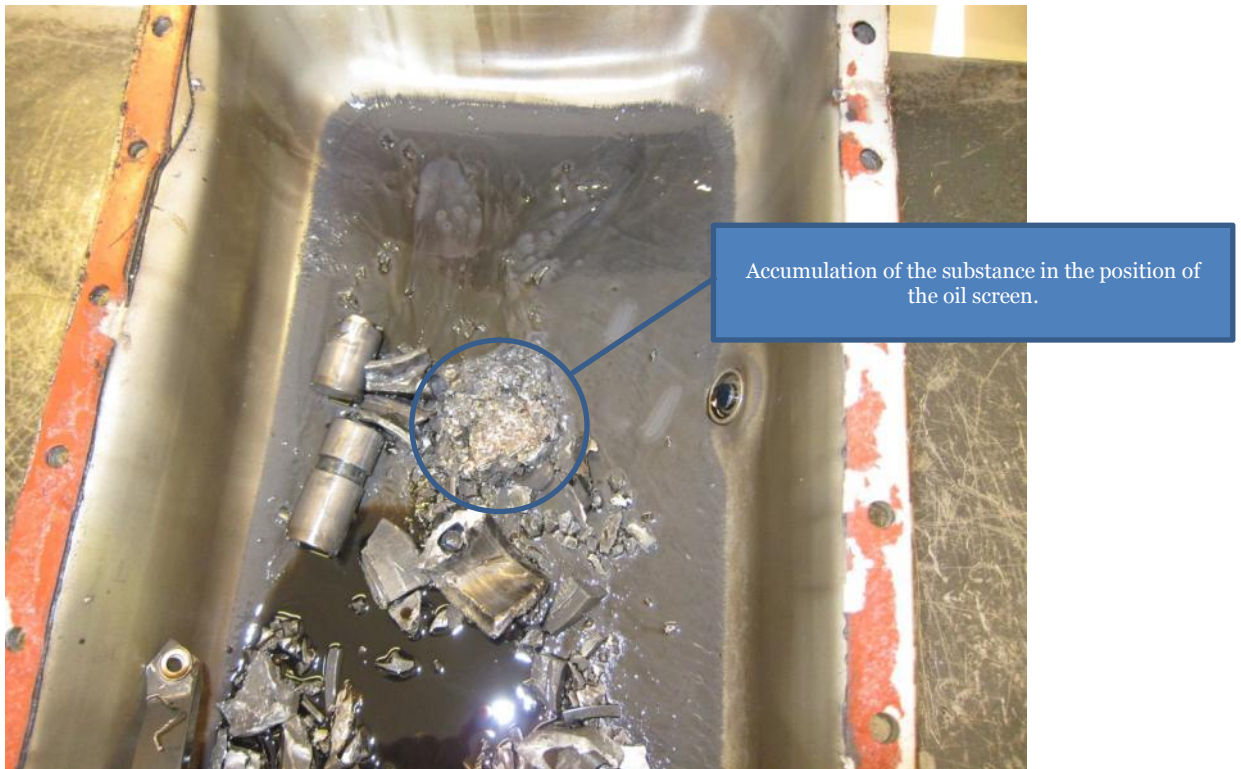
Once the oil pan had been removed, loose engine parts such as the valve lifter and broken parts of connecting rod caps were found - see Figure 10. There was also a viscous substance containing metal fragments, among other things. The substance was sent for analysis. The analysis revealed that the sample consisted of the same particles as the oil sample but with a higher concentration of lead or lead compound.

The oil screen was partially clogged.

The largest concentration of the substance was found in the area of the oil pan under the screen. Here, the substance had a firmer consistency and contained a larger concentration of solid metal particles.

Figure 9. Deposits and remnants of engine parts in the oil pan.

Act to change the maintenance programme for the engine type in question and other engines with similar fuel injection systems, such as Continental IO-520, so that an internal inspection of the oil pan is conducted in connection with oil changes, with the purpose of checking for the accumulation of waste products. (RL 2012: 14 R1)

Act to change the maintenance programme for the engine type in question and other engines with similar fuel injection systems, such as Continental IO-520, so that an internal inspection of the oil pan is conducted in connection with oil changes, with the purpose of checking for the accumulation of ~~waste products~~ **deposits**. (RL 2012:14 R2) EASA is also recommended to:

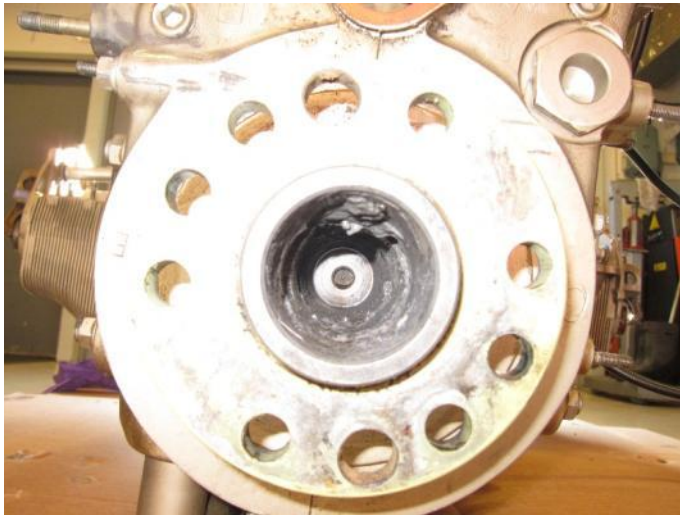
Large quantities of the viscous substance were found in the crankshaft with a moderately high density - see Figure 11. The substance was sent to the laboratory for analysis, where it was established that the substance consisted primarily of lead bromide.

Figure 10. Image showing remnants inside the front end of the crankshaft. The image was taken after some of the deposits had been removed.

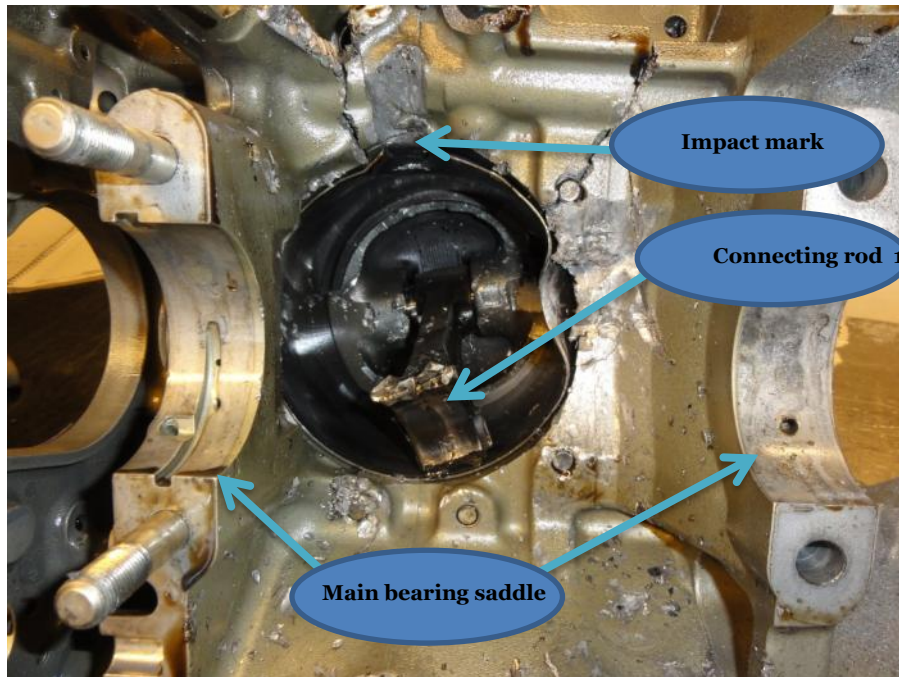
The crankcase was cracked in several places. At the cracks, the material bulged outwards from within. Connecting rod 1 had a fracture at the base. Impact mark from connecting rod 1 in the crankcase and cracks alongside the markings could be noted - see Figure 11. Connecting rod 2 was somewhat bent while the other connecting rods were apparently undamaged.

Crankshaft bearing 1 and the axial bearing were cut and the corresponding contact surfaces on the crankshaft were affected by heat. Other crankshaft bearings

and main bearings were scratched, had signs of wear and in many cases remnants of bearing material. The bearings were correctly in place. The oil ducts in the crankcase and crankshaft were not blocked. The oil pump did not appear to have any defects.

Figure 12. Image showing damage to the engine
