Final report RL 2013:03e

**Serious incident involving the airplane
LN-RPS on 4 April 2012 in the airspace
east of Gävle, Gävleborg County, Sweden**

Ref no L-30/12
2013-01-25

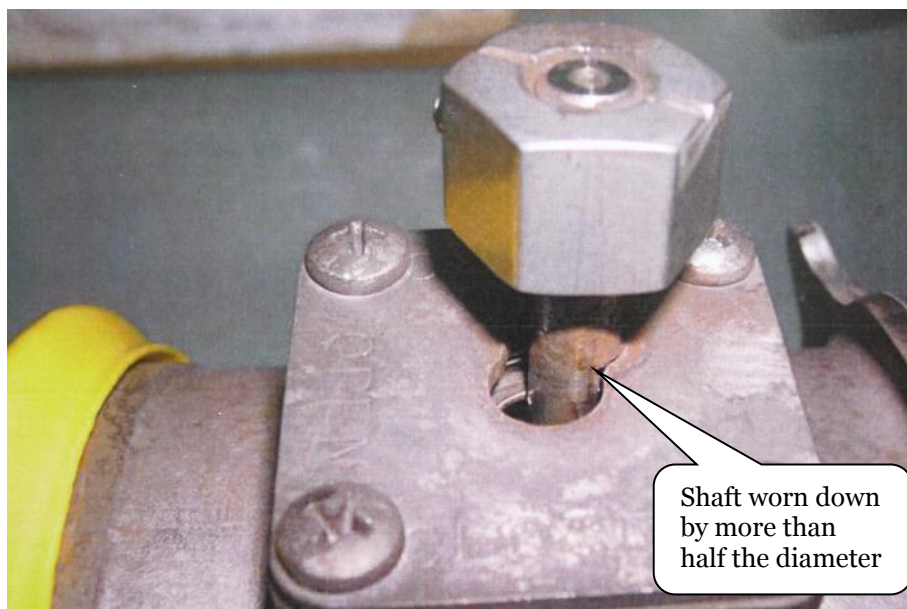
On the HSV, the wear was particularly extensive and the shafts and links have worn in a manner that maintenance workshops had not seen previously on components with the equivalent operating time, see Figures 5 and 6. On the HSV seal there was also a black deposit - a “Rub strip” - that is probably a result of running in the engine's compressor, when the compressor's blade tips come into contact with the seal made with the compressor housing. The deposit is then pressed out via the bleed air ports in the compressor housing and adheres to the valve's sealing surface.

Fig. 5. The input shaft in the High Stage Valve (HSV), right-side engine. (Photo: SAS)

The technicians found that the aforementioned units needed to be replaced on both the left and right engines. They also noted on the right side that the damper for the control valve, PCCV, could be turned freely; see Figure 6. Both of these units were replaced. In addition, the control valve for the high-pressure bleed air, HSR¹⁷, on the right side required adjustment.

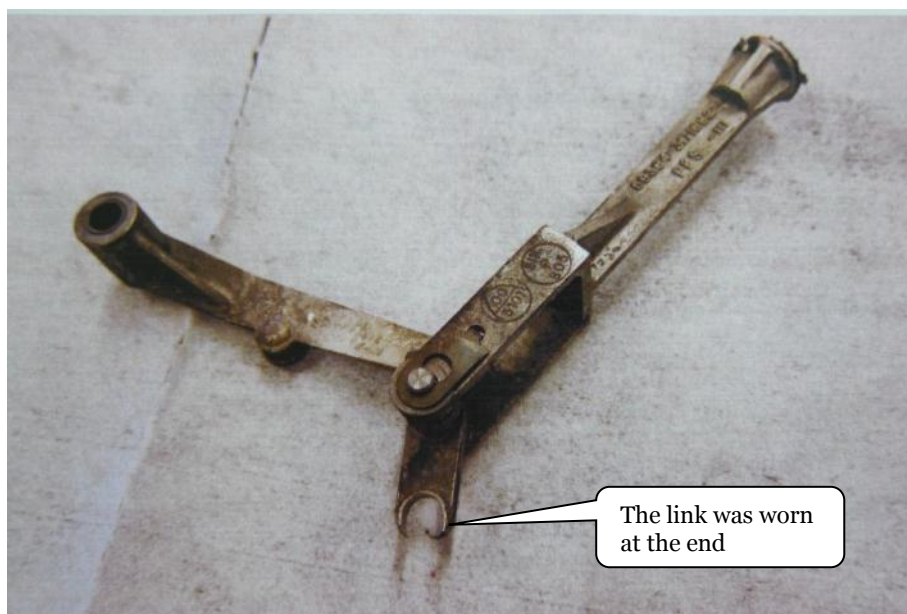
Fig. 6. The link system in the High Stage Valve (HSV), right-side engine. (Photo: SAS)
