Final report RL 2014:09e

Accident in Porjus, Norrbotten county on November 8, 2012 involving the helicopter SE-HOM of the model Bell 206B, operated by Fiskflyg AB.

File number L-125/12

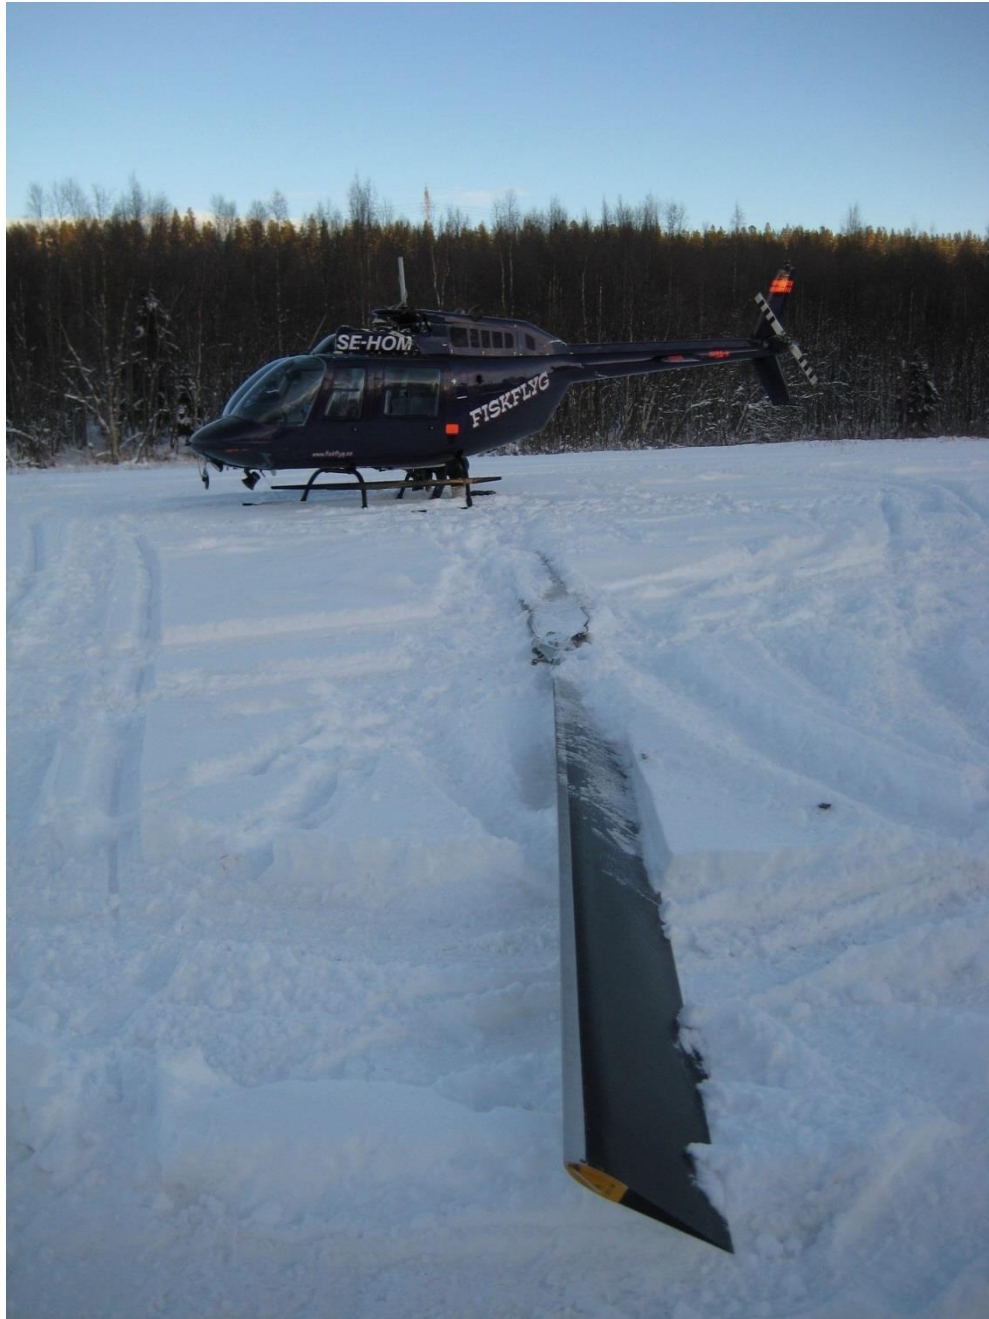
The helicopter was stationary when a heavy scraping sound was heard accompanied by vibrations of a frequency corresponding to the rotor speed. The vibrations continued when the main rotor speed decreased and they then increased sharply. The instructor shut off the engine. At the same time, a “schoff”, “schoff” sound was heard, after which the entire main rotor separated from the helicopter and ended up about 10 metres to the left of the helicopter, see Figure 1.

Fig. 1 The helicopter after the accident. (Photo Fiskflyg)

The damage to the helicopter was confined to the main rotor, mast failure, torn-off pitch links and broken “drive collar”. Upon main rotor separation, one of the blades struck the fairings that cover the main rotor gearbox and then also struck the left side of the fuselage rib at the division between fuselage and tail boom.

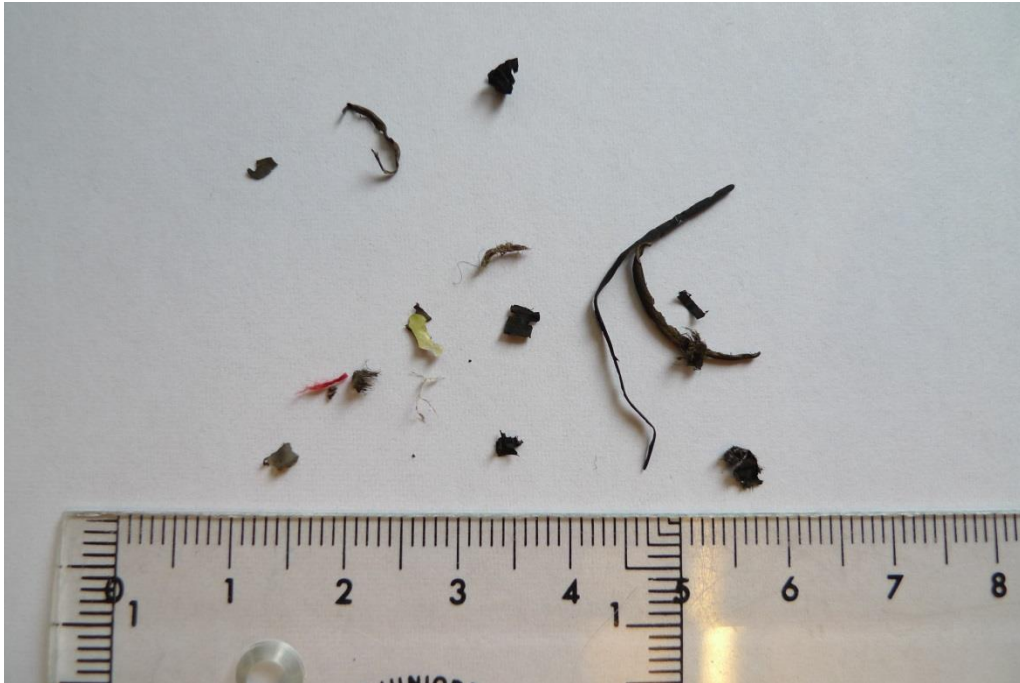
SHK has dismantled the rotor transmission and taken samples of the oil in the filter housing and in the bottom of the transmission. Figure 4 shows part of the material that was found in the transmission's filter housing.

The presence of iron (Fe) and water was relatively high in both oil samples. A particle count was performed on the sample from the bottom of the transmission, and the sample exhibited a large quantity of particles.

Fig. 4 Contaminants from the filter housing (screen filter) on the main transmission, debris from o-rings, sealants, textiles and paint.

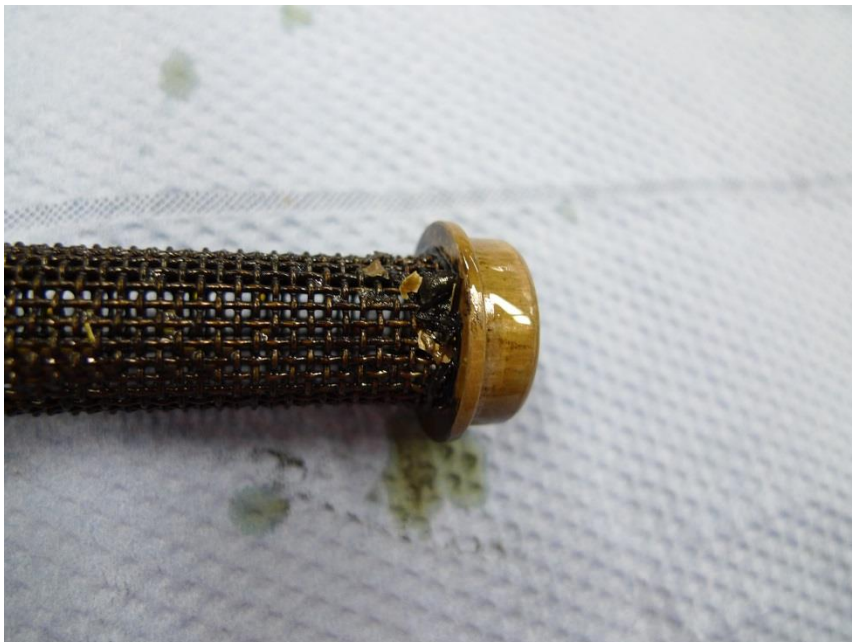
The transmission has a screen meshing to clear the circulating oil from larger contaminants. Here, pieces of solid objects were found, see Figure 5. The most common contaminants were paint debris and sealant material.

Fig. 5 The main transmission's coarse screen meshing with contaminants of sealant and paint debris.

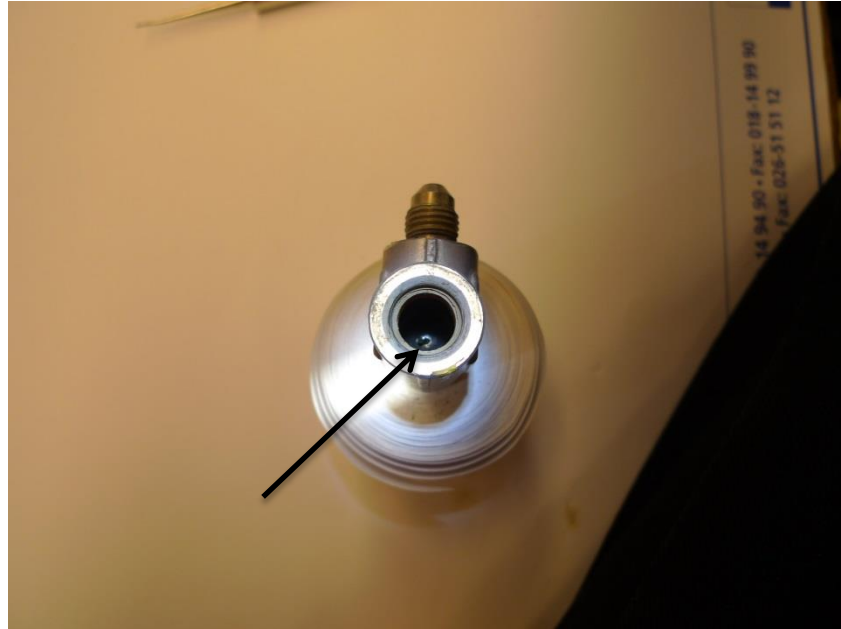
Fig. 6 Restrictor P/N 206-040-244-001, the contaminant is visible at the arrow tip.

The bottom of Figure 8, slightly to the right, shows “Restrictors in fitting”, where the flow out to the freewheel lubrication is limited by means of a restrictor whose orifice is 0.99-1.12 mm in diameter. At this restrictor, see also Figure 9, a contaminant was found.

Figure 6 shows the contaminant as a black dot at the tip of the arrow. Figure 7 shows the contaminant at greater magnification.

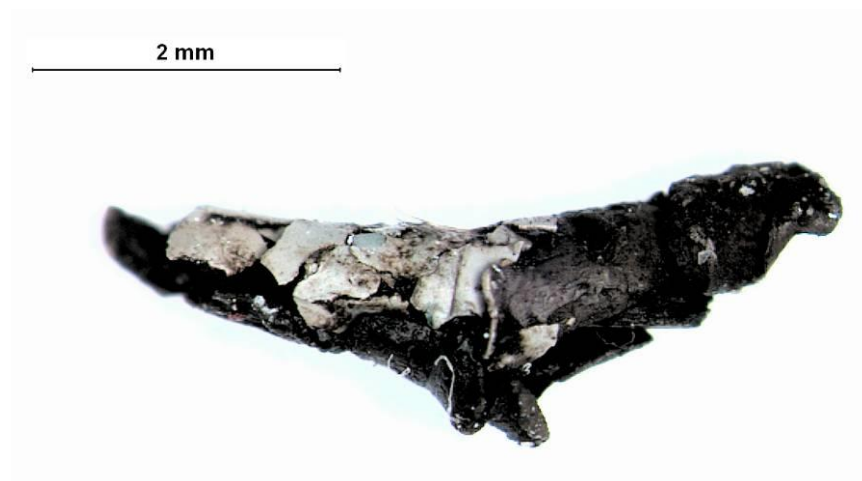
Fig. 7 The contaminant's size was about 1.4 x 4.2 mm.

By means of SEM⁶ and FTIR⁷ analysis, it has been possible to determine the origin of the contaminant. Comparisons with another sealant and paint debris from the main transmission show that the plug consists of sealant of type Pro Seal 890 Class B (AMS-S-8802, Class B, MIL-S-8802).

An analysis of the contaminant has shown that it consists of sealant material that has been used between the cover and the transmission housing.

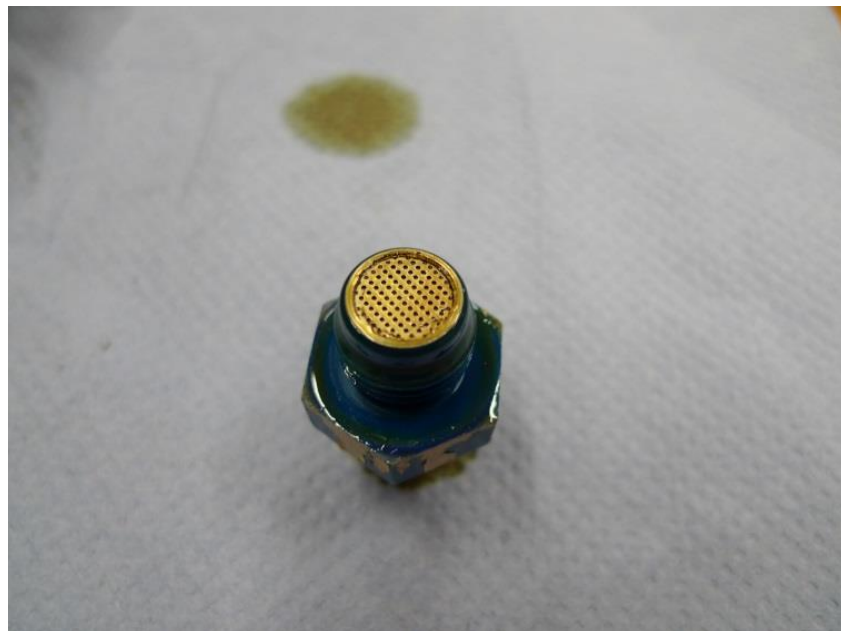
Fig. 10 Filter P/N 50-075-1. Upon examination, the filter was free from visual contaminants.

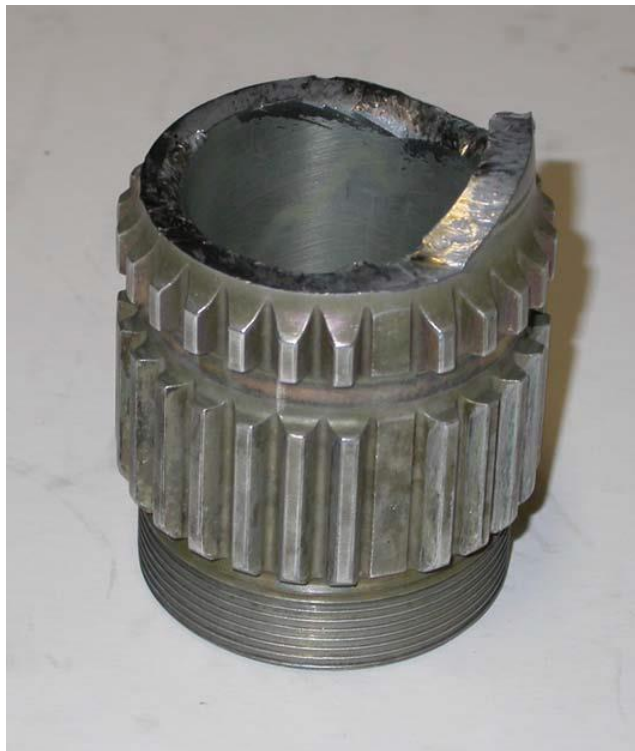
Fig. 12 Upper part of the helicopter mast.

The examination showed that the fracture surfaces had secondary damage due to “slippage” between the two fracture surfaces. Approximately 30-40 per cent of the section was undamaged, and it could be noted that this part of the fracture surface did not exhibit any traces of fatigue. The mode of failure was momentary overload in torsion, i.e. a shear fracture. The mast's material composition corresponds to the steel qualities stated by the manufacturer, AMS 4340 and AMS 4340H.

The area around the sheared section was examined by means of magnetic particle testing. The examination revealed no indications of cracks or defects.

The materials analysis shows that the mast has been twisted off due to overloading. SHK's calculation shows that the safety factor to torsional failure is at least 2.6 for a static load at full engine power. To achieve an overload failure thus requires an increased moment through dynamic effects.

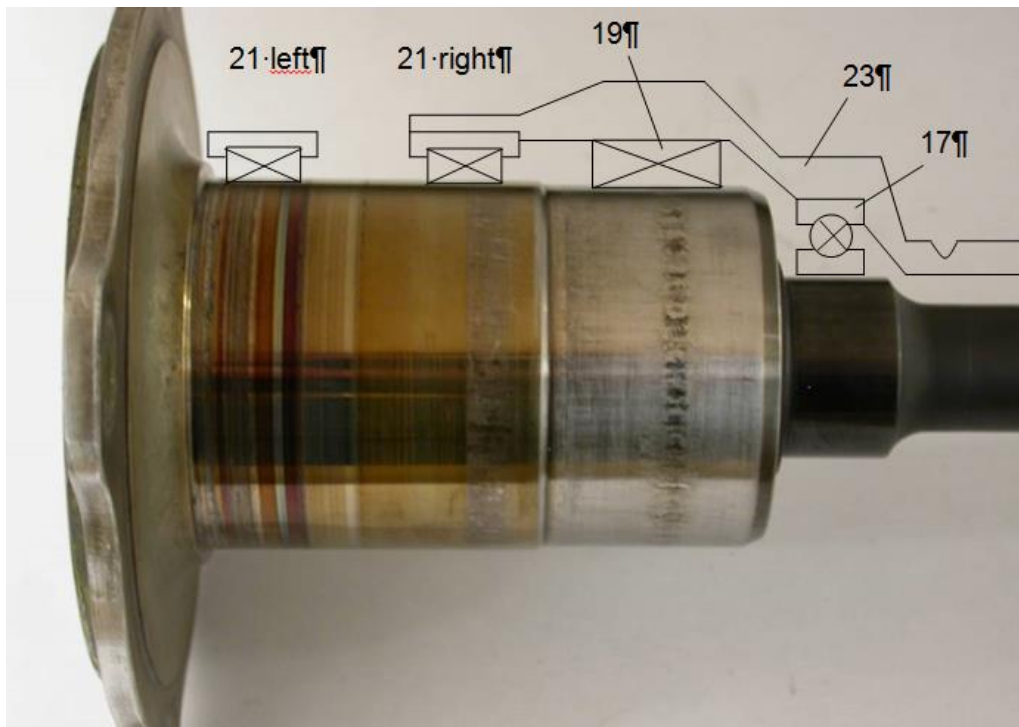
SHK has examined the freewheel. All four freewheel bearings showed damage and discoloration caused by lack of oil. Correspondingly, the freewheel's external and internal contact surfaces and its sprags were damaged by lack of lubrication. There were no chips at the chip warning system's indication plug on the freewheel's return oil side.

The contact surfaces both of bearings and the freewheel clutch were affected by heat, but not to the extent that the surface hardness was impaired. The bearing surfaces exhibited colour change. Wear marks on the inner part of the sprags in the freewheel and corresponding contact surfaces show that smearing of material had occurred, see Figure 13.

Fig. 13 Inner freewheel shaft with schematic description of bearings and sprags. The freewheel's sprags are Article 19 in the picture. All bearings (Articles 21 L, 21 R and 17) were damaged due to insufficient lubrication. (Photo: Exova)

The investigation has not been able to determine how long the freewheel had been without sufficient lubrication. The lack of lubrication has, inter alia, resulted in a raising of the temperature in the freewheel. This has probably damaged the freewheel's sprags, whereby the freewheel has not functioned in the intended manner.
