***Final report RL 2012:19e***

**Serious incident involving the aircraft SE-DRS  
in the airspace between Estonia and Finland  
on 7 December 2010**

Ref no L-170/10

2012-10-18

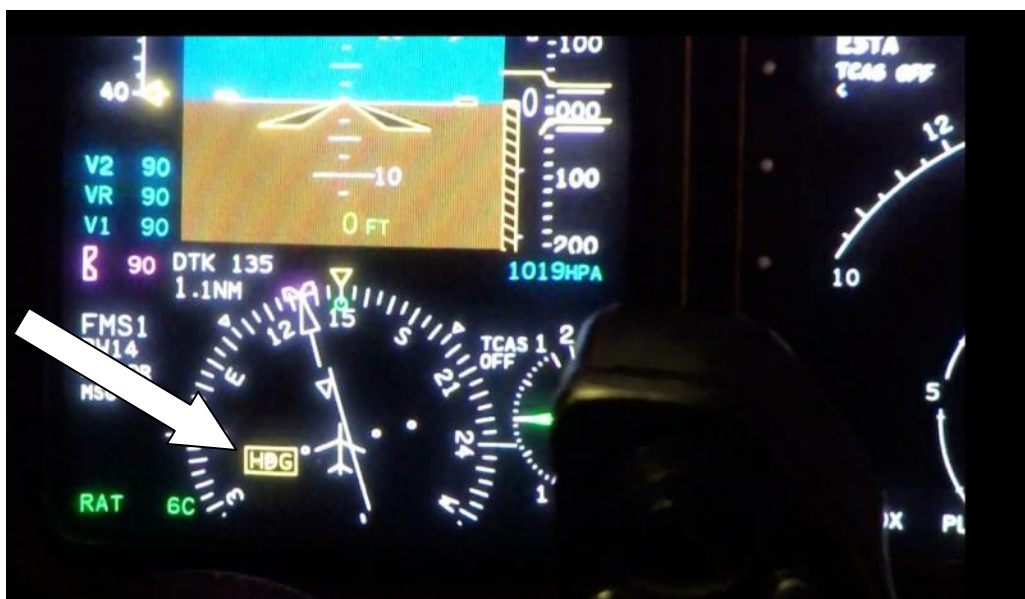
The warning indicated that the two sensors that detect the horizontal components of the earth's magnetic field were generating different signals. The two compass indications reportedly showed a difference of up to 180°. The discrepancy compared with the standby compass was up to 90°. These problems may arise where there are disturbances in the ambient magnetic field of the earth, such as those due to iron objects in the ground under the compass. In the present case, the commander suspected that the problems were due to the magnetic compasses being disturbed by reinforcement bars in the concrete surface of the taxiway.

Figure 3. Heading warning.

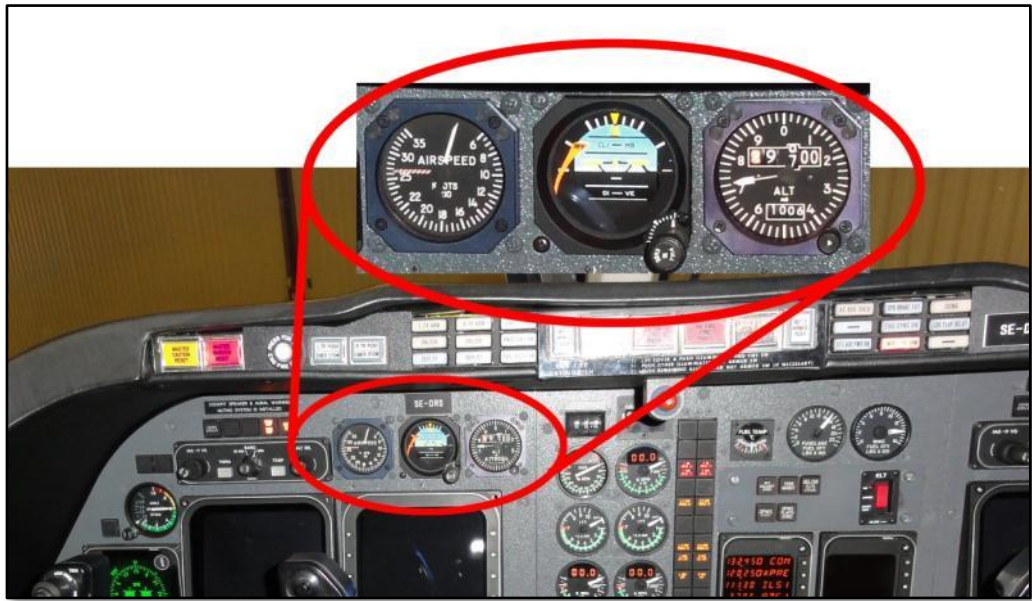
However, there was local radar at Tampere-Pirkkala Airport that made a PAR<sup>10</sup> approach possible. The crew therefore requested permission to land in Tampere and planned for a PAR approach. Approach and radar guidance were accomplished by means of the standby instruments, and the aircraft landed at Tampere-Pirkkala Airport without further problems.

Figure 4. Standby instruments.

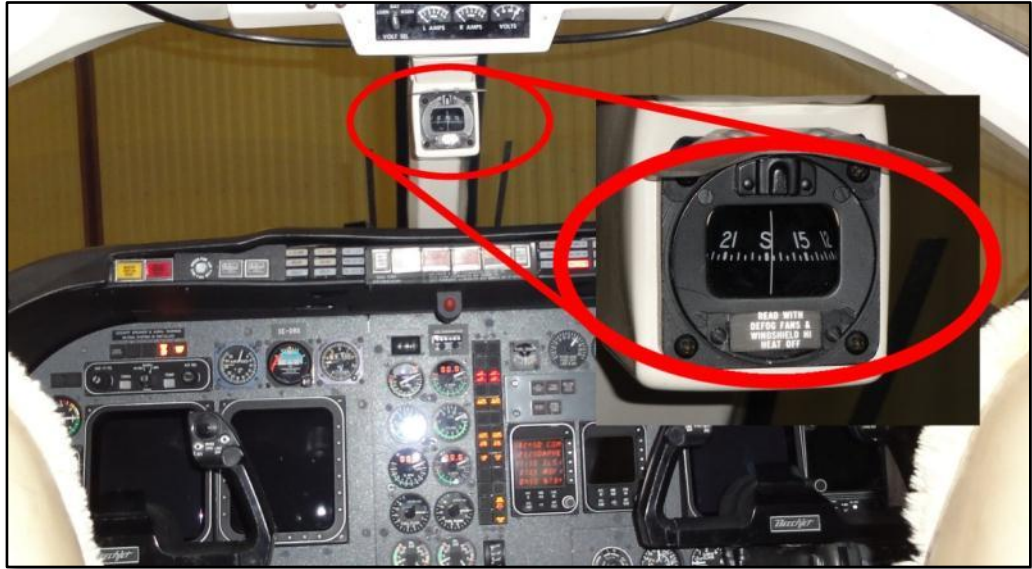
After about 5 minutes flight, parts of the navigation information disappeared and the heading warning was displayed again. The information reappeared, however, and the commander decided that they would continue the flight. However, the information disappeared again, and after it disappeared for the third time, they requested radar vectoring towards Helsinki Airport. The crew performed a fastslave<sup>5</sup> and flew on heading 350° towards a specified point outside Helsinki. Air traffic control informed them, however, that the heading they were holding was 30-40 degrees incorrect. This was shortly followed by a MAG<sup>6</sup> warning and Flight Director<sup>7</sup> warning, upon which the attitude information disappeared. In addition, the standby compass did not display a reliable heading because the front windscreen heating was on, which affects the standby compass.

Figure 5. Standby compass.

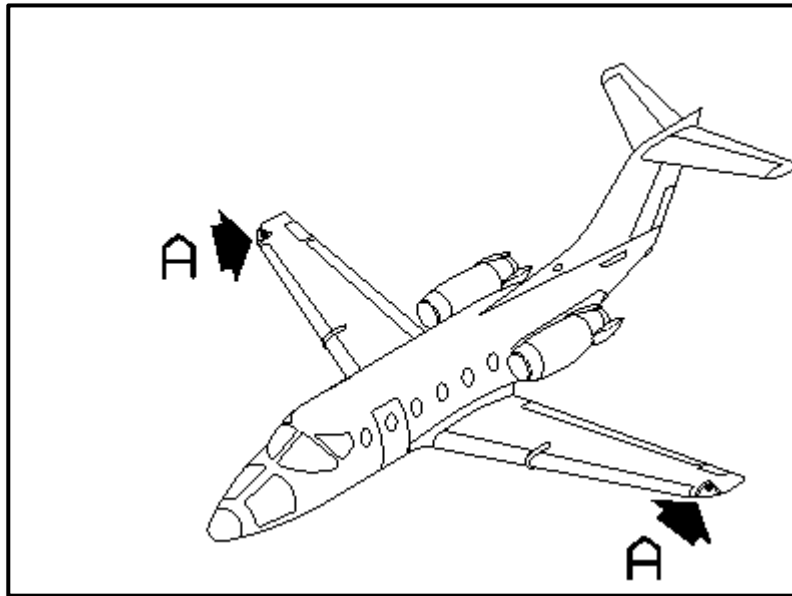
Getting a heading split<sup>19</sup> is fairly common at airports where the earth's magnetic field can be distorted. These problems are normally not localized to certain aircraft types, but may, however, be more sensitive on low-wing aircraft where the sensors are closer to the ground. This is due to the distortion of the earth's magnetic field being greater near the surface of the ground, since it is normally in the ground that the metals causing the magnetic field distortion are found.

Figure 7. shows the positions of the flux detectors (sensors) on the aircraft in question.

Figure 7. The position of the flux detectors on the Beechjet 400A.
