## *Final report RL 2014:01e*

**Serious incident at Pajala Airport on 13 February 2013 involving the aircraft ES-PJB of model Jetstream 3102 operated by AS Avies.**

File No L-38/13

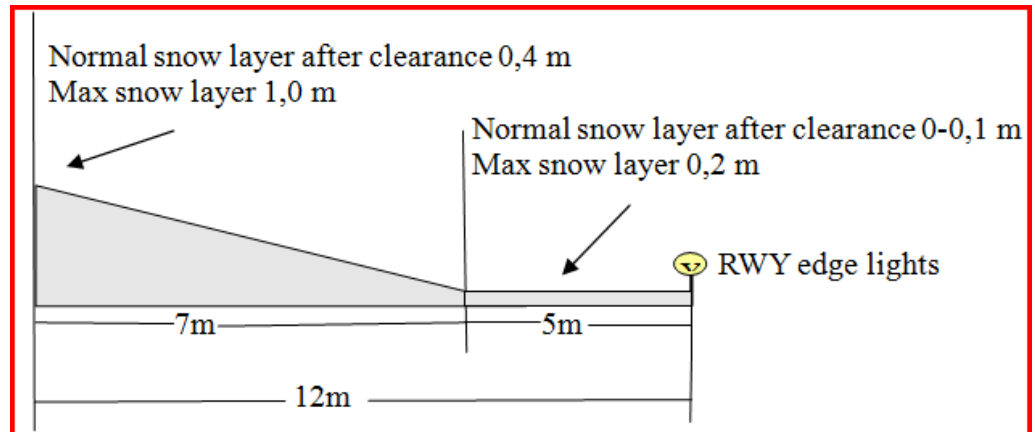
Figure 3 - Snow clearing profile at Pajala Airport.

On the day in question, the airport had a “winter runway”, that is, the runway was covered with a thin layer of hard-packed snow. Due to the prevailing weather with snow at times, there had been some clearing of the runway during the day. In connection with snow clearing, the strip area outside the runway is also cleared as shown in figure 3.

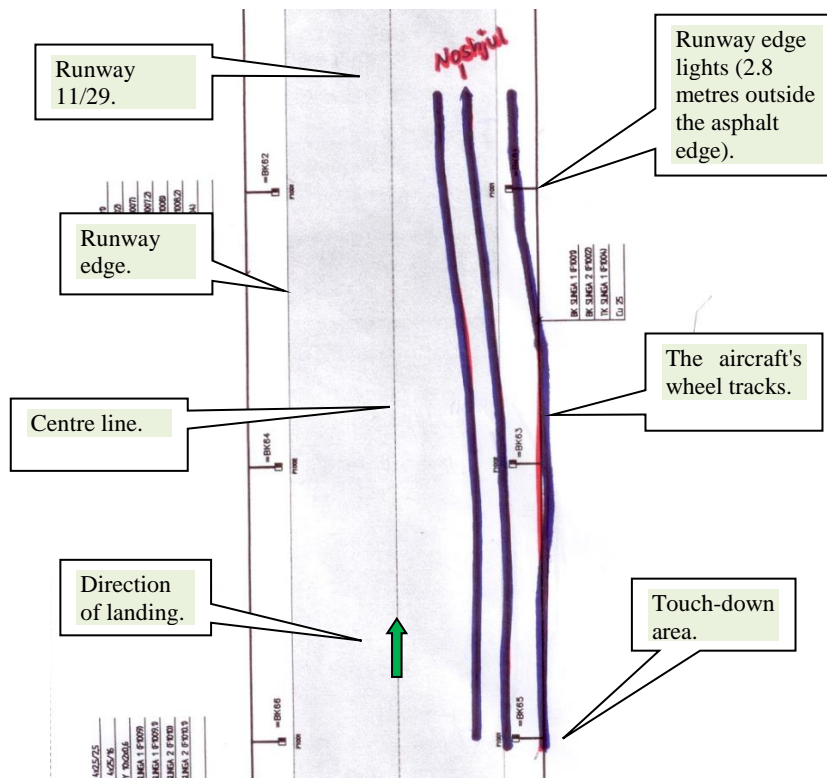
Figure 4 - Sketch of the aircraft's tracks.

After the incident, the ground staff and the crew inspected the site of the incident. According to the commander, this took place mainly to ensure that none of the aircraft's wheels had collided with a runway edge light. In connection with the inspection, the tracks were measured by the ground staff and documented in the sketch in figure 3 below.

The sketch in figure 4 shows that the touchdown was made with the nose wheel and the right main wheel outside the runway's asphalt edge. The aircraft has then rolled parallel to the runway for about 100 meters, passing on the outside of two runway edge lights with the right main wheel. The aircraft then passed another runway edge light with the right main wheel rolling between the light and the runway's asphalt edge.
