Final report RL 2014:02e

**Accident at Aitik on 15 August 2011
involving helicopter SE-HVI of type Bell
206L-3, operated by Fiskflyg AB.**

Ref no L-84/11

2014-02-17

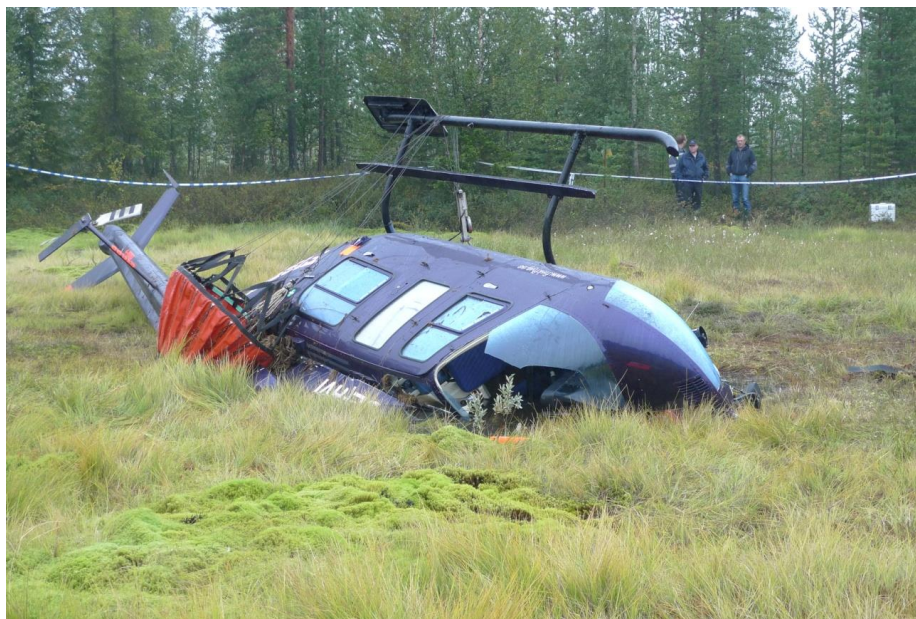
During the task, the pilot had been to the smaller tarn a great number of times when the crash occurred. When the pilot had lowered the container into the water to fill it and subsequently commenced climb in order to lift the container up out of the water, the helicopter banked suddenly to the left with a pronounced nose rise. The pilot applied full cyclic stick to the right and simultaneously lowered the collective lever in order to correct the rolling movement to the left. The pilot experienced something clatter above the cabin, upon which the helicopter rotated to the left at a high roll speed and with the nose high. Shortly thereafter, the helicopter came down into the partially buoyant, flowing and layered portion of the tarn. Just before impact, the pilot heard a heavy sound from the transmission. Figure 2 shows the helicopter in its final position after the incident and with its Bambi Bucket hanging over the skid.

Figure 2. Crash site.

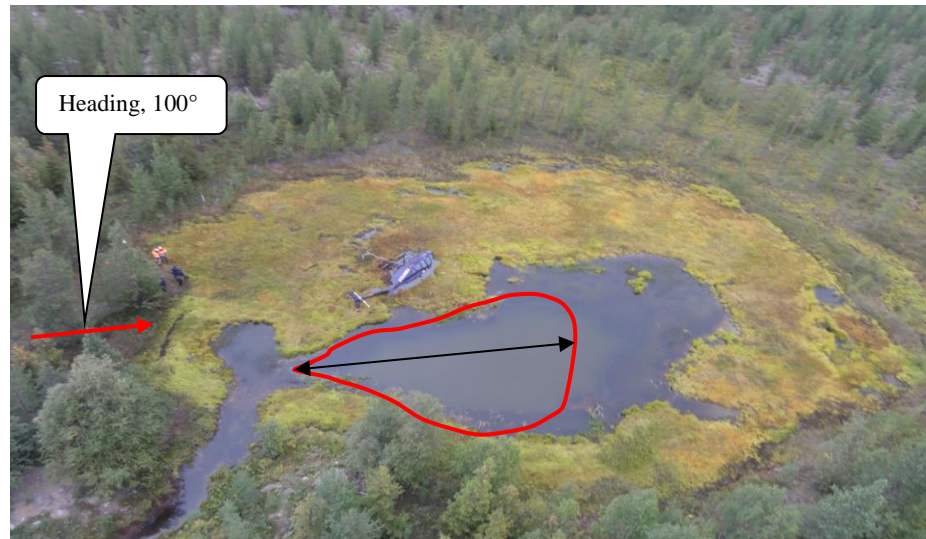
Figure 4. Overview picture of the tarn from the south. Within the part of the tarn marked in red, the water depth was more than one metre. The black arrow indicates a distance of around 20 metres.

Figure 4 shows how the tarn looked from the south. It should be noted that the area with a water depth greater than one metre constituted less than half the tarn's free water surface.

The helicopter came to rest on its right side in the tarn. The entire main rotor and mast situated above the main rotor gearbox separated from the helicopter. The parts found on the ground and in the surface of the tarn were lying in a semicircle to the right of the place at which

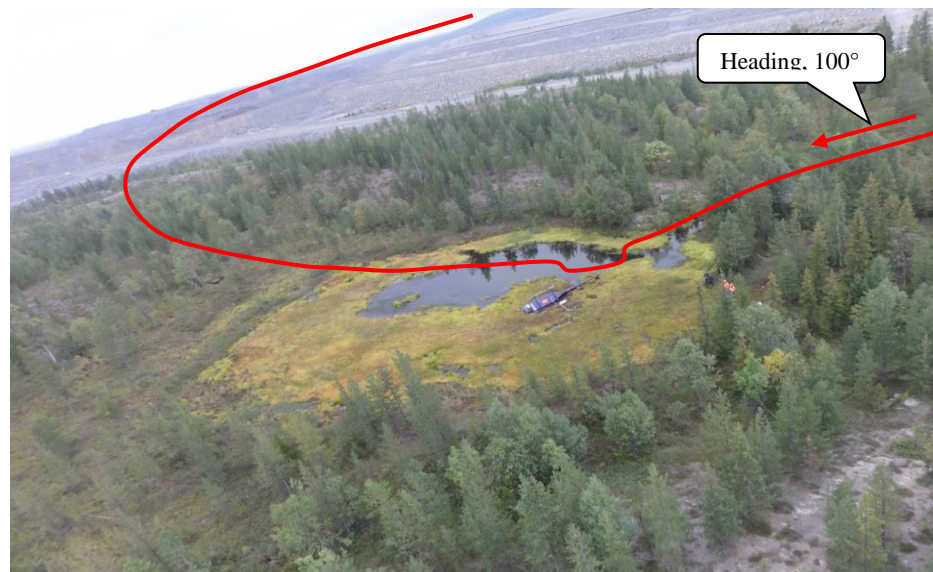
Figure 5. Overview picture of the tarn from the north. Approach and climb out when filling Bambi Bucket at the tarn.

The tarn leg of the flight has been exemplified in Figure 5. The heights of the tree curtains are shown as well as a ridge between the tarn and the forest edge (to the top of the picture). The tailings dam can be spotted at the top edge of the image.

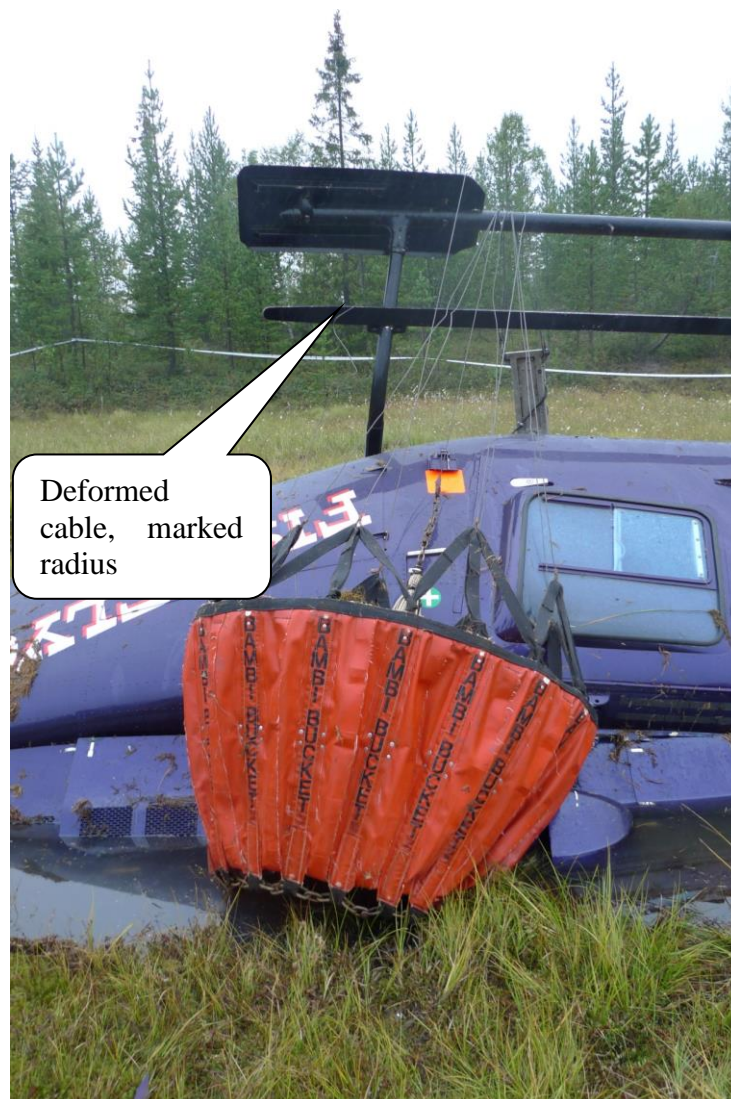
The rear mount of the left skid shoe had been overloaded and was twisted about 30 degrees clockwise as seen from behind. The cable as well as the skid and skid shoe exhibited wear damage which upon comparison was found to be matching, see Figures 6, 7 and 8.

Figure 6. Bambi Bucket, left skid and skid shoe, note the radius of the marked cable.

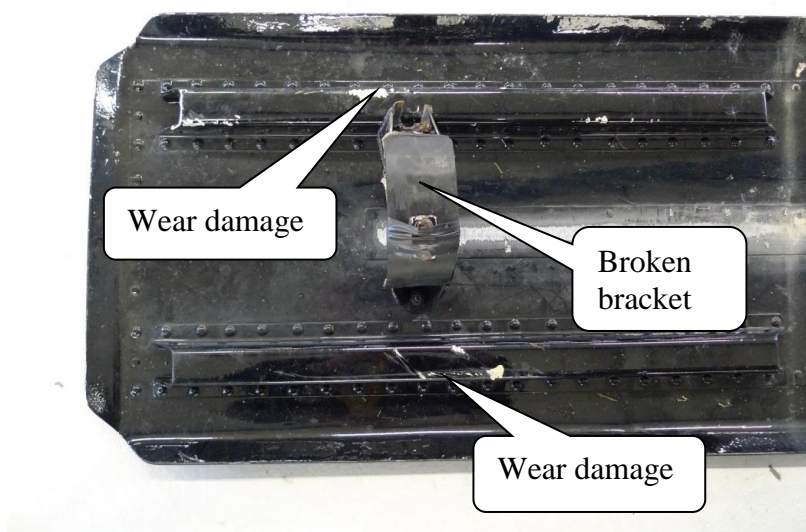
Figure 7. Left skid shoe, note wear damage from the cable and broken bracket.

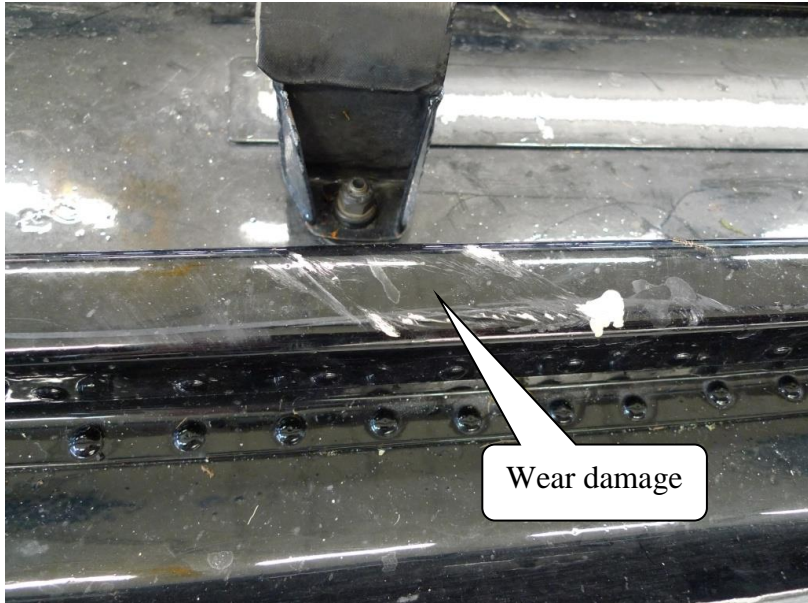
The permanent deformation of the skid shoe, as well as the position and deformation of one of the cables, indicates that the cable had been in contact with the skid shoe under load, see Figure 8.

Figure 8. Close-up image of the left skid shoe, note wear damage from the cable.

In light of the damage visible on the rear mount of the left skid shoe, the cable, the landing gear skid and the left skid shoe, SHK feels it is clear that during the final lift of the Bambi Bucket, a cable was hanging over the left landing gear skid and skid shoe.

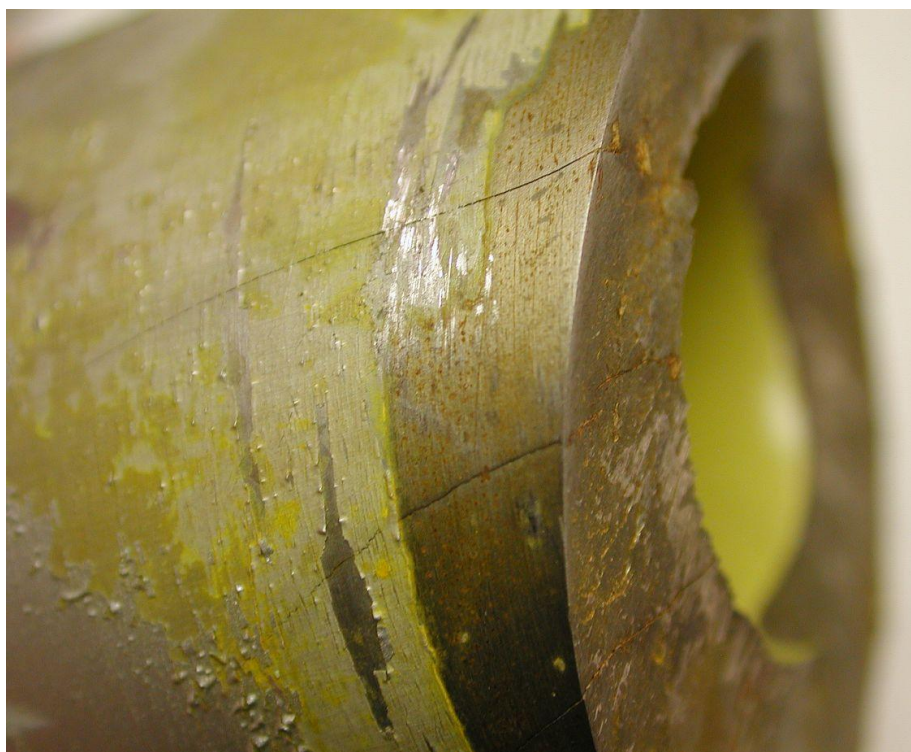
The examination established that the mast's primary mode of failure was overloading through torsion (twisting). The cracks sloping at 45° on the mast's periphery indicate the mode of failure, see Figure 9. The material of the mast is ductile⁸ and the superposed bending force deformed the mast (bent the mast) when the rotor disc came in contact with the tarm's water surface.

The mast wall thickness in the fracture surface was checked. It varied from 8 to 12 millimetres (in the section subjected to wrenching). Nominally, the mast material's thickness is 10.5 millimetres.

The mast's chemical composition is consistent both with AMS 6414 and AISI 4340. The hardness was determined on a cleaned, polished surface at five measurement points according to Vickers⁹ (HV10), and the average value was 408.

Figure 9. Mast, sloping cracks in a direction of 45° that are typical for torsion failure.

SHK has found that the mast's dominant mode of failure was overloading through torsion (twisting). The cracks sloping at 45° on the mast's periphery indicate the mode of failure. The bent part arose when the rotor disc came in contact with the tarn's water surface. The failure of the mast did not initiate the crash. Other damage to the helicopter also arose as a result of the accident.

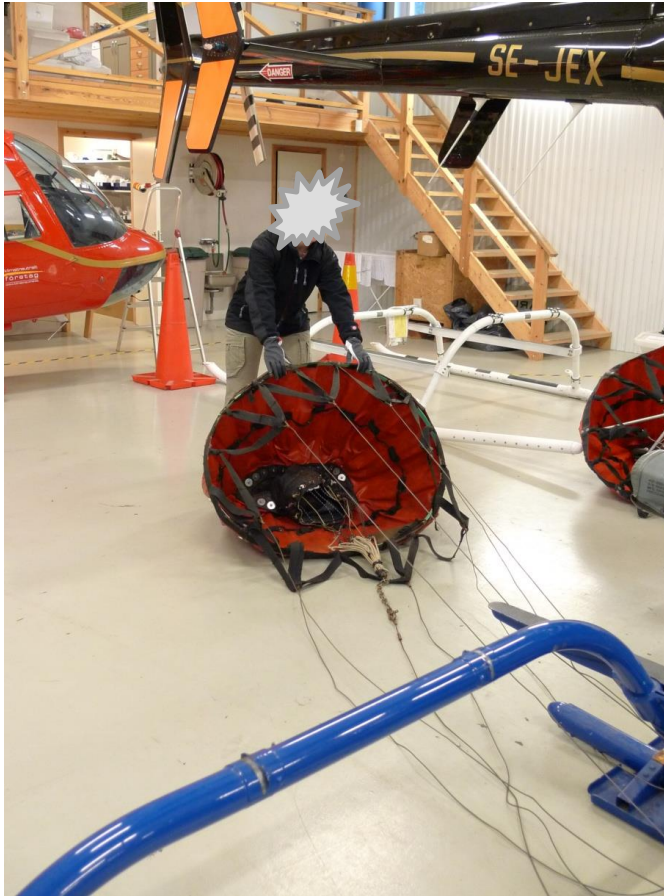
Lining up the cargo hook's position (in the horizontal plane) and laying out the lines to the sack showed that the angle from the helicopter's centre line to the rearmost point of the skid was about 40°, see Figure 10. The container's angle (double cone angle) between the cables when it is filled with water is around 20°. If the sack is not filled with water, the cone angle is slightly less, and the sack must in this case swing out > 30° to touch against the skid. If the angles are considered in a vertical plane across the cargo hook and the direction of flight, the result is of approximately the same magnitude as in the first case.

Figure 10. Bambi Bucket angled about 30° to the left behind the helicopter.

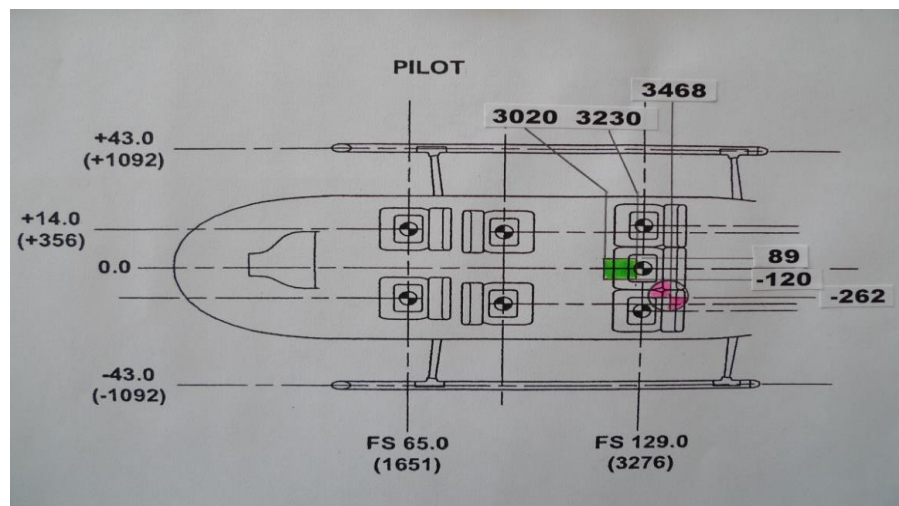
Figure 11. Schematic presentation to scale of the longitudinal and lateral centres of gravity when the cable is around the left landing gear skid, Bambi Bucket completely filled with water. The green area marks the permitted centre of gravity, and the pink-white symbol shows the actual centre of gravity.

For an illustration of the centre of gravity, see Figure 11. The calculations above show the centre of gravity when the load is lifted and the cable has hooked into the left landing gear skid and is over the skid shoe.
