Final report RL 2013:19e

**Accident involving the aircraft SE-MBC
on 28 February 2013 at Borlänge Airport,
county of Dalarna, Sweden**

Ref no L-20/13

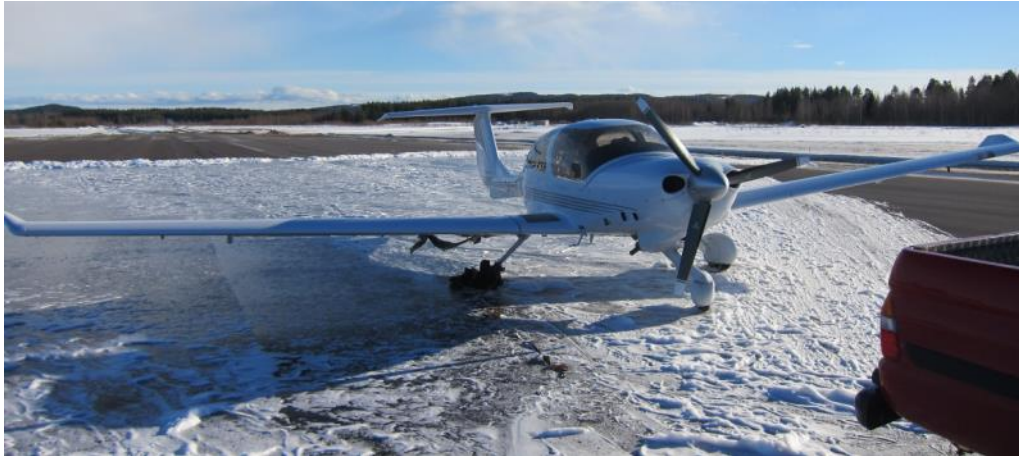
Fig. 1. DA-40D SE-MBC during salvage. Photo: Borlänge Rescue Services.

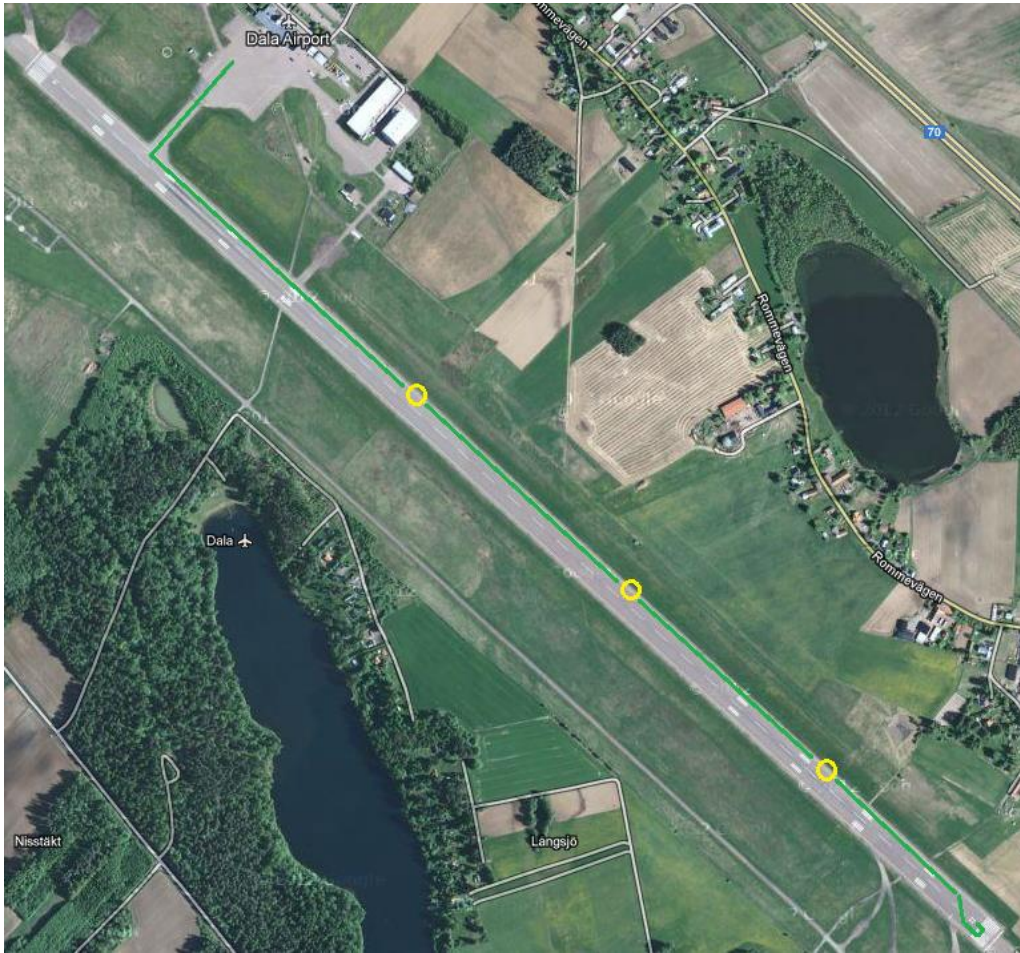
The total taxiing took five minutes and was 2 100 metres long, just over 2 000 metres of which was taxied in a tailwind of 21 knots. The taxi route has been drawn by the pilot during the interview and may be seen in Figure 2.

During the taxiing on the runway, the pilot stated that there had been difficulties in taxiing the aircraft in a straight line and it was necessary to use the right brake to a great extent. The taxiing was commenced along the left side of the runway and continued on that side with a number of stops, marked in yellow in Figure 2.

Fig. 2. Borlänge Airport. Taxi route according the pilot. Photo: Google Earth, © Lantmäteriet Dnr 2013/0375

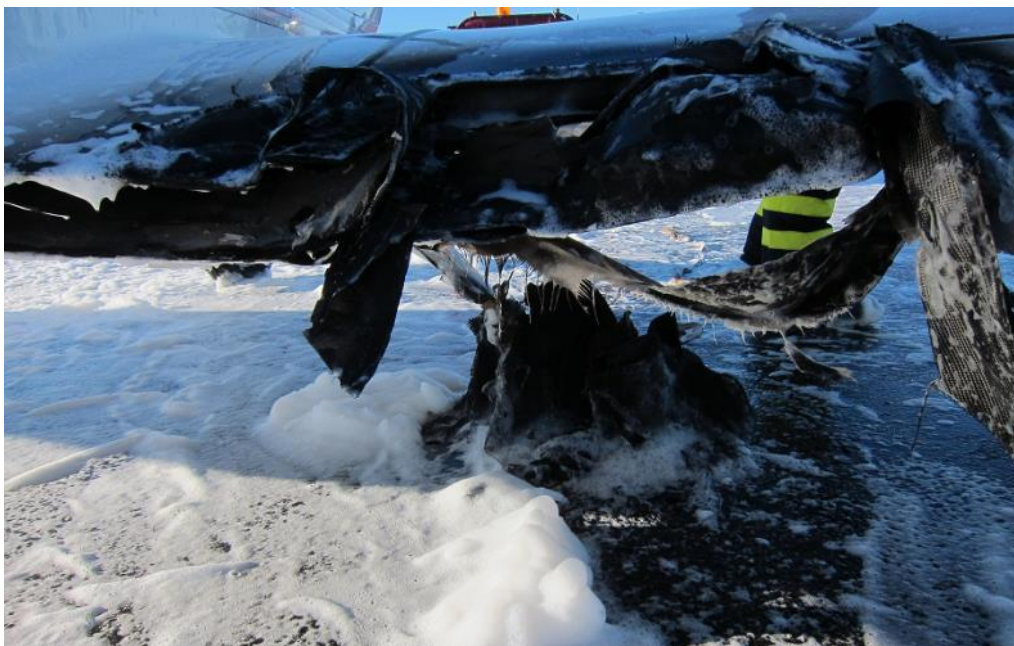
The damage was substantial. The right brake, wheel with tyre and fairing, as well as landing gear and the inner part of the right wing and its flap, were ravaged by fire (Fig. 3).

Fig. 3. Damage to wheel, wing and flap. Photo: Borlänge Rescue Services.

A fire started at the right wheel. The fire spread to the inner and rear part of the right wing and its flap (Fig. 3). A portable fire extinguisher was on board but was not used.

The aircraft was equipped with wheel fairings of composite material, which contributed to the confinement of the heat that arose as a consequence of the overheated brake. This contributed to the occurrence of a fire.

It is not possible to establish whether it was the right tyre or fairing that ignited first. The fire spread to the inner and rear part of the right wing and its flap (Fig. 3).

The type certificate holder has responded to the accident and has introduced a warning in the AFM (revision 6). The warning elucidates the importance of avoiding prolonged use of the brakes when taxiing due to the risk of overheating, with reduced braking action as a consequence.

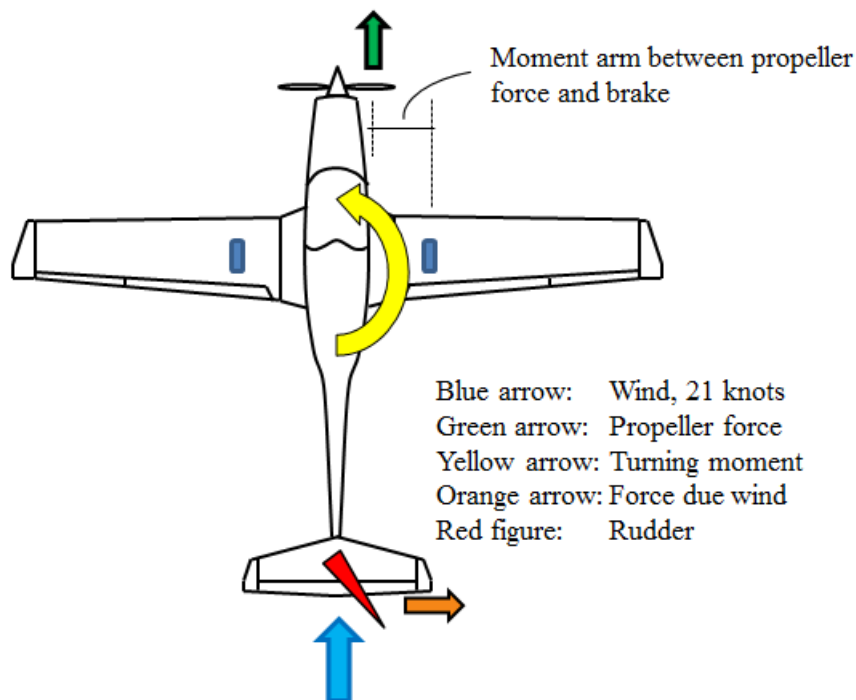
When the pilot steered to the right, the rudder acted so as to catch the wind (Fig. 4). The rudder lost its normal and desired steering function since a surface was created upon which the wind acted. This resulted in a moment that swung the aircraft to the left.

The clockwise-rotating propeller produced a moment that forced the aircraft to the left (Fig. 4). This moment was strengthened in line with the engine's rpm. The short moment arm that exists between the propeller's thrust and the right brake meant that it was necessary to use both a great engine output and braking effect in order to counteract the moment and thereby maintain the heading.

Fig. 4. Forces and moments at the time of the accident.

Given the short moment arm between the right wheel and the propeller's thrust, it is likely that a great engine output was used. The energy from the engine output was thereby transferred to the brake, which came to be overheated.
