Statens haverikommission
Swedish Accident Investigation Board

Final Report RL 2011:10e

**Serious incident to Aircraft LN-KKD
at Arlanda airport, Stockholm County,
Sweden on December 20, 2009**

Case L-22/09

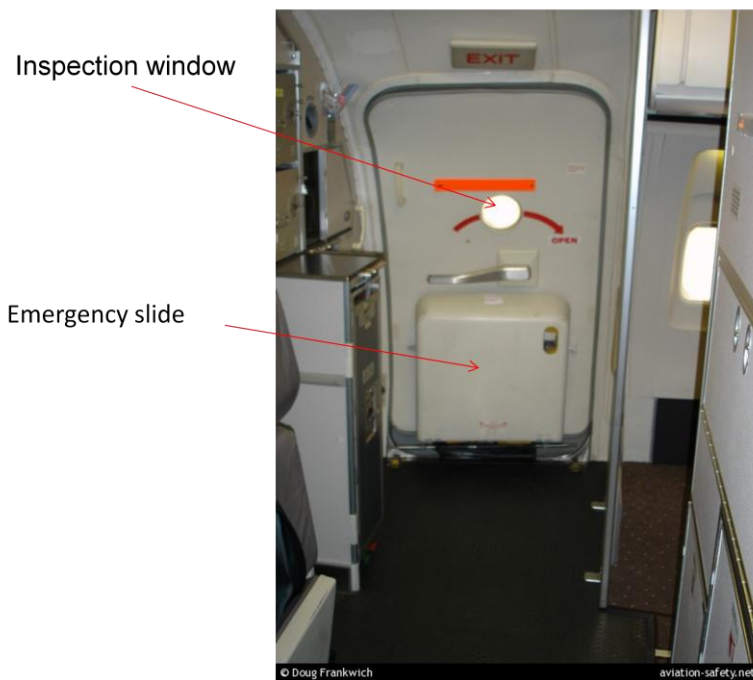
Fig. 3. The service door on the right side of the airplane.

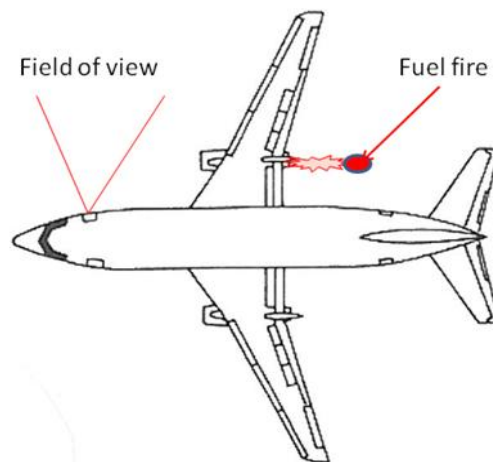
The aisle was now blocked and prevented the cabin crew to view the rear part of the cabin, and the field of vision through the inspection window in the door was too narrow to allow inspection of the right side engine and the surrounding area. It was therefore not possible for the cabin crew in the forward cabin to find out if a fire had occurred in or outside the airplane, or if other hazards existed. The cabin crew at the front doors therefore found it safer to evacuate the aeroplane after the alert from the passengers. The aeroplane's two front doors were opened and the evacuation slides⁹ were deployed automatically.

Fig. 4. Approximate field of vision from the inspection window in the service door and the approximate location of the transient fire on the ground.

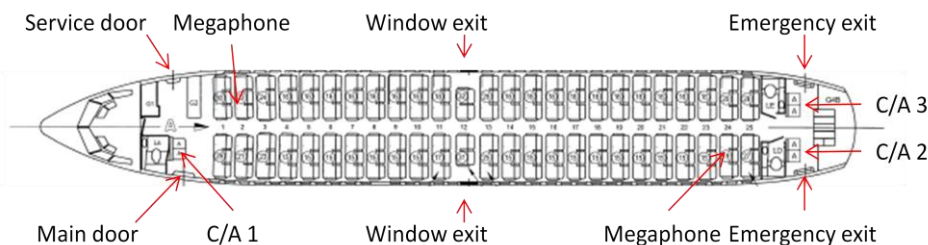
The cabin crew checklist for emergency evacuation (Evacuation Procedure) implies that the cabin crew members are at their ordinary work stations. In a cabin crew of, as in this case, three C/As, the C/A 1 is supposed to open both the cabin and service door, C/A 2 should open the left rear door and C/A 3 the rear door on the right side, see Figure 5.

Fig. 5. Location of emergency exits and megaphones, and the work stations of the cabin crew members on take-off and landing.

C/A 3 operated the forward doors, instead of C/A 3 normally operating the rear right side door. However, there was neither possibility nor reason for C/A 3 trying to reach the airplane's rear part, in the situation that prevailed. The sequence of events could possibly been different if C/A 3 had stayed at the normal work station when the passengers alerted about fire. C/A 2 and C/A 3 together would have been in a better position to evaluate if there was a hazardous situation, and thereafter try to calm the passengers in this part of the cabin.

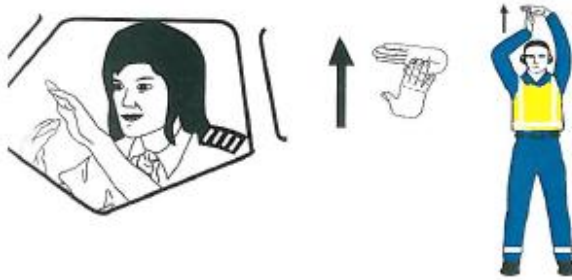
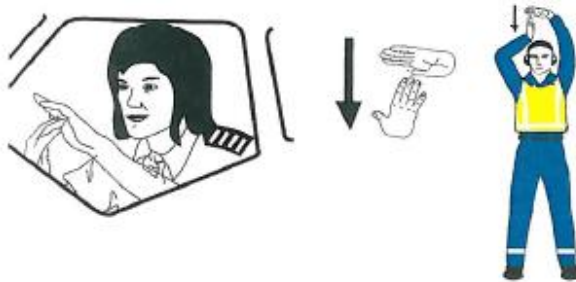
Fig. 6. Hand signals for connection and disconnection of ground power in the Nordic Aero AB's training materials.

The disconnection of ground power was neither signalled by the ground staff nor agreed by the pilots. This did not directly influence the occurrence, but was still a distraction in the preparations for departure. It is noted that hand signals for connection and disconnection of ground power were not described in the Norwegian's pilot manual, AOM Part B. However, it is an established routine that communication should occur between the pilots and ground staff when ground power is disconnected.

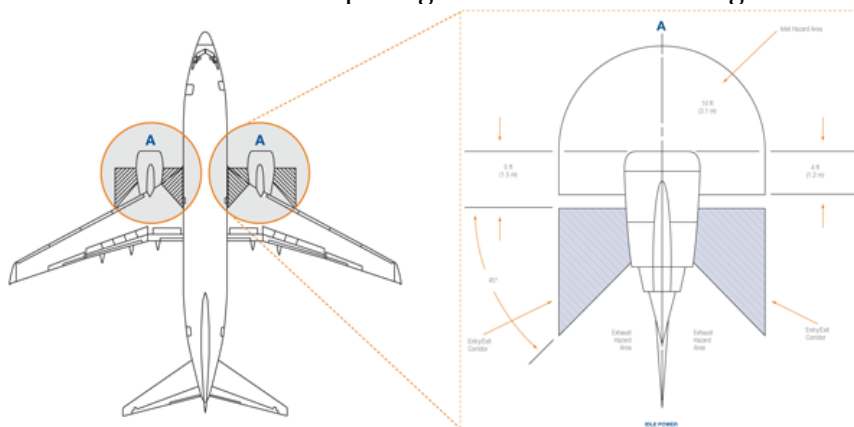
The fuel supply to the airplane's right engine was cut but the engine's internal parts were still rotating, when the first passengers slid down on the ground. According to the airplane manufacturer's diagram, the danger zone in front of a running engine is a semicircle of 10 feet (3 m) radius, Figure 8. The distance between the service door opening and the front of the engine is about 6 m.

Fig. 8. Danger areas around running engines for Boeing 737.
