**Statens haverikommission**  
Swedish Accident Investigation Board

***Report RL 2011:03e***

**Aircraft accident to helicopter SE-JBU,  
north-north-west of Klutsjön, Dalarna county,  
on 1 July 2009**

Case L-08/09

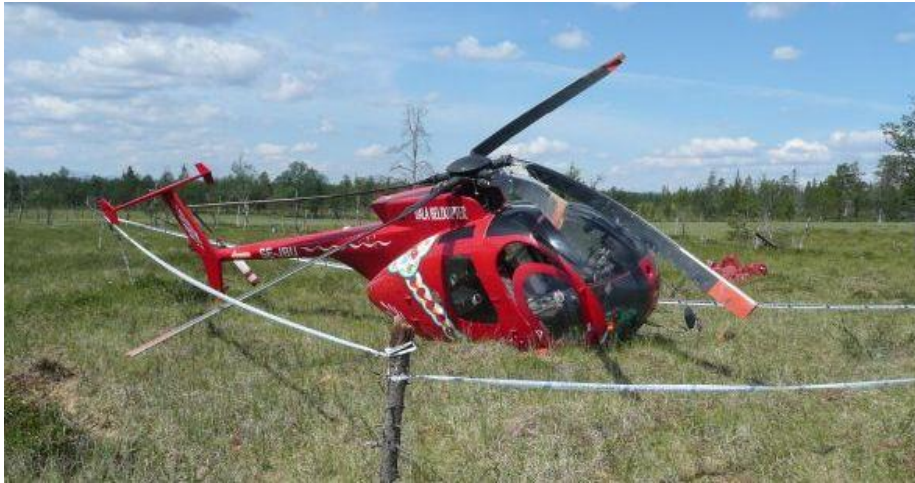
Figure 5. SE-JBU

On impact the landing skids broke so that the underside of the helicopter cabin contacted the ground.

The descent rate of the accident helicopter was high on impact. Despite the soft and energy-absorbing boggy ground surface, which helped to mitigate the ground impact, one landing skid broke and there was compression damage to the pilot's seat.

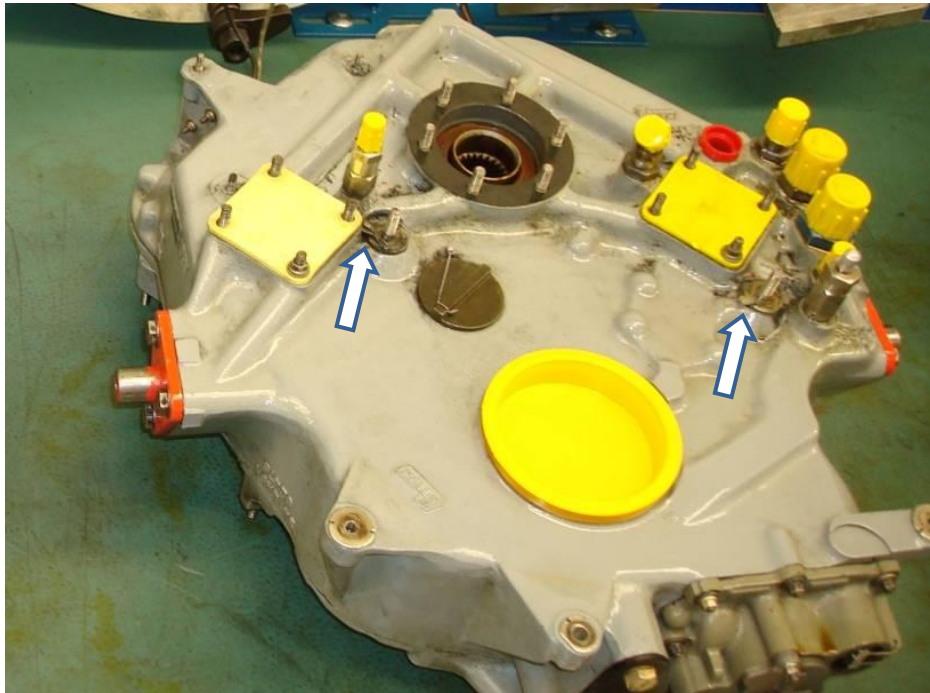
Figure 6. Loose studs in the bolted connection

The engine was taken to an authorised aircraft engine workshop for further examination. While the engine was being dismantled it was noted that two studs for securing the connection between the compressor and the gearbox were loose. They could move some tenths of a millimetre axially, and it was possible to turn them by hand. These studs should normally be anchored permanently in the gearbox housing.

The stud connection consists of a total of five threaded studs and nuts. The loose studs were located beside each other on the same side of the gearbox. (See the illustration below.)

During dismantling of this particular engine it was found that two of the studs on the same side of the gearbox housing were loose and could move axially. This could have meant that the stud and nut joint had some play on one side, so that there could arise a slight angle between the contact surfaces of the compressor and gearbox, and thereby also between their common centrelines for the drive shaft.

Apart from a visual check of the nuts and studs in their installed state, there is no requirement to check the fasteners in the gearbox. How long the engine in this case operated with loose studs is not known. It is the opinion of SHK that this could however have been long enough to create a non-linearity of the drive line that contributed to fretting damage occurring on the Splined Adapter.

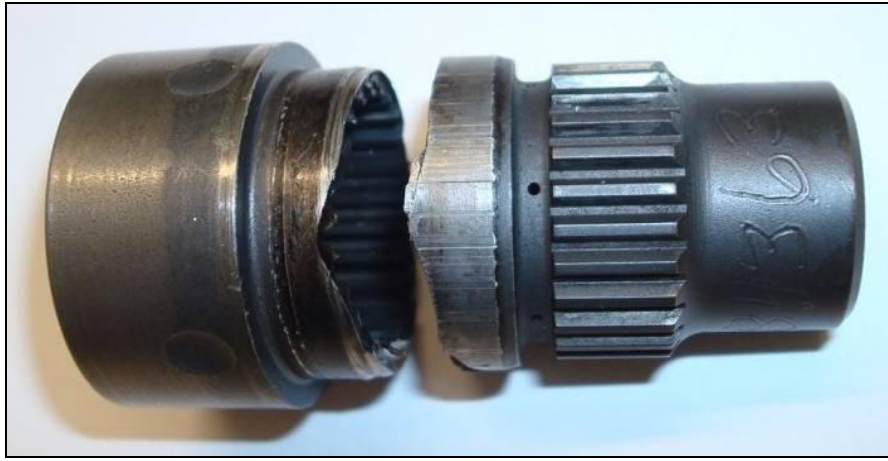
Figure 7. Fractured Splined Adapter

The adapter has a circumferential fracture at the centre of its cylindrical section. At the point where the fracture occurred the internal splines begin, where the spur adapter gear shaft shall engage. The fracture is partly just inside and partly just outside the ends of the splines. The fracture surfaces has secondary damage that arose when one half rotated on the inside of the impeller. See the photograph below.

The fracture surface has the typical appearance of fatigue. On one half there is an area, which was probably the starting point, which had no secondary damage. The fracture has originated from the outside of the cylindrical part of the adapter. During growth the crack has propagated from the outside and in towards the tops of the splines on the inside, while growing circumferentially.

The engine stoppage on the accident helicopter SE-JBU was caused by a fracture of the silver-plated version of the Splined Adapter, P/N 23076559. Even though this was the first reported fracture of a silver-plated adapter, this event implies that further measures may be necessary before a final solution is achieved.

- prescribe measures that would lead to phasing out of Splined Adapters of the earlier design sooner than March 2012 (*RL 2011:03 R1*), and to
- ensure that the engine manufacturer investigates the risk that fretting damage and fatigue fractures on Splined Adapters could be caused by non-linearity in the engine drive shaft line as a result of loose studs in the stud and nut coupling between the compressor and the gearbox, and if this is so, to initiate the necessary maintenance measures in order to eliminate such a risk (*RL 2011:03 R2*).

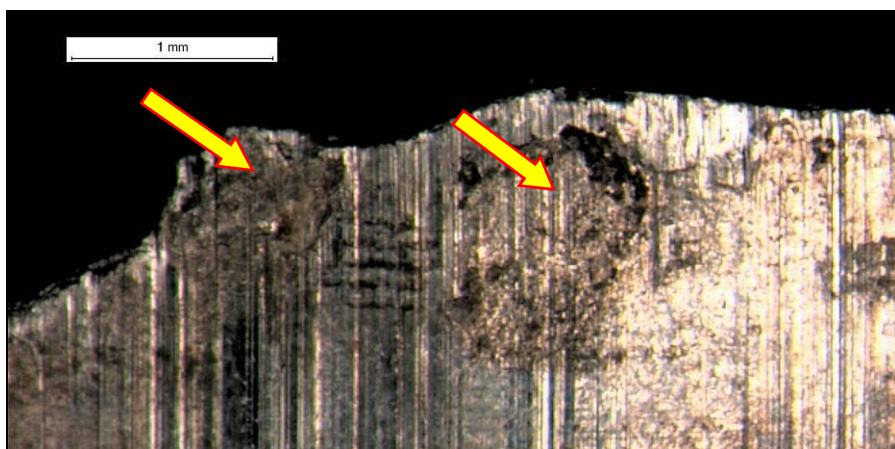
Figure 10. Fretting damage on the cylindrical part

At the initiation area on the cylindrical part of the adapter there are two areas of fretting damage, and the crack started from one of these.

The background to the problem is that during operation there can occur a small relative movement (chafing) between the outer contact surface of the adapter and the opposing inner diameter of the impeller, which can damage

the protective oil film and allow metal-to-metal contact. In this way mechanical abrasion can take place between the surfaces, which can lead to fretting damage.

Fretting damage is the classic initiation point for fatigue cracks in parts that are exposed to oscillating loads in an unfavourable loading spectrum. In this respect the high operating speed of the engine is of great importance.

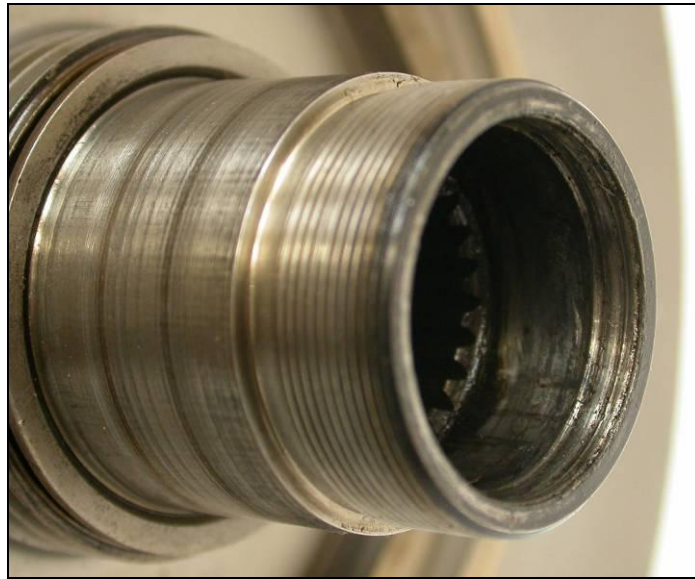
Figure 11. Secondary damage to the impeller

On the inner diameter of the impeller secondary damage has occurred as a result of the rotation of one of the broken adapter halves.

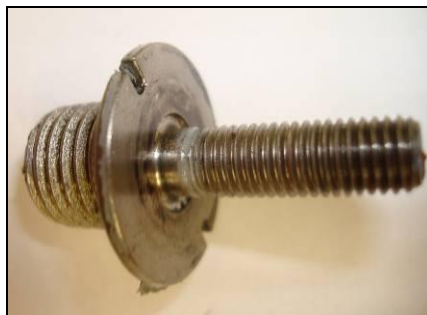
Figure 12. Loose stud

Two of the gearbox housing studs could be unscrewed without using a tool. The damage to the securing threads shows that the studs had moved inside the threaded holes in the gearbox housing.

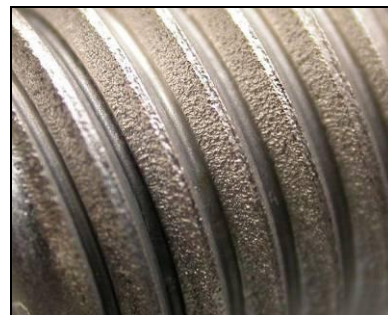
Figure 13. Worn securing threads

On one of the studs part of the thread had detached from the gearbox housing and become trapped in the stud thread.

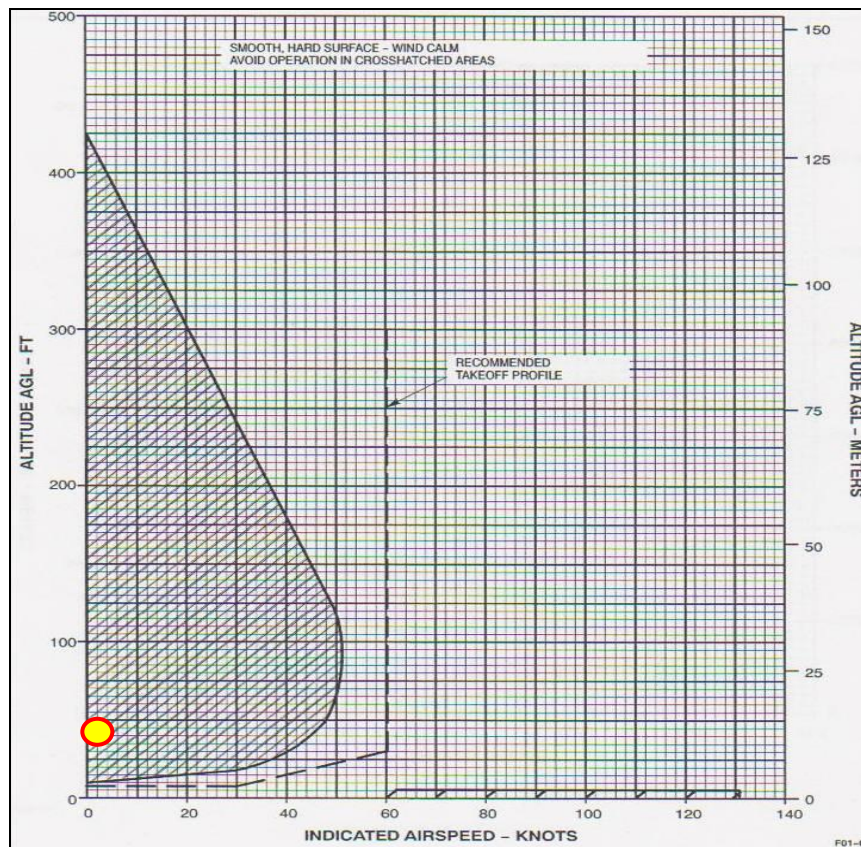
Figure 14. Speed/altitude diagram showing the recommended flight range

During the investigation it was found that the engine stoppage occurred while the helicopter was being operated within a range of speed and altitude where the loss of engine power normally means that it is not possible to perform a safe emergency landing.

When flying at a sufficient speed or at a sufficient altitude the pilot, in the case of a sudden loss of engine power, is able to establish a controlled auto-rotation and perform an emergency landing of the helicopter. In the diagram below, taken from the flight manual for the helicopter, the manufacturer has indicated the speed and altitude ranges within which establishment of controlled auto-rotation is difficult or impossible, so that flying within these ranges should be avoided.

A circle has been drawn on the diagram to show the approximate flying situation when the engine stoppage occurred.
