Final report RS 2014:05e

Trans Agila- grounding in Kalmarsund,
Sweden on 29 November 2012

File No S-184/12

2014-05-13

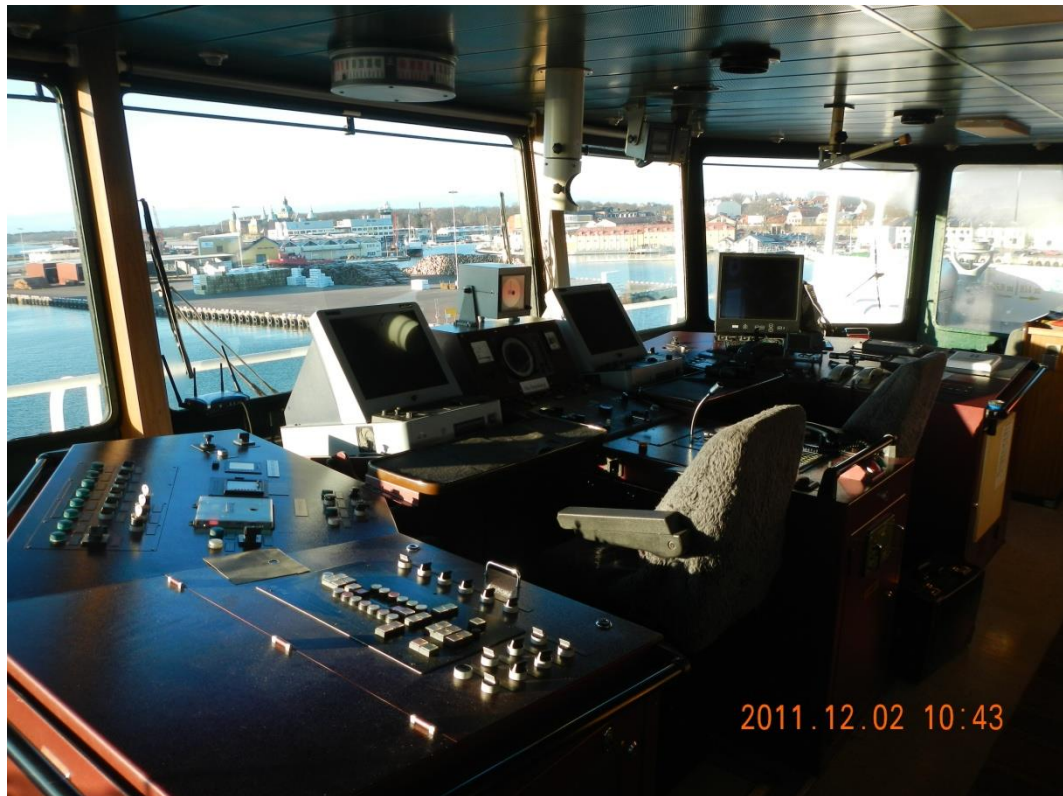
Fig. 1. Interior from the ship's bridge.

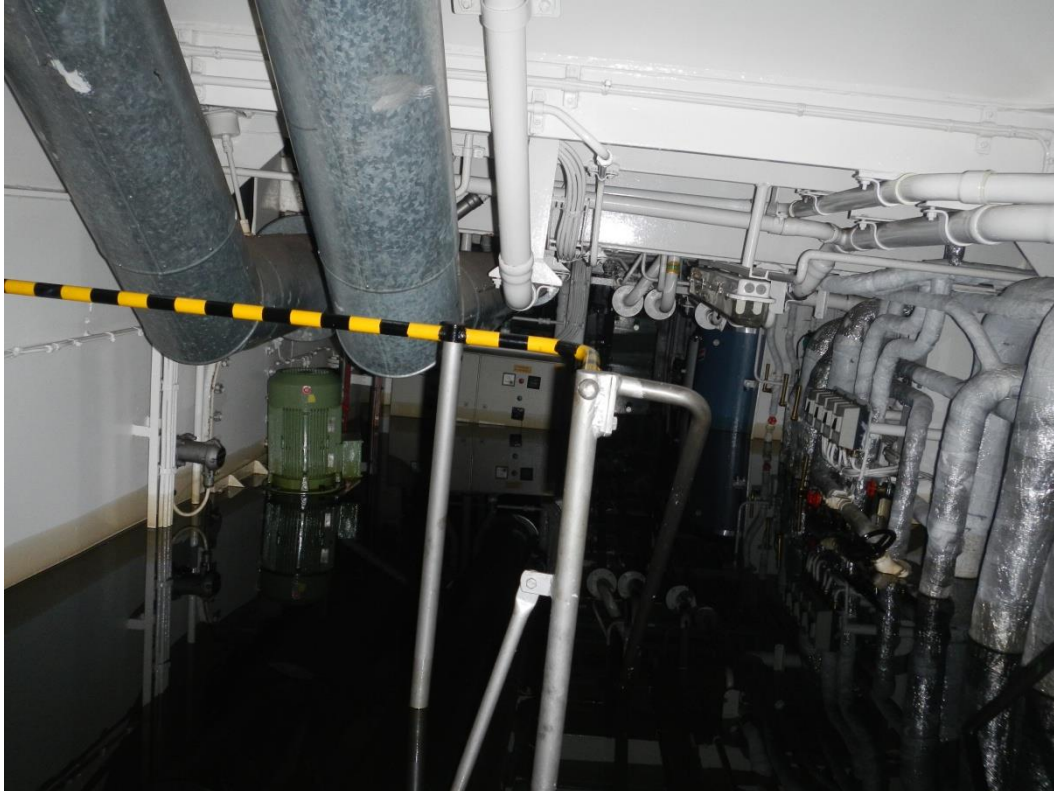
Fig. 2. The engine room after the flooding.

The damage to the ship's bottom meant that water penetrated into the engine room (See Fig. 2). From here the water continued to the hold via a lead-through/bushing in the bulkhead between the engine room and the cargo hold. The opening was situated in a box-shaped extension to the bulkhead in the engine room and constituted a cable run-through between the hold and the engine room. After the grounding, the crew tried to stop the water flow from the hold by sealing the hole with available miscellaneous material (see Fig. 6). By doing this, and by using submersible pumps in the cargo hold, it was possible to prevent the ship from sinking completely. Despite the fact that *Trans Agila* could be prevented from sinking and that she therefore could be towed away, the vessel has not been repaired and became regarded as a total loss for the owners.

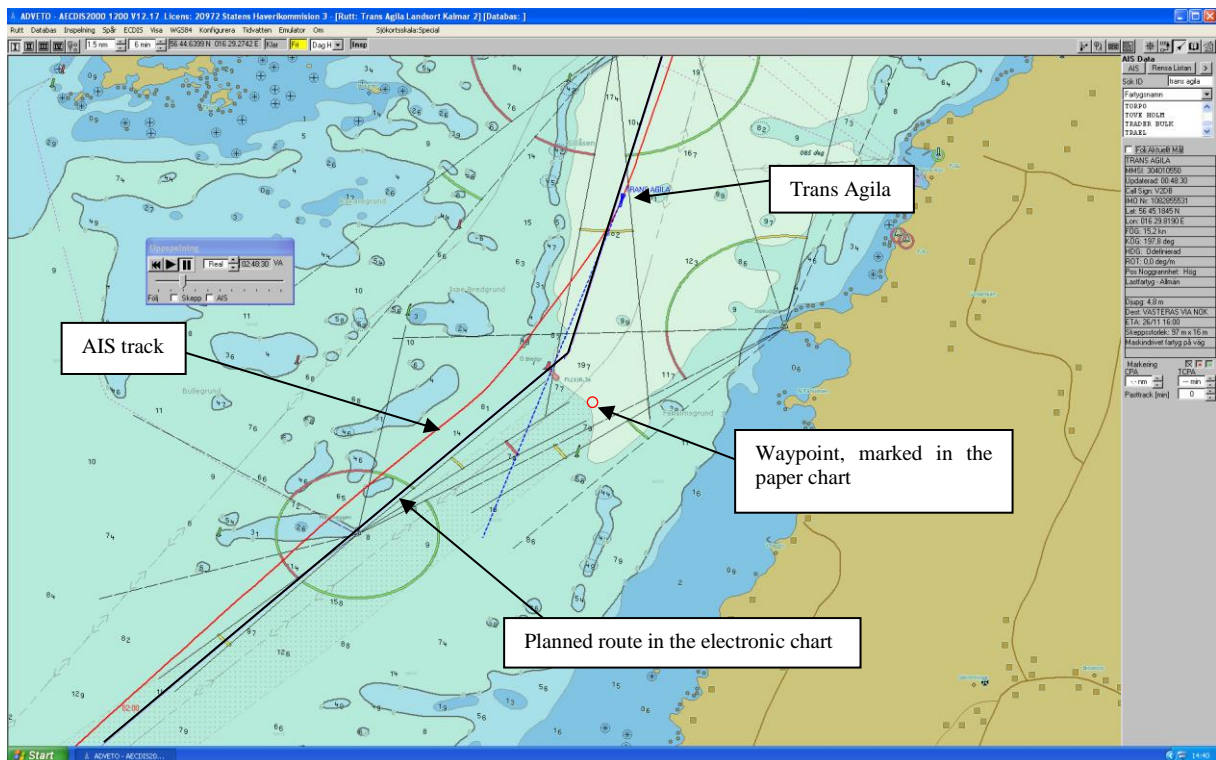
A line drawn between these points lies immediately north of both the light buoy Östra Bredgrund and the lighthouse Masknaggen. This route plan had been entered in the vessel's electronic sea chart (see Fig 3).

Fig. 3. The ship's route planning according to the electronic chart (blue), AIS track (red) and waypoint in the paper chart.

In addition, there was also a manually inserted position on the paper chart, southeast of the buoy Östra Bredgrund, marking a waypoint (se Figs 3 and 7). This waypoint differs from the corresponding one on the electronic sea chart.

As can be seen in Fig. 3, the vessel did not follow the planned course anyway, and there are indeed no demands that this must be the case. Deviations are permitted – it is, after all, the actual physical circumstances that must in the final instance dictate the route that is taken by the vessel. On the other hand, the possibility cannot be ignored that the course entered on the electronic sea chart, which shows a more northerly route, may have caused the second officer, either consciously or subconsciously, to choose to pass Masknaggen on the northern side.

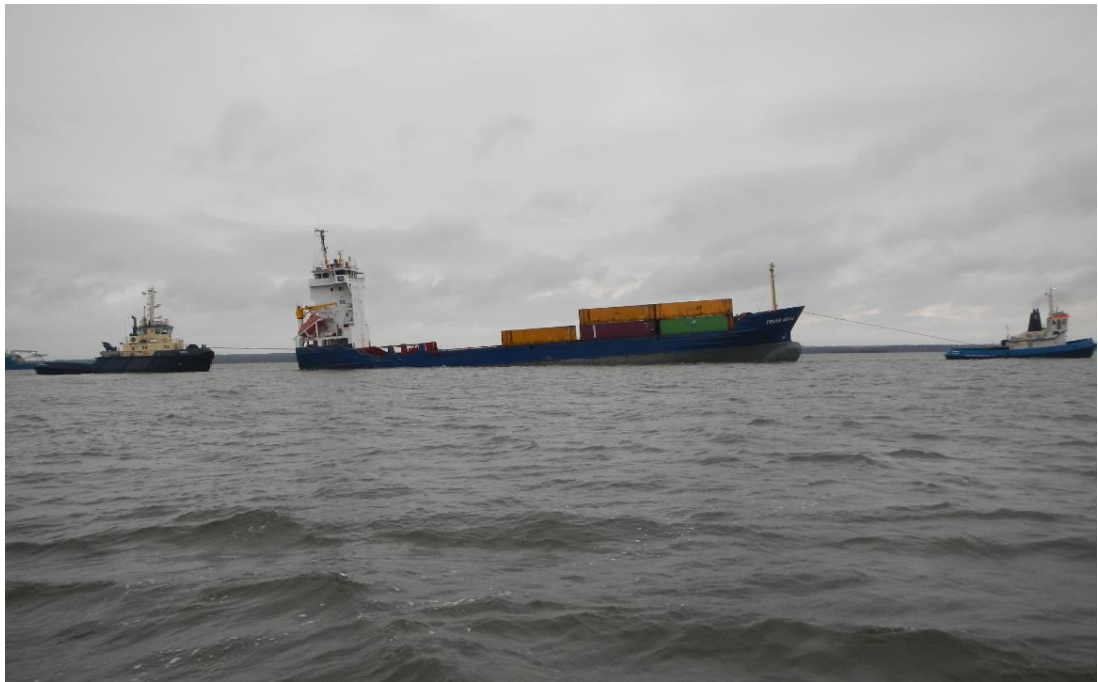
Fig. 4. Photo of the salvage work.

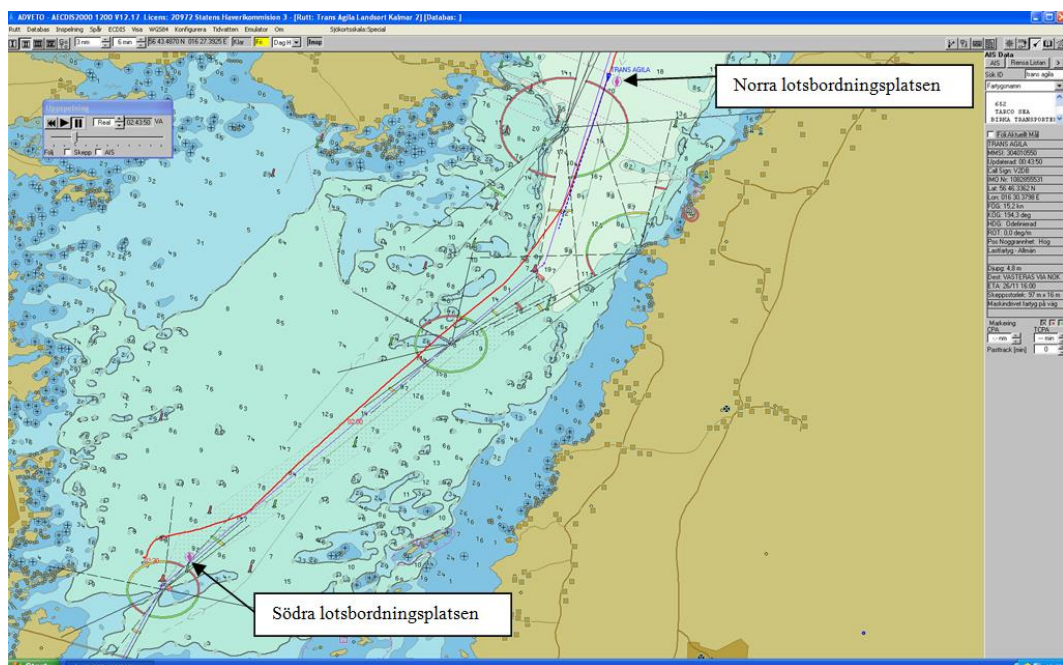
Fig. 5. The northern boarding point is voluntary. Compulsory pilotage does not come into effect until immediately after the southern boarding point. The red line represents the actual course of the vessel according to AIS.

According to the Swedish Transport Agency's statistics, eleven vessels have run aground over the period 2003-2012 in Kalmarsund, in which context the actual groundings have been the initial events. On none of these occasions was there a pilot on board. Seven of the incidents involved vessels larger than 500 gross. Of these incidents, five occurred within the pilot boarding points that were marked on the charts (see Fig. 5).

- In consultation with the Swedish Maritime Administration, conduct an investigation and analysis of accidents in Kalmarsund, and in conjunction to that review the possible need to change the area for compulsory pilotage (*RS2014:05 R1*).

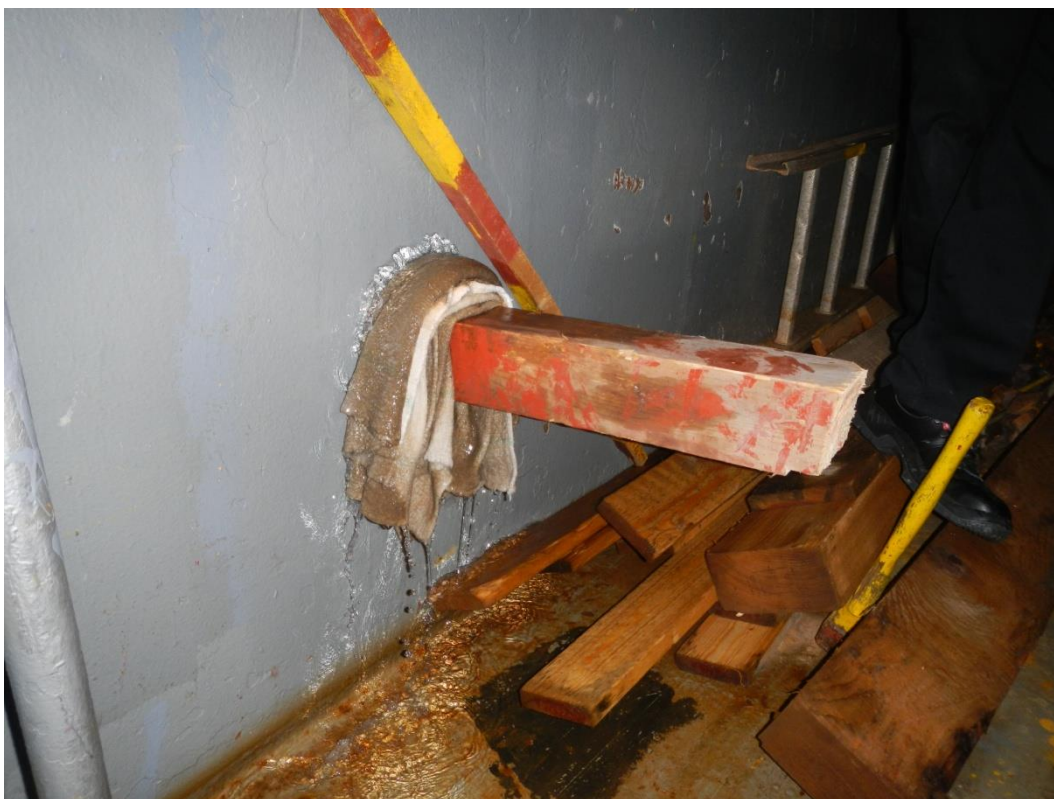
Fig. 6. An attempt to block the flow of water from the engine room. Photo taken from the cargo hold.

The damage to the bottom of the ship was limited to the engine room. Nevertheless, the cargo hold was partially filled with water owing to a bulkhead lead-through that did not fulfil applicable requirements. Responsibility for the technical standard of the vessel always rests with the master and the shipping company, while inspection is the responsibility of the flag state or – as in this case – a classification society, to whom the task has been delegated. It may appear strange that neither the crew nor the shipping company or the classification society, had noticed the non-watertight lead-through/bushing. Such faults, even though they may appear to be minor in nature, can in the long run lead to major damage.

- Review its routines in order to avoid work on hulls and machinery, that is not carried out in conformance with the regulations, being passed as approved (*RS2014:05 R2*).

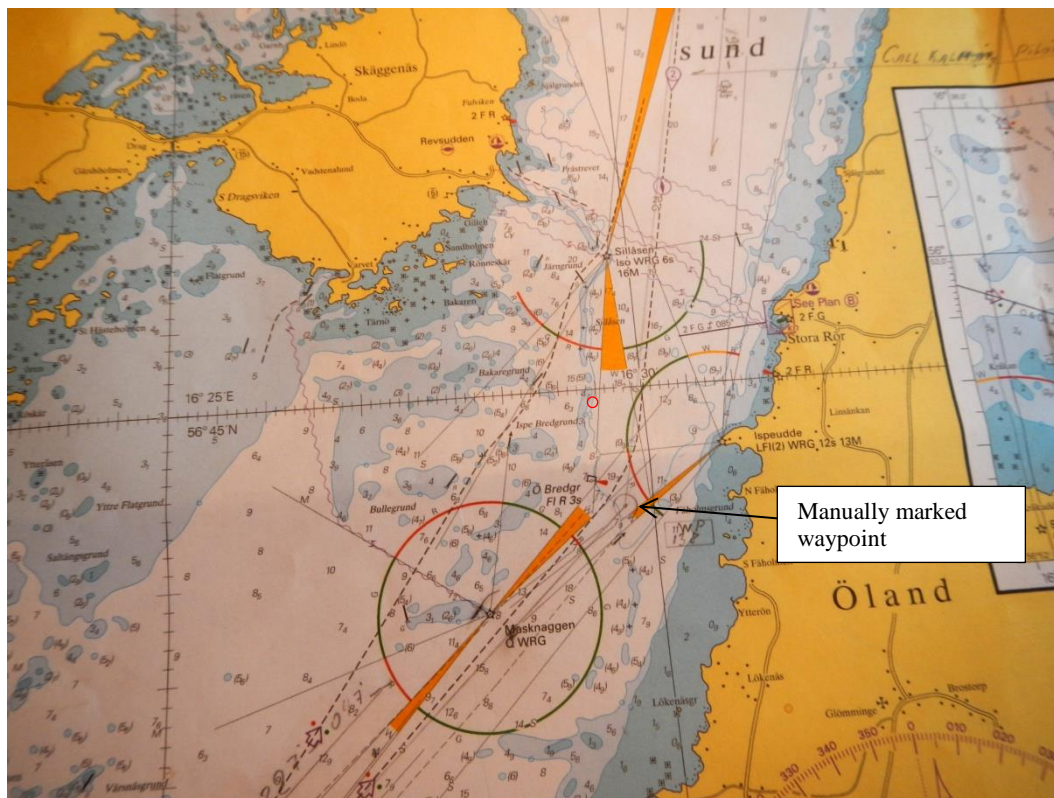
Furthermore, the manually placed waypoint in the paper chart (Fig. 7) indicates that the crew did not pay much attention to the formally documented voyage planning in practise. Possibly, this manually marked waypoint is the master's instruction or directive to the second officer (which he of some reason did not follow) but the investigation has not been able to clarify this.

Fig. 7. The vessel's paper chart. Note the manually marked waypoint SE of Östra Bredgrund.
