# Ambulance Helicopter Accident in Åland on February 12, 2022

L2022-01

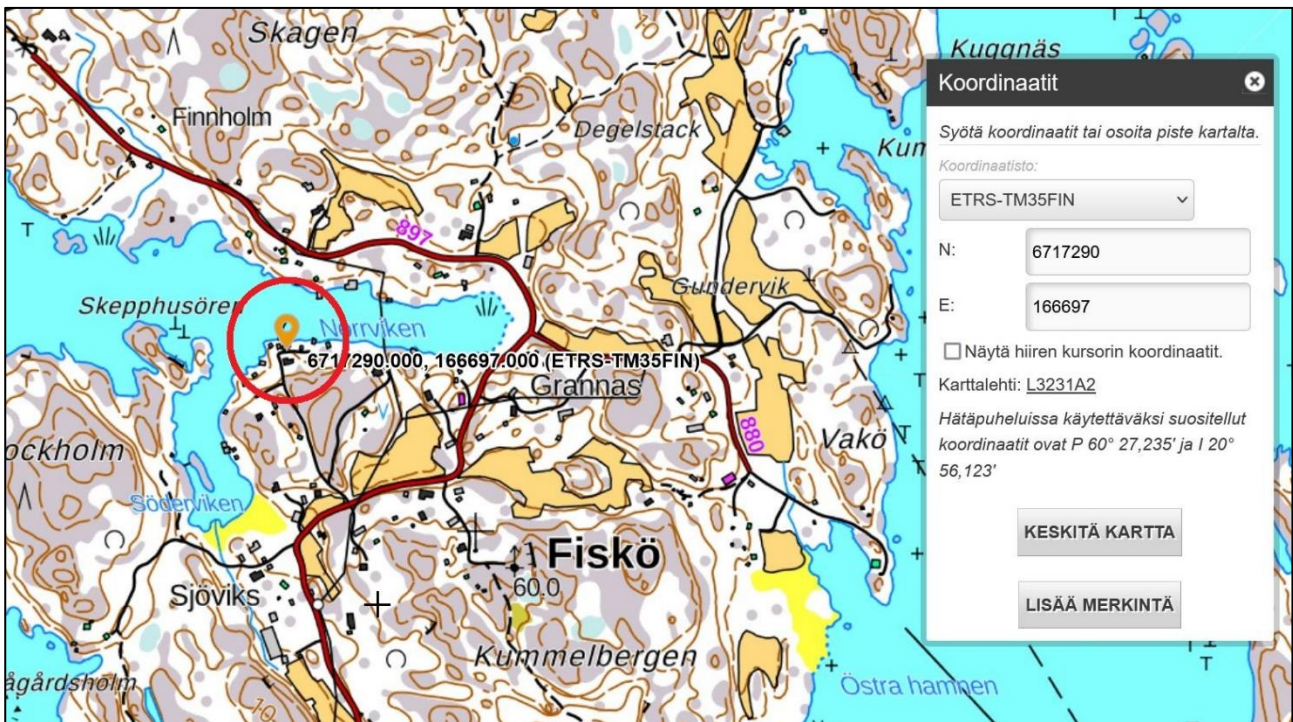
At 1610 h, about halfway into the flight, the PSAP called the crew informing that the patient was on Fiskö. Because the distance from Fiskö to Korsö precluded transport of the patient to the helipad before the helicopter's arrival, the PSAP suggested that the crew proceed direct to the accident site at 60°27.1315'N, 20°56.1865'E, about 5 km northwest of the helipad.

**Kuva 2.** The accident site location derived from the rescue department's report. (Background map: National Land Survey of Finland, topographic map, open data, 11/21)

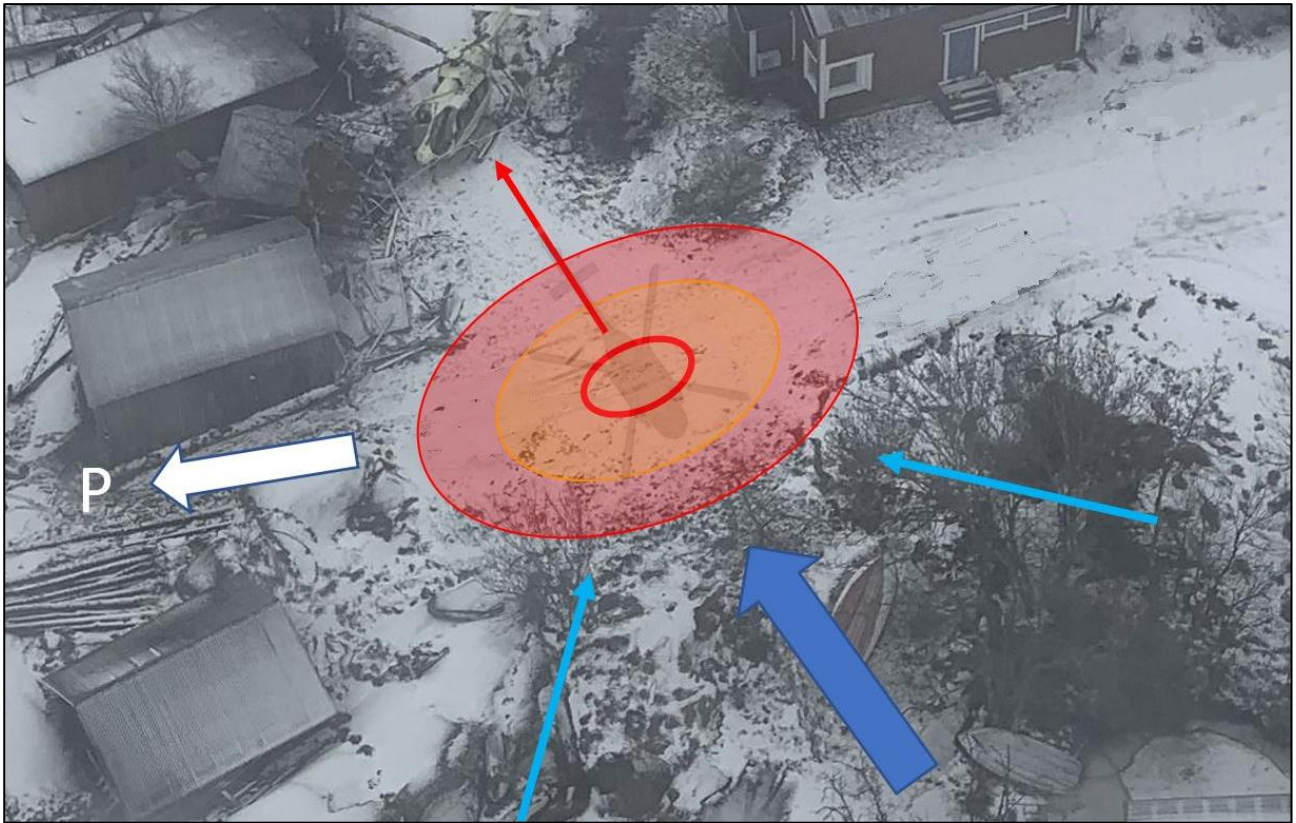
The yard was bordered by sheds and other buildings with loose objects stored alongside. A boat was stored against the wall of a shed located to the right of the direction of landing. The helicopter cleared a tall birch tree, also to the right of the approach path, by about 6 m. After the pilot had brought the helicopter to hover, the crew member opened the door and scanned the area below and to the left for any obstructions that would be a factor during landing. He notified the pilot of a bush to the left of the helicopter's tail about 6 m away but paid no particular attention to the fact that the ground was partially covered with ice.

Since the landing site appeared good, the pilot elected to land. Even though landing was uneventful, and the helicopter appeared stable after setdown, the pilot felt it was slightly tilted to the right. With the flight controls neutralized, the attitude indicator showed 2° to 3° right bank, well below the maximum permitted value of 8°. The pilot set the engines to idle.

**Kuva 3.** The landing point and danger areas. The 11-meter diameter yellow circle represents the danger area beneath the main rotor disc. The pink outer circle is the 17-meter diameter danger zone around the helicopter. The red arrow indicates slide direction. Prevailing wind was from the direction indicated by the thick blue arrow, variable between the thin blue arrows. The white arrow points to grid north. (Photo: SIAF, taken on February 13)

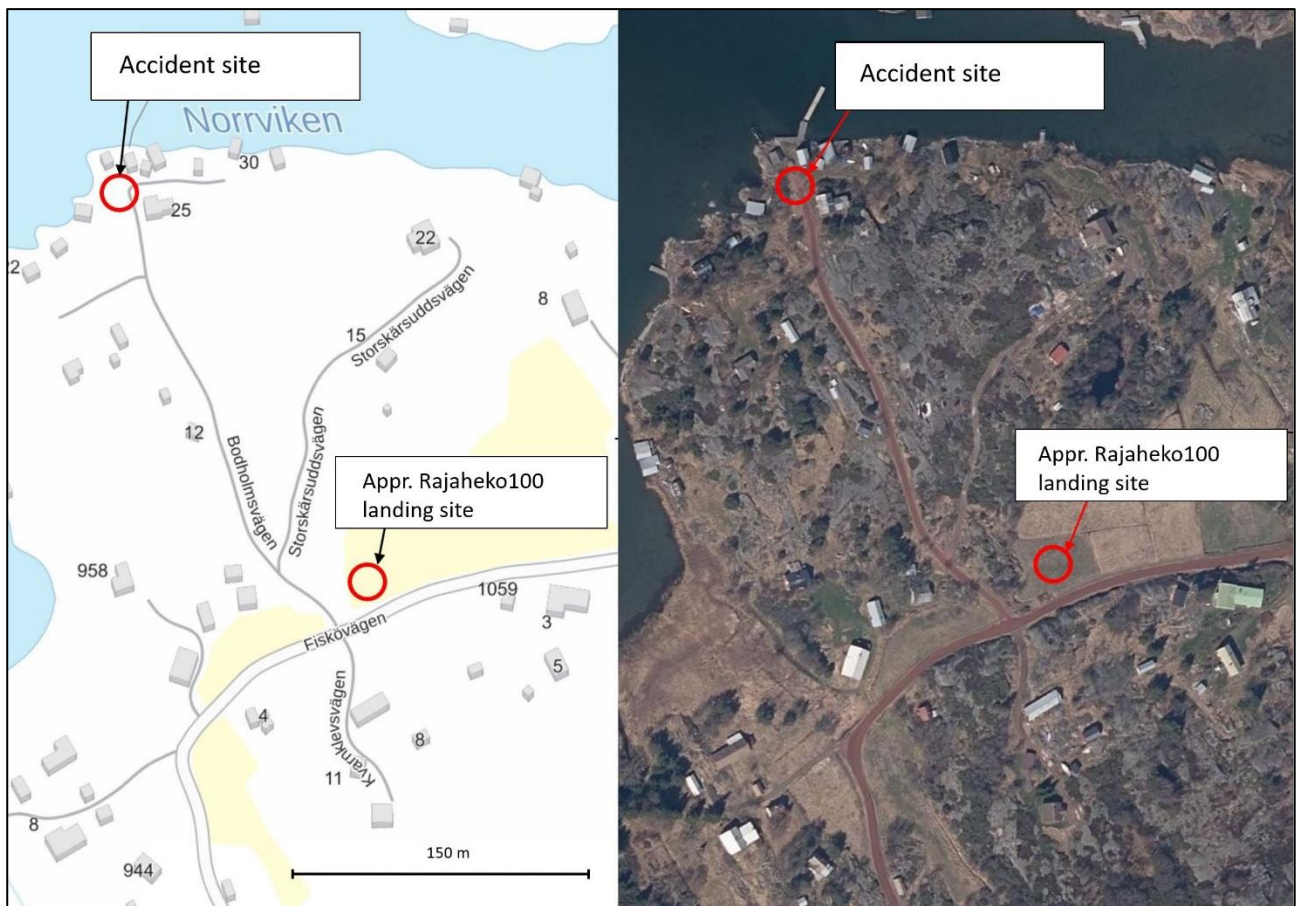
After several phone calls it was confirmed that a Border Guard helicopter and a patrol boat were on their way to the accident site. The helicopter landed about 250 m away from the accident site 45 min after the alert. It then took off with the patient and the accident helicopter crew on board and landed at Mariehamn Central Hospital. After the helicopter crew had disembarked, it proceeded to transport the patient to Turku University Hospital.

**Kuva 4.** The accident location and the landing site of the Border Guard helicopter. (Photo: National Land Survey of Finland, annotated by SIAF)

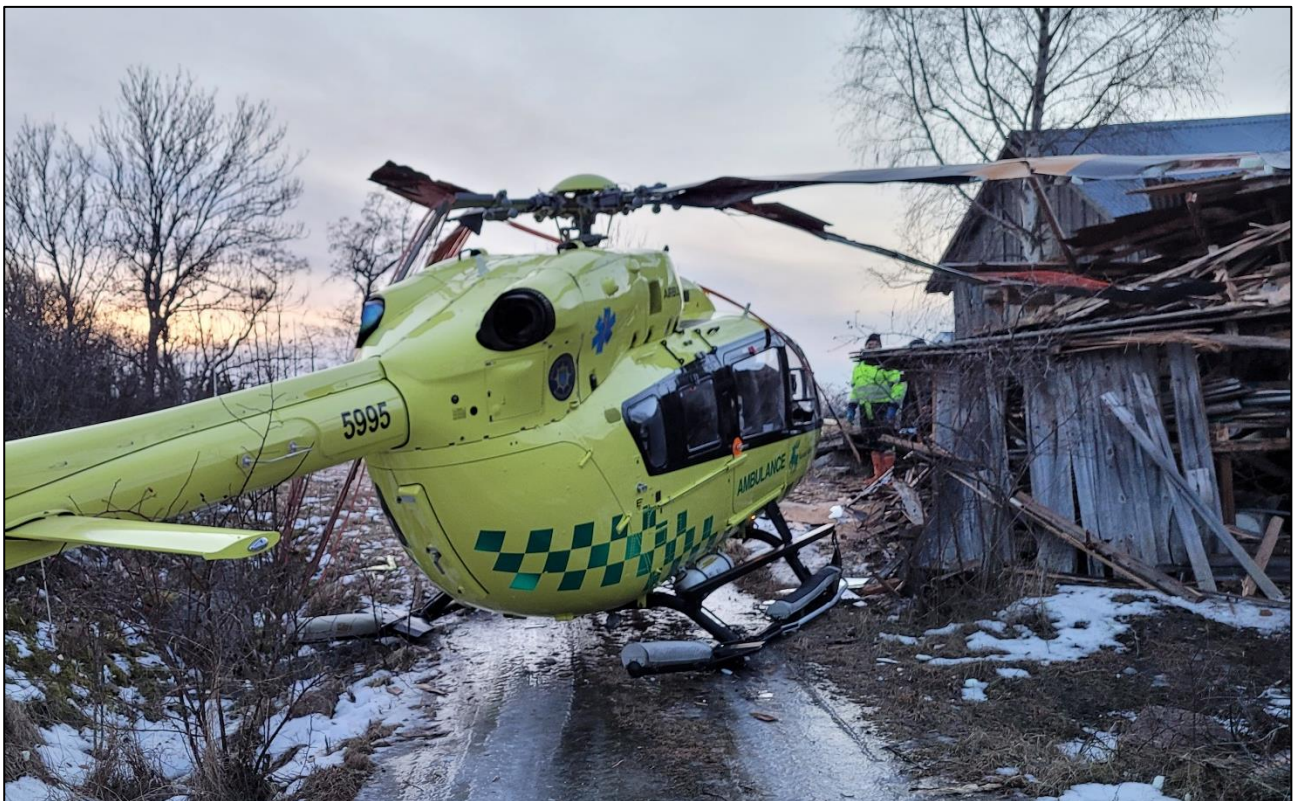
**Kuva 6.** The damaged helicopter and the boat shed. (Photo: Babcock Scandinavian)

The helicopter sustained substantial damage that necessitated costly repairs. The boat shed was damaged. The nurse, who occupied a rear seat, received minor injuries. The accident did not cause fuel or oil leaks.

*the European Aviation Safety Agency (EASA) informs helicopter operators of a need to fit slide stoppers on the landing skids for operations in winter and under slippery conditions. [2023-S2]*

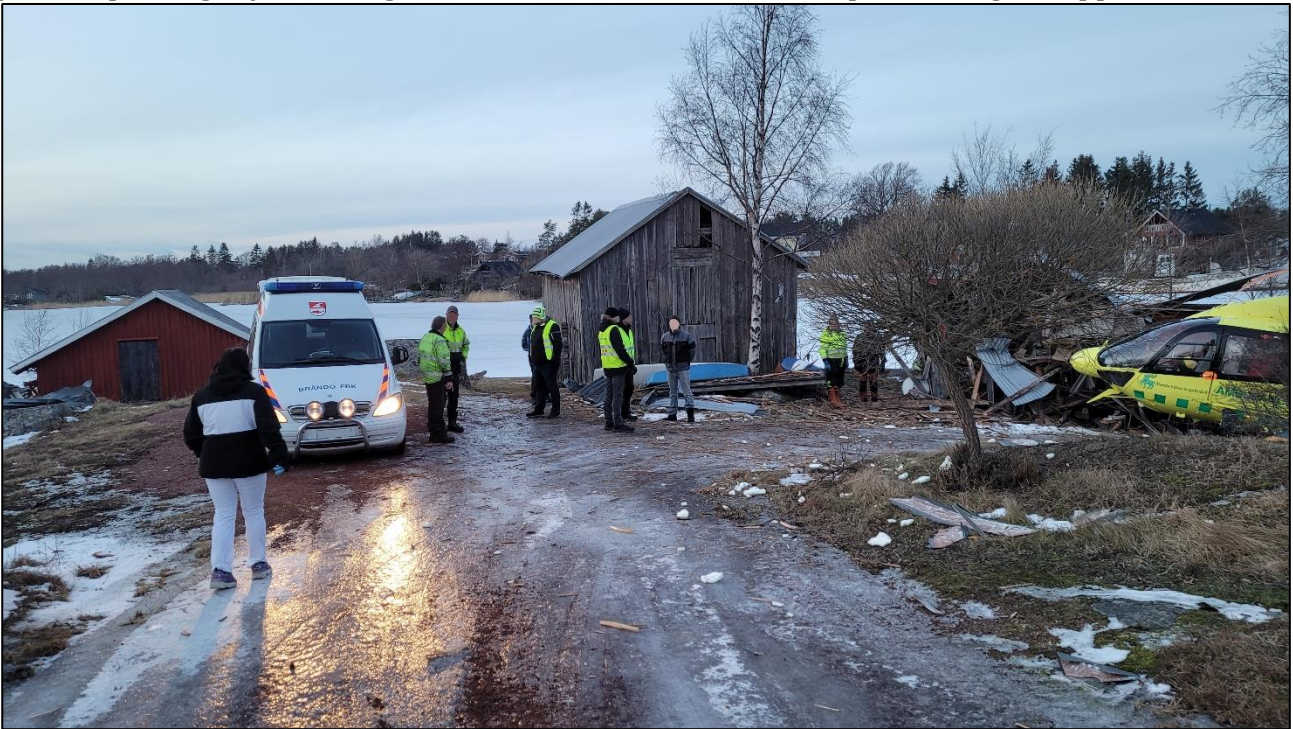
**The landing site** and its surroundings were free of obstacles that could have jeopardized the landing. The crew elected to land in the yard of the house where the patient was waiting for pick-up. Several houses and sheds were located in the vicinity of the landing site, and boat was stored against the wall of a shed on the right-hand side as seen from the direction of landing. Miscellaneous loose objects were scattered on the ground. The partially ice-covered yard sloped slightly to the right and aft as seen from the helicopter during the approach.

**Kuva 8.** The white van is parked on the intended landing point. The helicopter is in its final position with the fuselage almost exactly aligned with the direction of landing. The photo was taken approximately 30 min after the accident. (Photo: Babcock Scandinavian)

6. The landing site was confined and challenging. The crew found it adequate for landing, but because the crew members focused on obstacles bordering the site and on loose objects, they did not recognize the hazards caused by the slippery, sloping surface. The helicopter set down with the skis only partially on gravel.

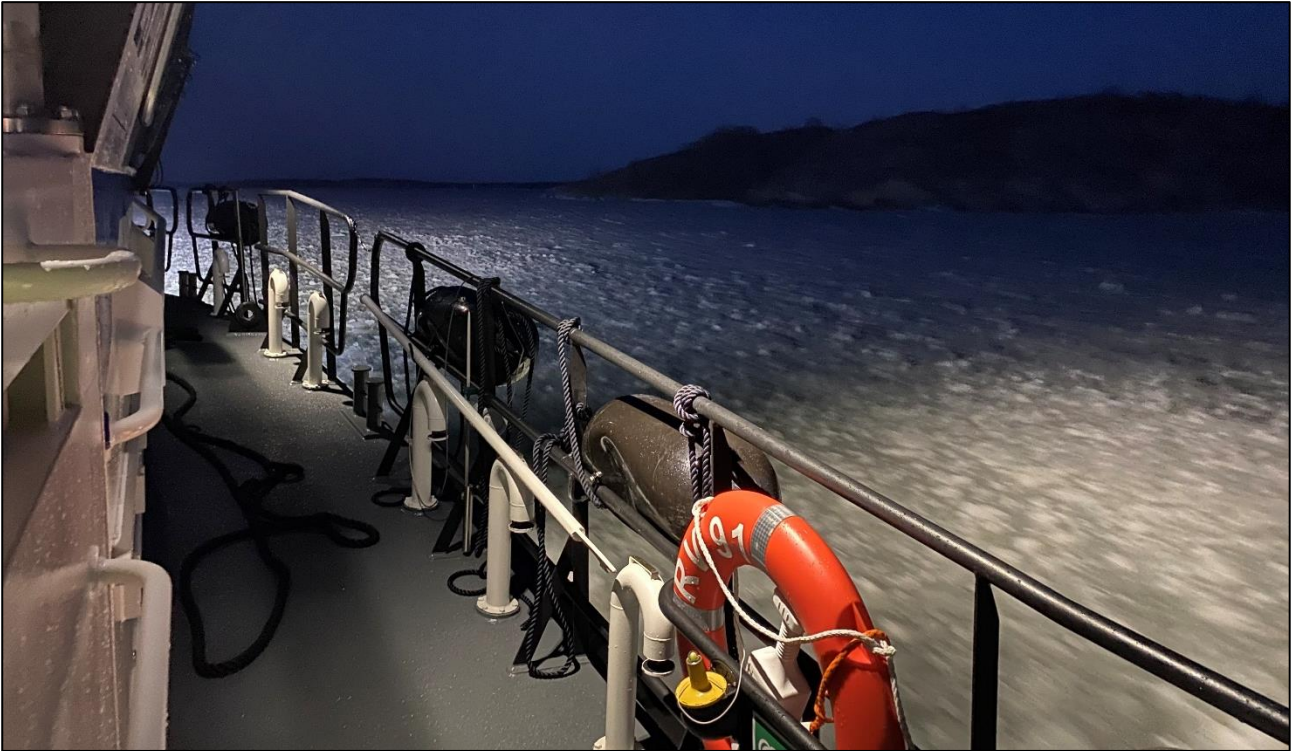
**Ice conditions** around nearby islands and islets were such that the units that were on their way to the accident site were transferred from BLS211 to BLS103 due to the latter's better ice-going performance. This was done at the port of Lappo.

**Kuva 9.** Ice conditions as seen from the deck of coastal patrol boat BLS103. (Photo: Mariehamn Rescue Department)
