## Report RL 2003:03e

***Accident involving aircraft SE-EEU  
in the airspace approximately 20 km  
south of Linköping, E County, Sweden,  
on the 23<sup>rd</sup> of July 2001***

### **Report RL 2003:03e**

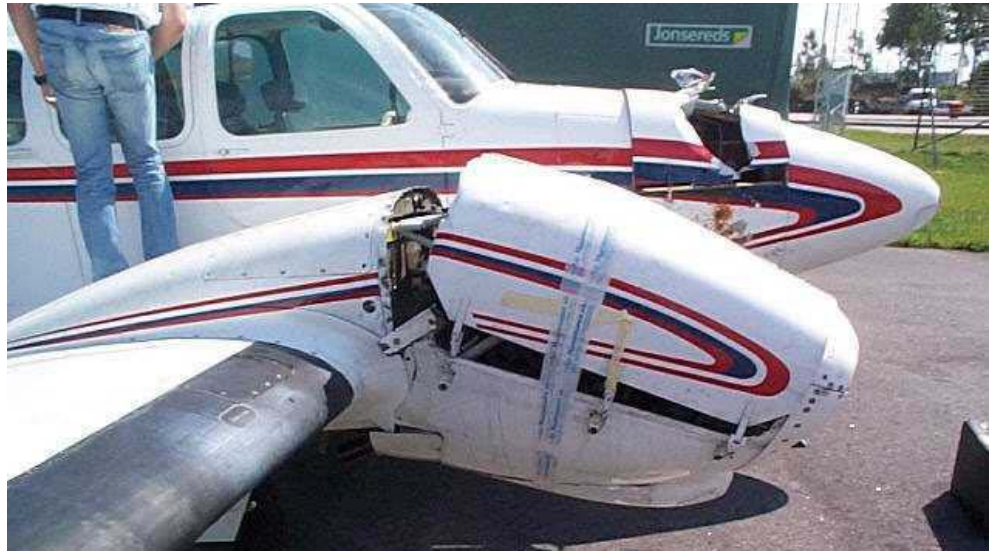
Immediately after the landing it could be determined that one of the two propeller blades on the right-hand engine had fractured close to the propeller hub and separated from the propeller. All of the engine brackets on the right-hand engine had broken and the engine was hanging down into its cowlings with a 20 to 25 degree angle. Several portions of the engine installation had been broken. The propeller blade that had separated had, among other things, caused damage to the nose section of the aircraft and the right-hand aileron.

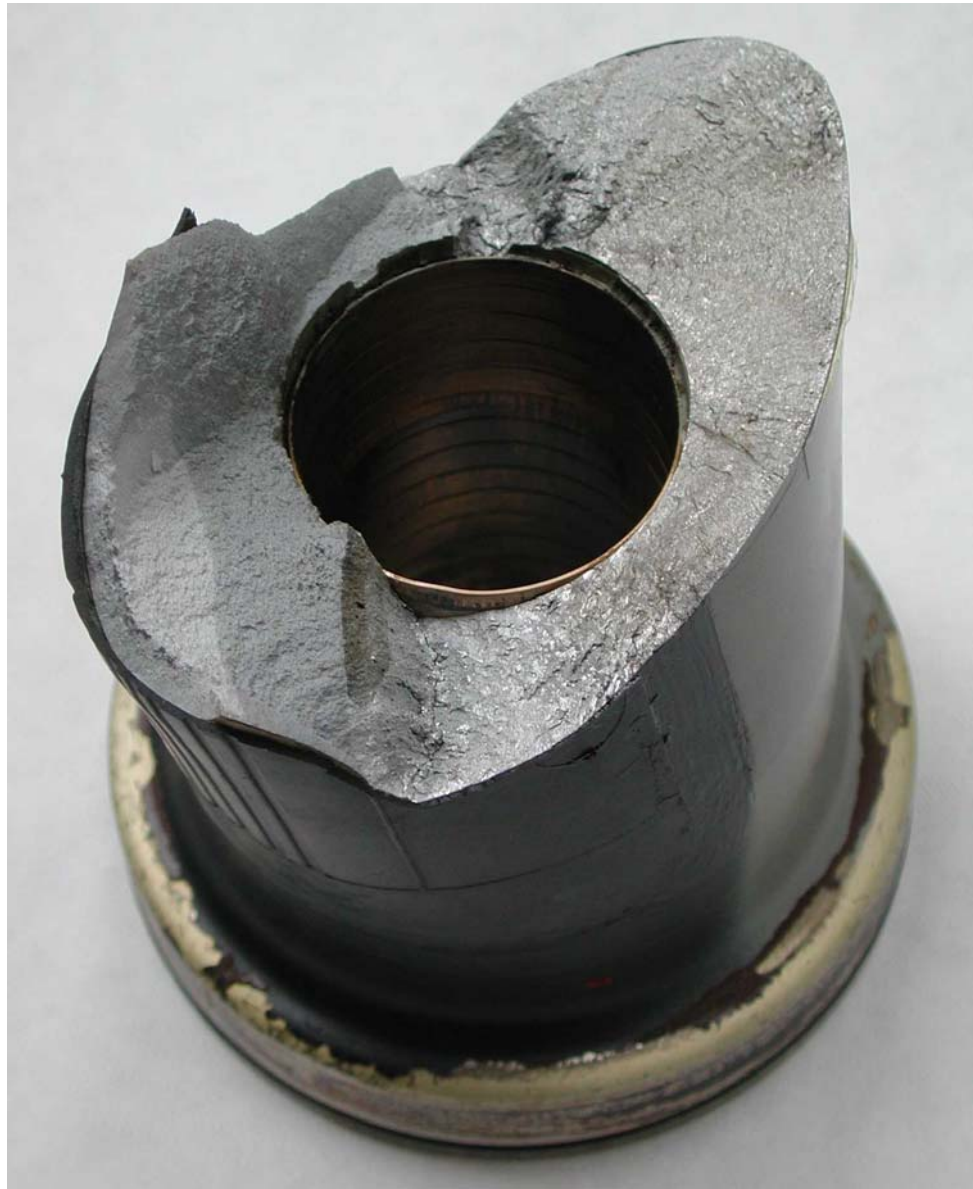
One propeller blade on the right-hand propeller had fractured about ten centimeters from the blade root flange and separated from the propeller hub. The separated propeller blade has not been recovered. The opposing propeller blade was intact. During removal of the propeller hub no failure or abnormality was found.

- The fracture took place as a consequence of a fatigue crack in area "A".  
(Se 1.16.4)
- The fatigue crack has originated along an approximately 0.2 mm deep "irregular turning groove".
- The "irregular turning groove" could have originated during manufacturing as the consequence of a damaged cutting tool.
- In the vicinity of the fracture surface, a certain amount of porosity is evident in the material, however this is not considered to have had any significance in fracture development.
- There are some minor burns on the bronze bushing (probably from lightning strikes). These are also deemed not to have had any significance in fracture development.
- The material in the blade, AA 2025, fulfils applicable specifications.
- Concerning undercutting, see section 1.16.3.

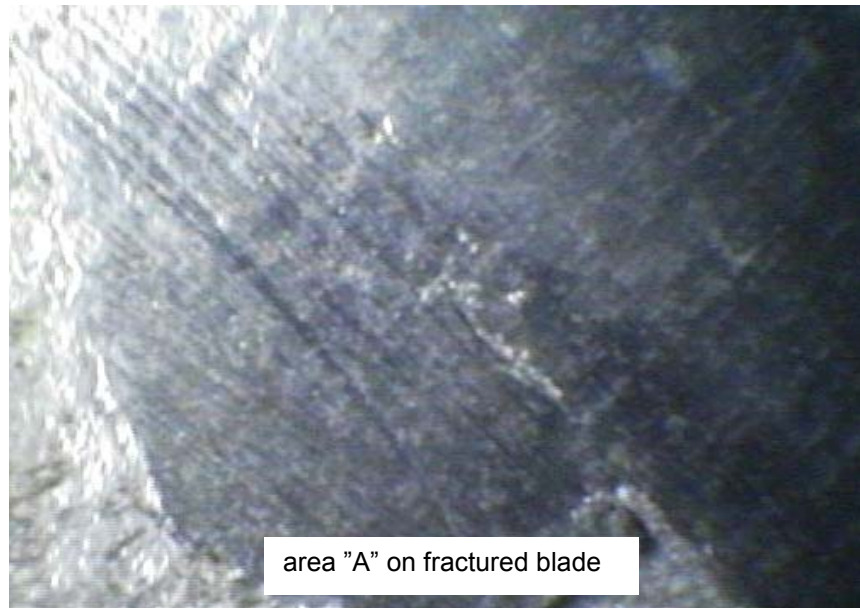
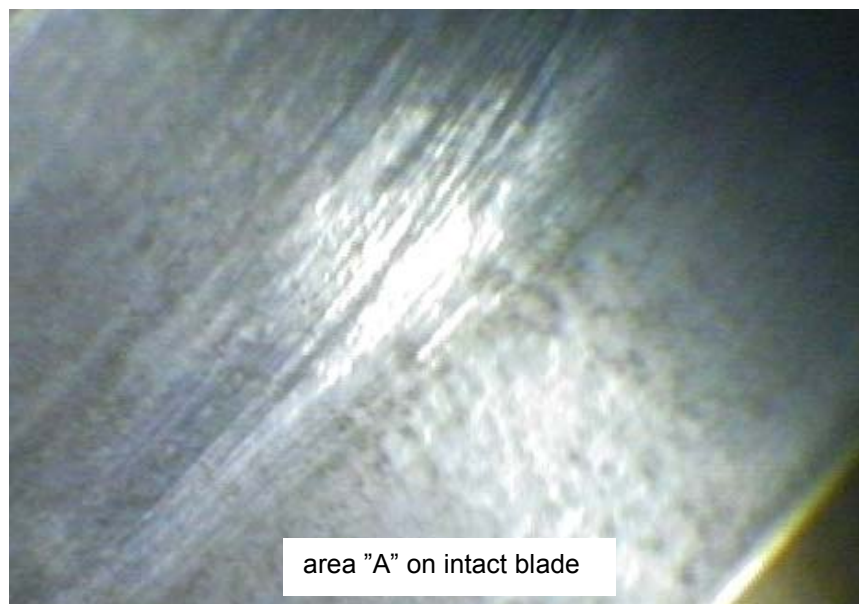
- Inspection of area "A" according to applicable instructions in SB 136H (se 1.16.4) is in actuality difficult to accomplish.
- In area "A" the same type of surface was found as in the fractured blade. (See photo below) The so-called undercut within area "A" was measured to between 0.32 and 0.37 mm. According to the blueprints in SB 136H, the undercut may be a maximum of 0.25 mm (0.010 in).
- About the same values were obtained during inspection measurement of the undercut on the fractured blade.

To sum up, the report shows that the fracture took place due to a fatigue crack. The crack has originated in a turning groove in a fillet in the blade

root's guide channel (area "A"). Contributory has been that the undercut in the fillet was too deep.

The Civil Aviation Administration is recommended to insure that a suitable operating hour limit is introduced for the propeller type; alternatively that a more reliable method is developed for inspection of the propeller blade’s critical areas. *(RL 2003:03 R1)*

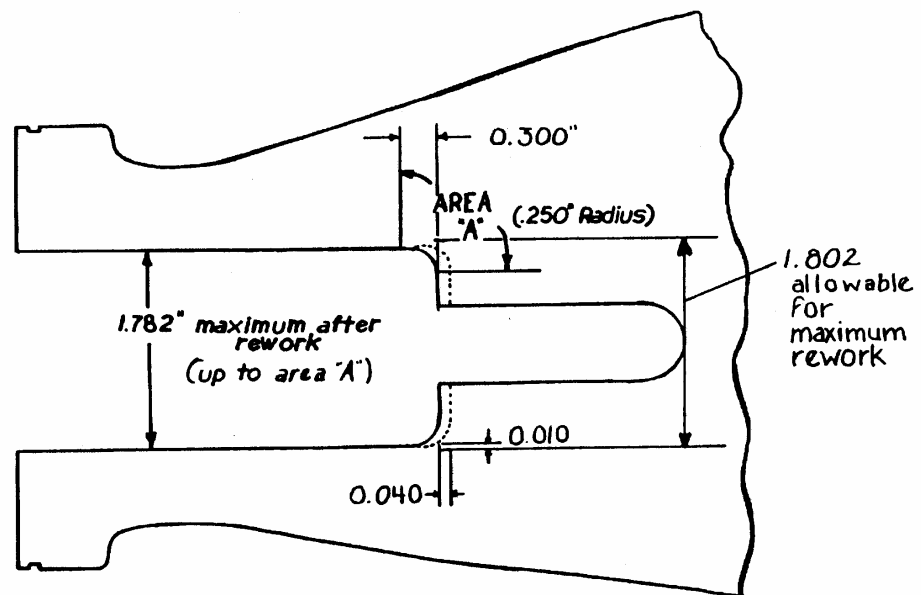
The propeller manufacturer Hartzell issued a Service Bulletin, (SB) 136E on 14 October 1988, which concerns, among other things, the propeller type in question. The bulletin stipulated that a special inspection, and if required a polishing of an indicated (area "A") in the propeller root guide channel was to be accomplished at the latest during the next overhaul of the blade. The inspection could be accomplished without removal of the bearing bushing within the channel. The reason behind the inspection was stated to be the desire to avoid scratches and machine tool marks in this area that could lead to the emergence of corrosion.

In 1991 a propeller of the same type was subjected to a blade failure. The cause was considered to be a fatigue crack, which was initiated by corrosion damage in this area (area "A").

This induced Hartzell to issue a Revised Version (SB136G) of the previously issued bulletin on the 15<sup>th</sup> of November 1991. In this, among other things, a requirement is made to remove the bushing sleeve prior to inspection and possible treatment. This in order to be able to accomplish the work with better precision. On the 12<sup>th</sup> of March 1993 the manufacturer issued yet another Revised Version of the bulletin, SB 136H, containing complementary instructions for inspecting and polishing of the surfaces concerned. According to the bulletin the inspection shall be accomplished with a borescope or with a light and a mirror.
