Final report RL 2016:10e

**Accident at LövnäsvalLEN, Dalarna county,
on 06/02/2016 involving the helicopter
SE-JLZ of the model EC 120B, operated
by Jämtlandsflyg**

File no. L-17/16

30/11/2016

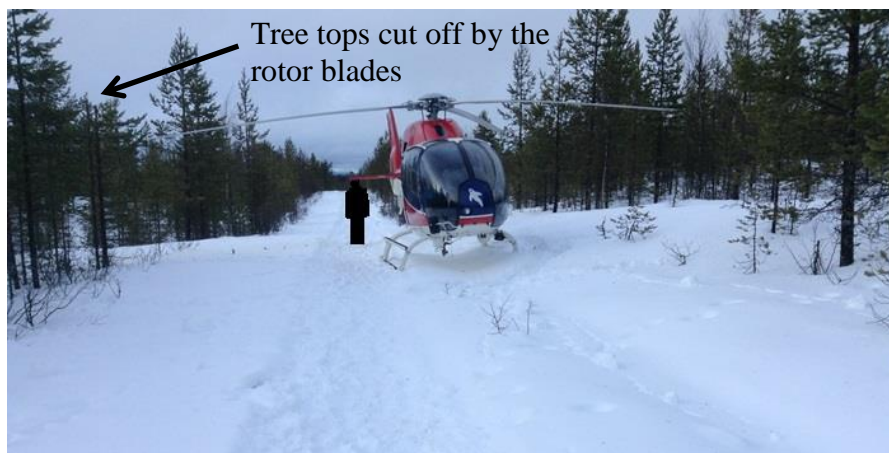
In connection with landing with a helicopter on a minor, snow-covered road in an area of dense forest, the helicopter's rotor blades came into contact with two tree tops on the right side of the helicopter, upon which all three rotor blades were damaged.

Figure 1. The helicopter after landing at the accident site. Note the damaged tree tops in the left of the picture. Photo: Jämtlandsflyg AB.

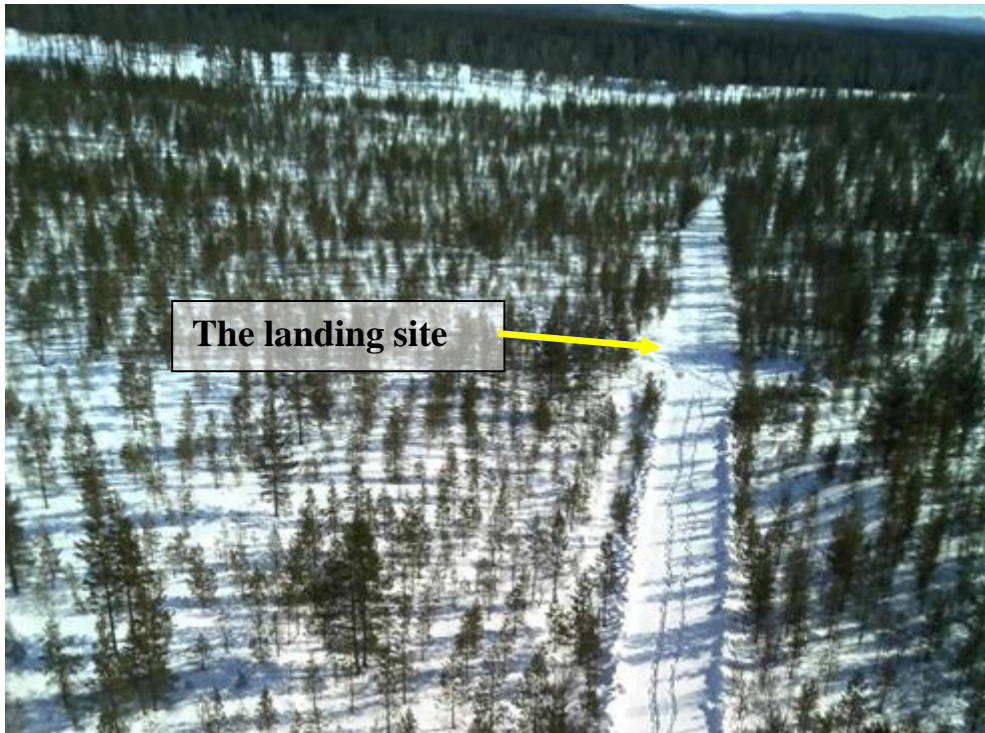
The area in question does not offer many suitable landing sites (see Figure 2). The opportunities for landing on the open areas that exist are largely limited on account of the inclination or snow depth. The site chosen was considered suitable, even though it was assessed to be narrow. The landing was deemed necessary for carrying out the assignment. SHK’s examination shows that the distance from rotor centre to the two closest obstacles was at its shortest 5.3 metres (see Figure 3).

Figure 2. The landing site photographed in the direction of landing. At the time of the examination, the road was ploughed, which was not the case when the accident occurred.

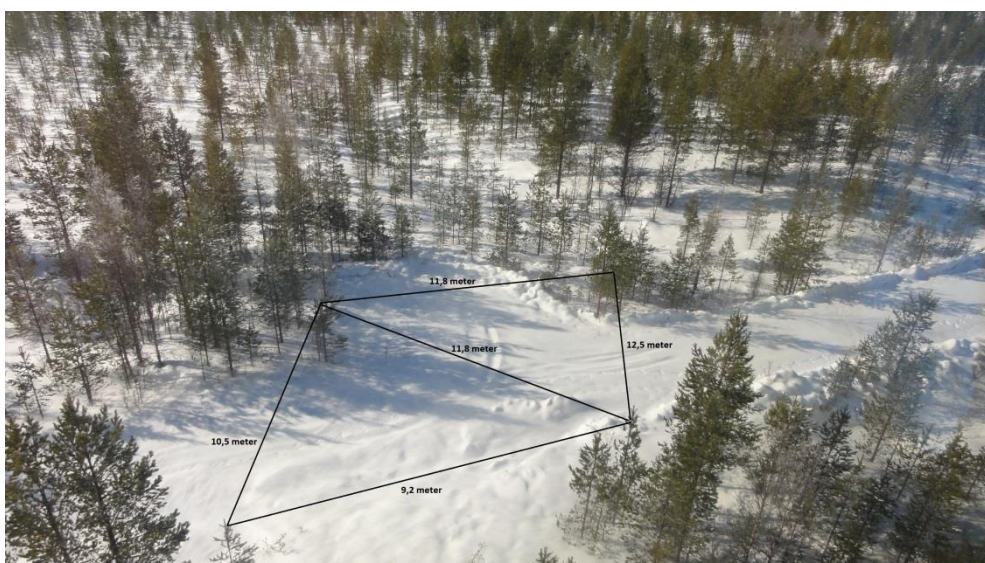
Figure 3. Distances between obstacles at the accident site.

SHK's examination of the accident site shows that the specified requirement of minimum distance to fixed obstacles could not be maintained in any position at the landing site in question. It cannot be ruled out that the fact that the pilot was flying from the left seat might have contributed to the impression that the distance to obstacles on the right side was sufficient to avoid contact with the rotor blades.

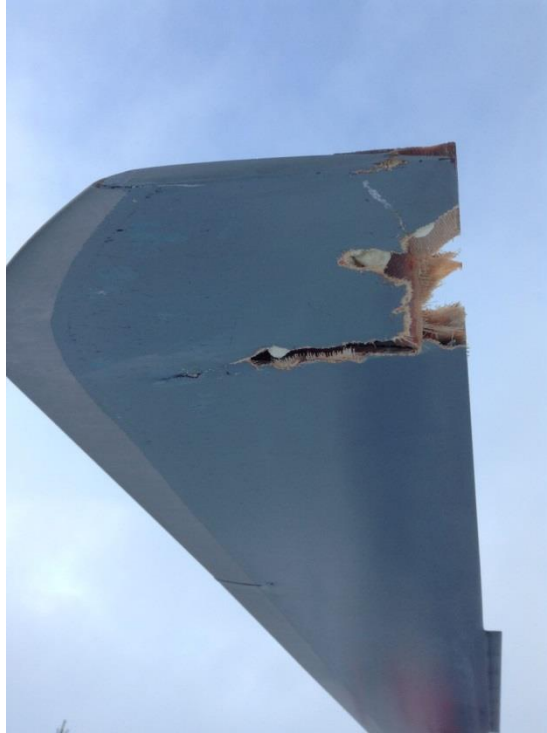
The damage to all rotor blades was substantial. The rotor blade with s/n 1099 (Figure 6) sustained the most damage, with a broken rear edge and delamination along the rear part of the blade's outer area. The two other blades sustained limited impact damage but exhibited substantial delamination in the blade's rear part. The damage was of such a nature that the blades were not possible to repair. The blade bolts and the blade dampers also had to be replaced on account of damage.

Figure 6. The image shows the rotor blade that sustained the most damage. Source: Jämtlandsflyg AB.

The damage to the rotor blades was localised to the rear parts of the blade tips, with delamination and material broken off as a consequence. The damage has probably been caused by means of lateral impacts on the tree tops through which the tree tops have been cut off by the front edge of the rotor blades.

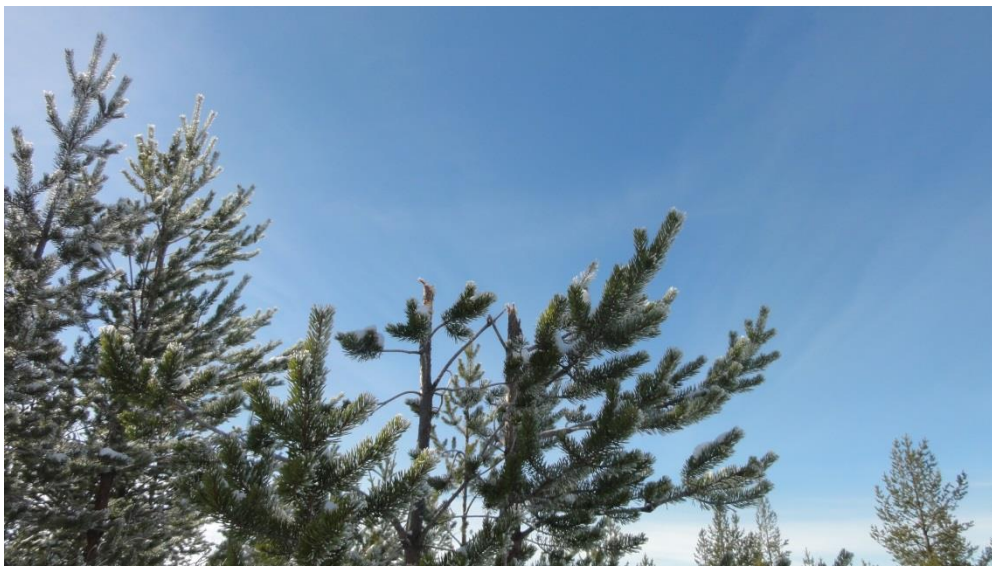
The damage to the tree tops is shown in Figure 7 and Figure 8.

Figure 7. The trees that damaged the rotor blades.

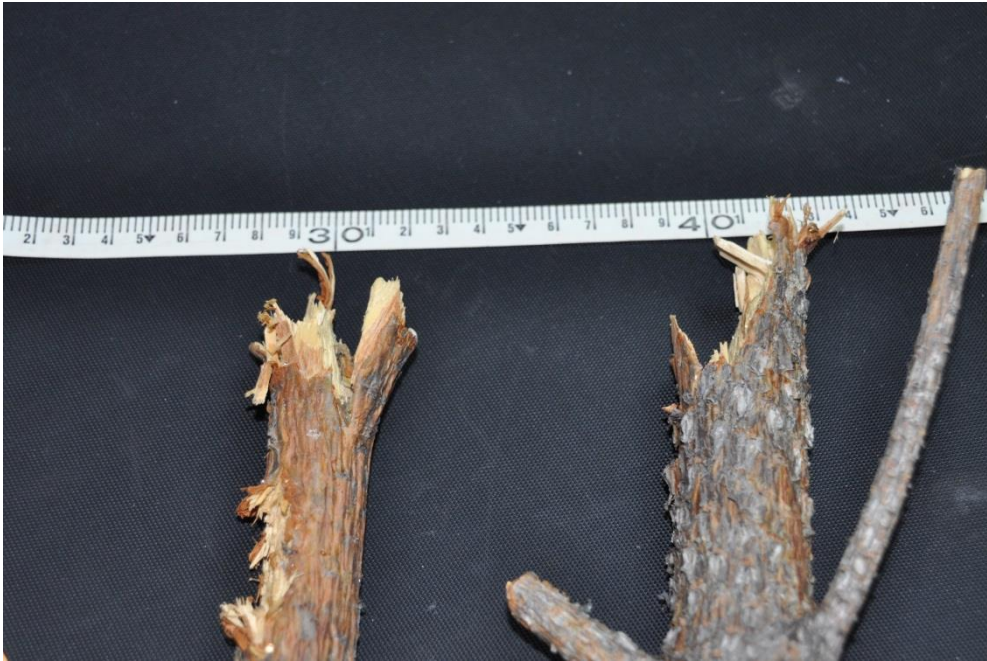
Figure 8. The tree tops' diameter max. 4 cm.
