Civil Aviation Organization of the  
Islamic Republic of Iran

**PS752 Accident Investigation**

# FACTUAL REPORT

**July 2020**

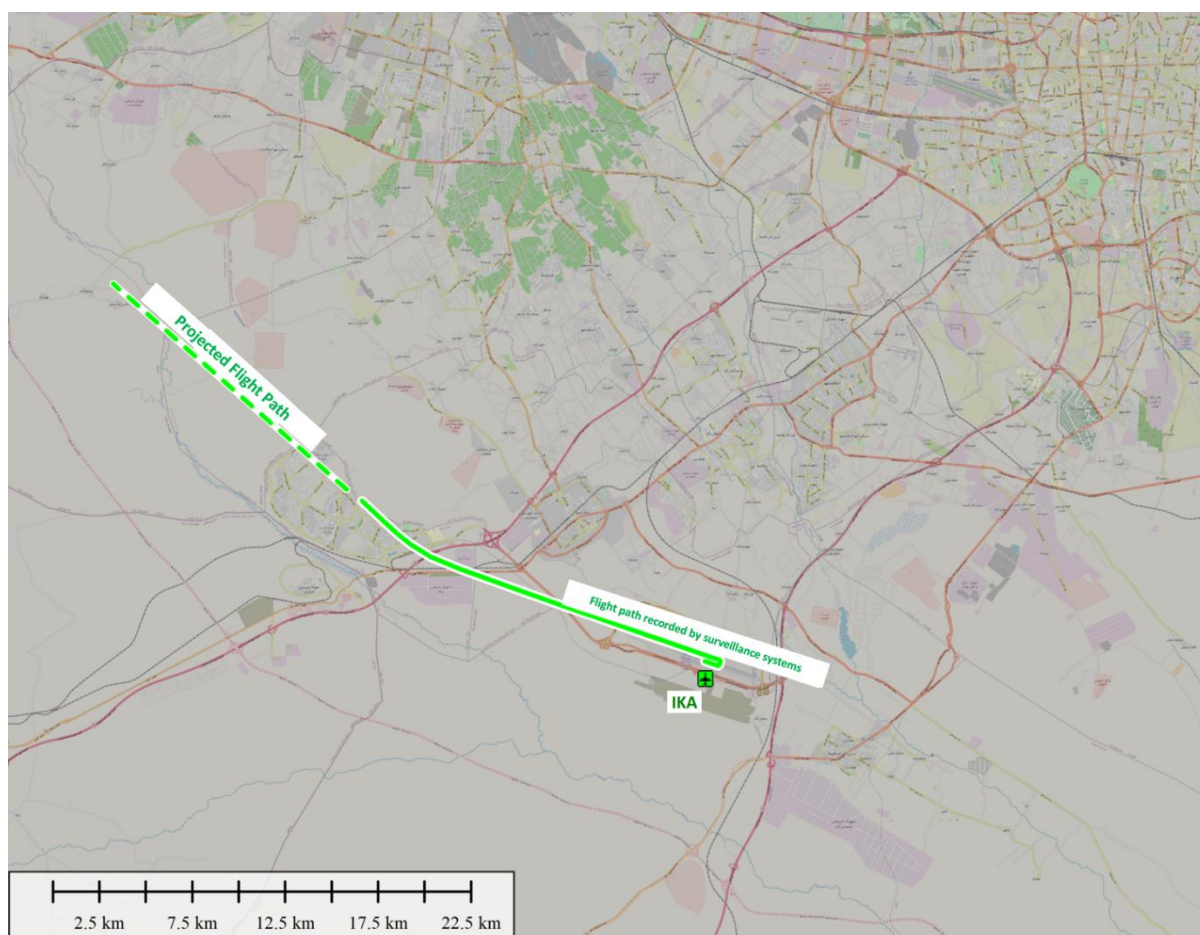
4. At 02:23:48, the Area Control Center forwarded the Ukrainian flight's request to the Air Defense Coordination Center, which subsequently issued the clearance accordingly.
5. At 02:40:20, Ukraine International Flight PS 752 received the takeoff clearance from IKA<sup>3</sup> ATC tower.
6. The flight proceeded towards the flight route at the planned altitude and trajectory. (Figure 1)

Figure 1- PS752 recorded flight path

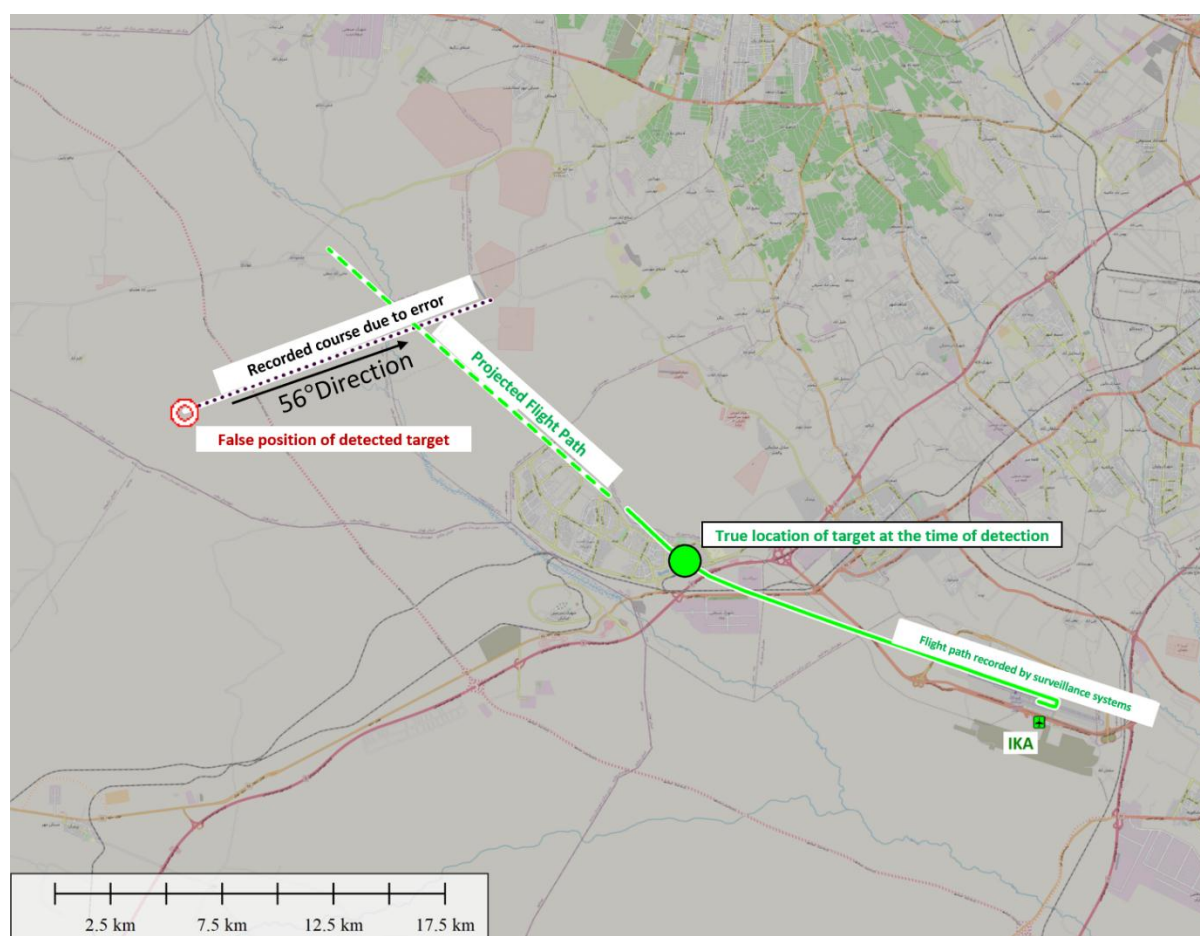
<sup>4</sup> After the relocation of one of the air defense units of Tehran, clearly causing a change in its heading, a failure occurred due to a human error in following the procedure of system north alignment. As a result, a 107-degree error was induced in the system. As such, while the PS752 aircraft was flying, the direction of objects and targets detected by this system was being observed with an increase

8. At 02:43:56, the air defense unit operator detected a target at his 250-degree azimuth, flying on a 52-degree course. At the same time, after takeoff, the PS 752 had been flying towards the defense system from a 143-degree azimuth. The aircraft was passing a 309-degree course.
9. At 02:44:21, the operator notified the specifications of the detected target to the Coordination Center over the communication network (note paragraph 10 on the communication status). The target was, in fact, the very PS 752 flight departing from IKA, detected by the system as a target approaching Tehran from approximately the southwest. (Figure 2)

Figure 2- The true location of the aircraft at the time of detection and the false location and course due to north alignment error

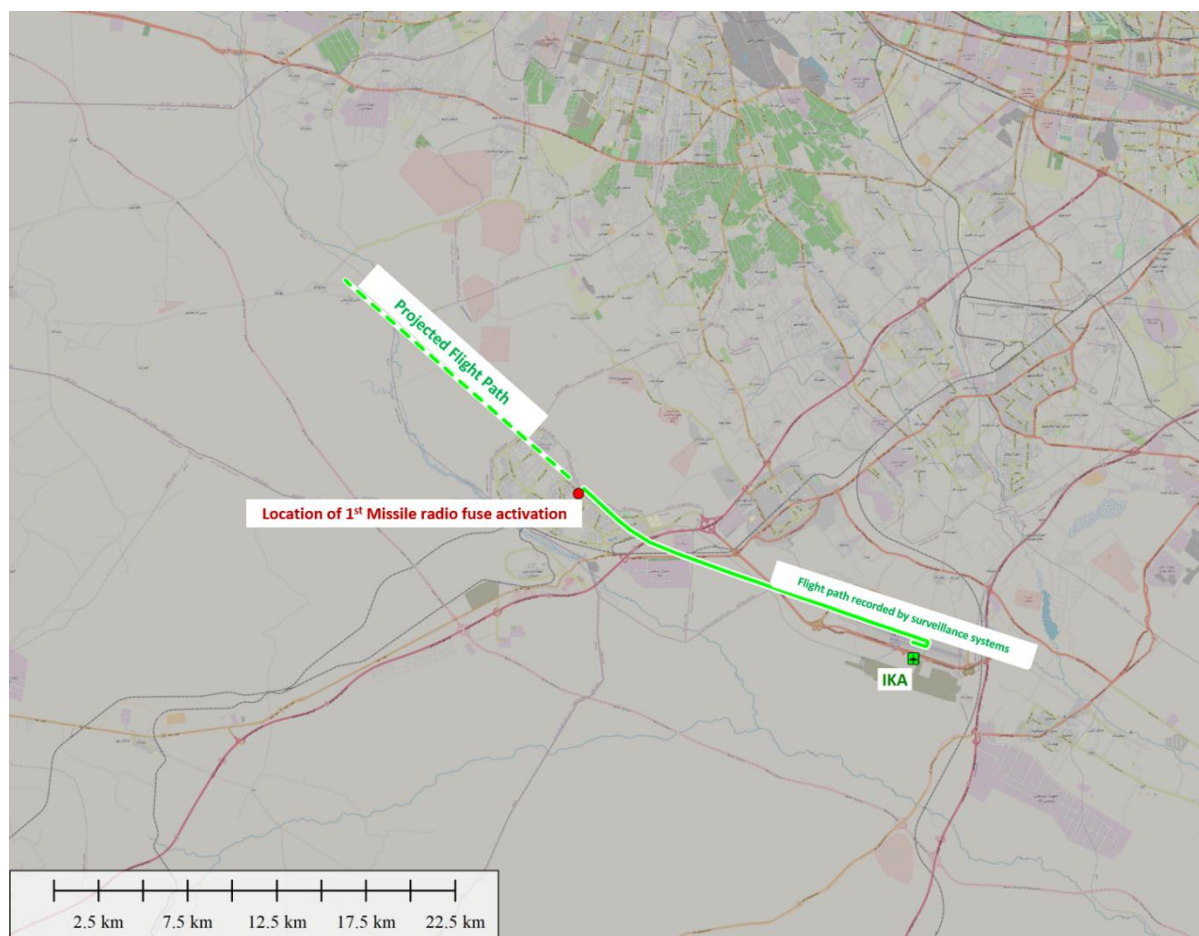
14. The missile radio fuse was activated when the aircraft had reached the last position recorded by the dependent surveillance systems<sup>6</sup>. The activation occurred at 02:44:59. (Figure 3)

Figure 3-The location of the first missile radio fuse activation

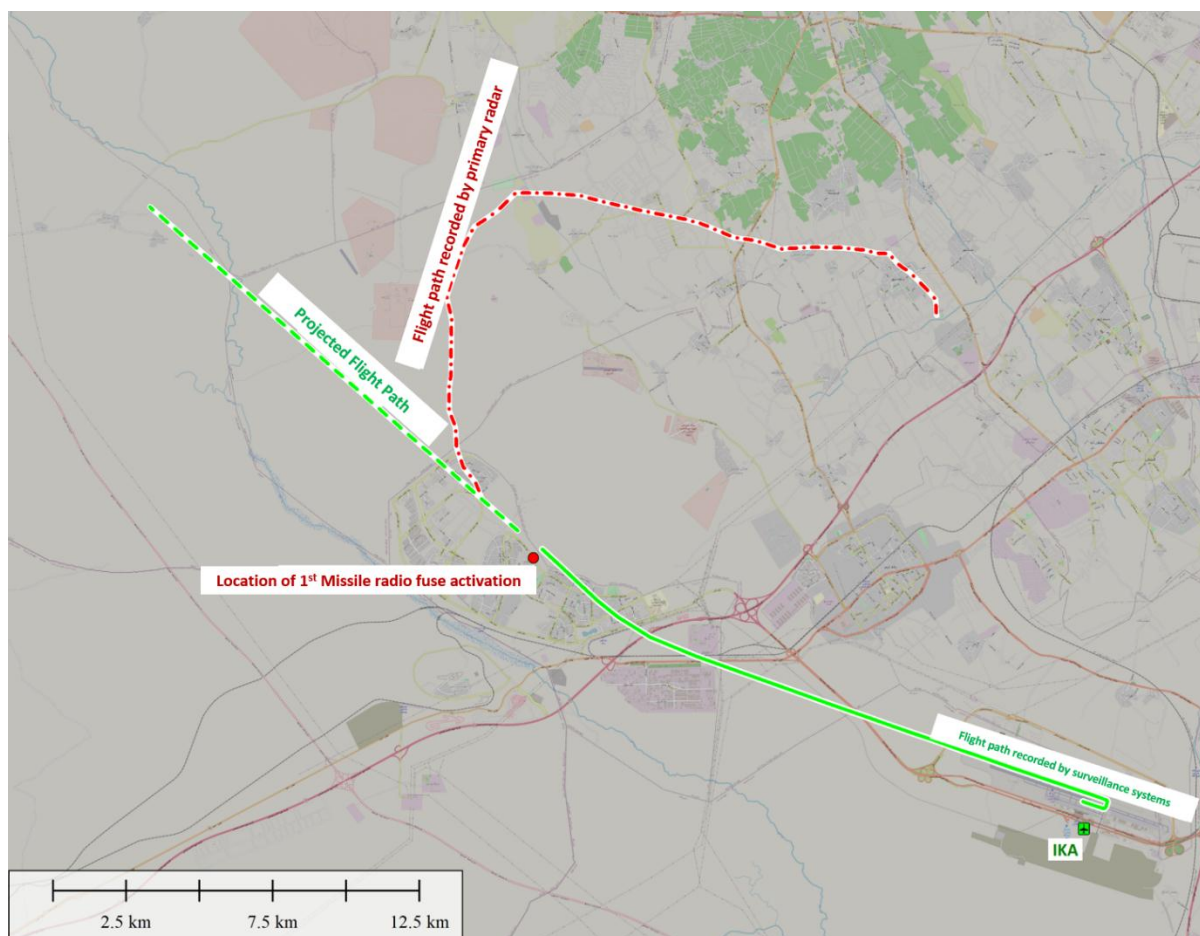
15. At 02:44:58, the last information received from the aircraft included the Secondary Surveillance Radar (SSR) transponder and Automatic Dependent Surveillance-Broadcast (ADS-B), after which the receiving of such signals was terminated. This time corresponds to the first missile radio fuse activation. From then on, the aircraft position was only being recorded by the Primary Surveillance Radar (PSR). (Figure 4)

Figure 4- Termination of SSR/ADS-B signal and recording the remainder of the flight path by PSR

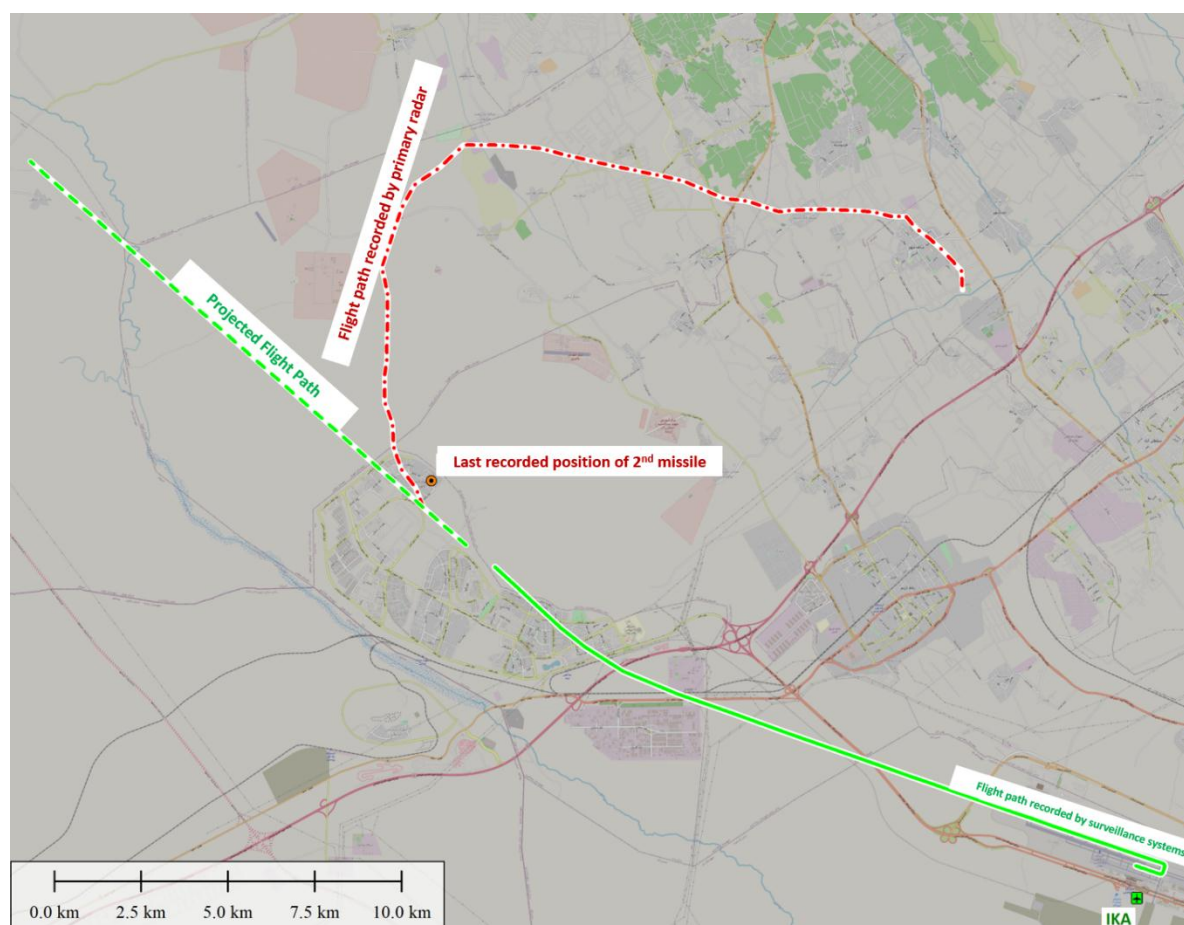
16. After the first missile radio fuse was activated, the air defense unit radar still locked on the target, and the defense system kept detecting and tracking it.
17. By observing the continuity of trajectory of detected target, the second missile was fired at the aircraft by the operator of defense system at 02:45:11.
18. At 02:45:24, the last communication between the missile and the defense system was recorded in a place close to the aircraft route. After that, the defense system showed a message indicating the strike had failed, with the aircraft clearing from the radar lock-on after some time. (Figure 5)

Figure 5- Last position recorded from 2<sup>nd</sup> missile by air defense unit

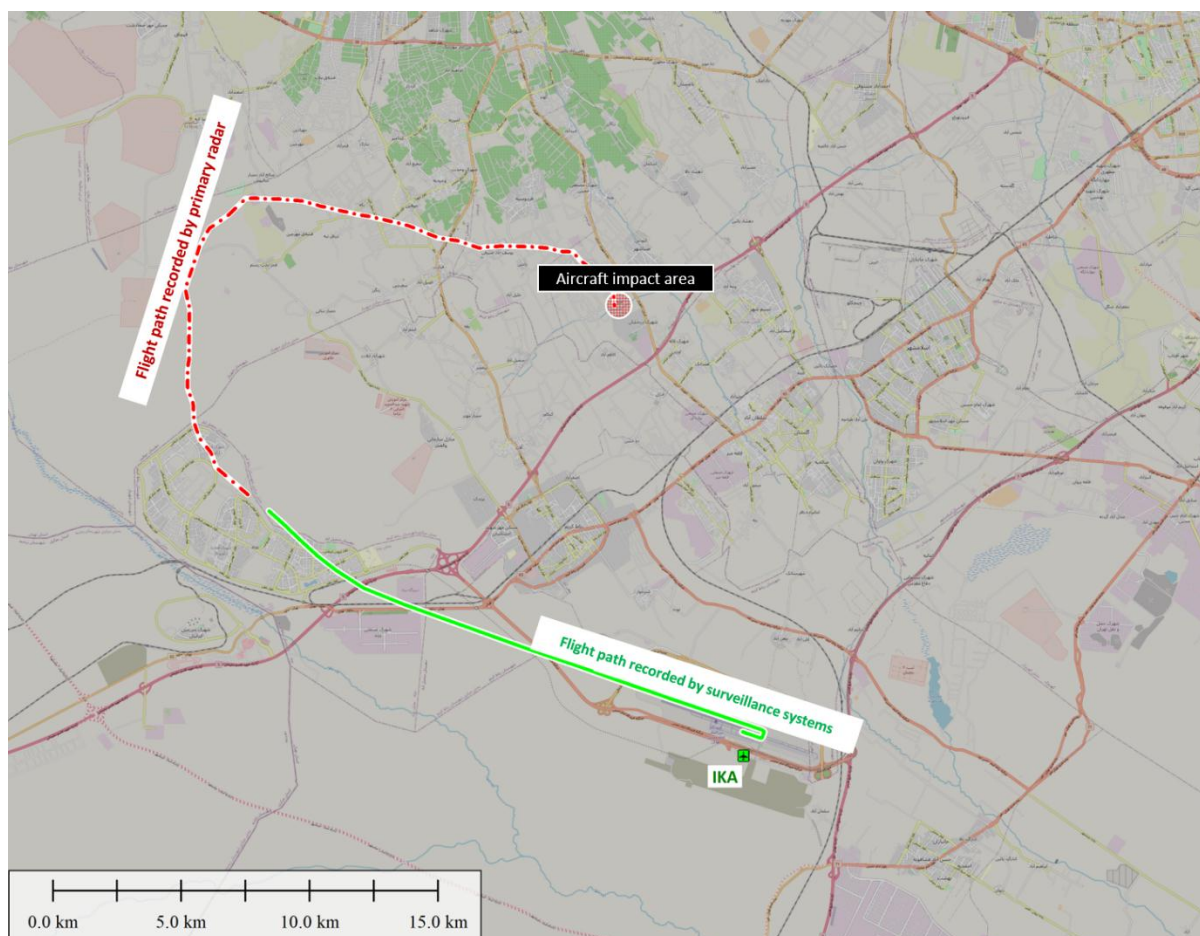
19. The aircraft turned to the right, the route of which can be seen in Figure 6. Due to the radio communication disconnection, there is no information on the aircraft altitude during the time when it was being detected by the Primary Surveillance Radar.
20. The evidence shows that at about 02:46:11, a fire broke out on the aircraft, which was intensifying.
21. At 02:48:23, the aircraft crashed into a playground in Khalajabad near Shahedshahr area at the location marked in Figure 6. An explosion occurred the moment the aircraft impacted the ground. The aircraft then kept hitting the ground and bouncing on a route towards the airport, making the aircraft pieces, victims' properties, objects and body remains disintegrate completely in a vast area near a residential complex, recreational and sports park, gardens and the surrounding agricultural land.

Figure 6- The aircraft impact area

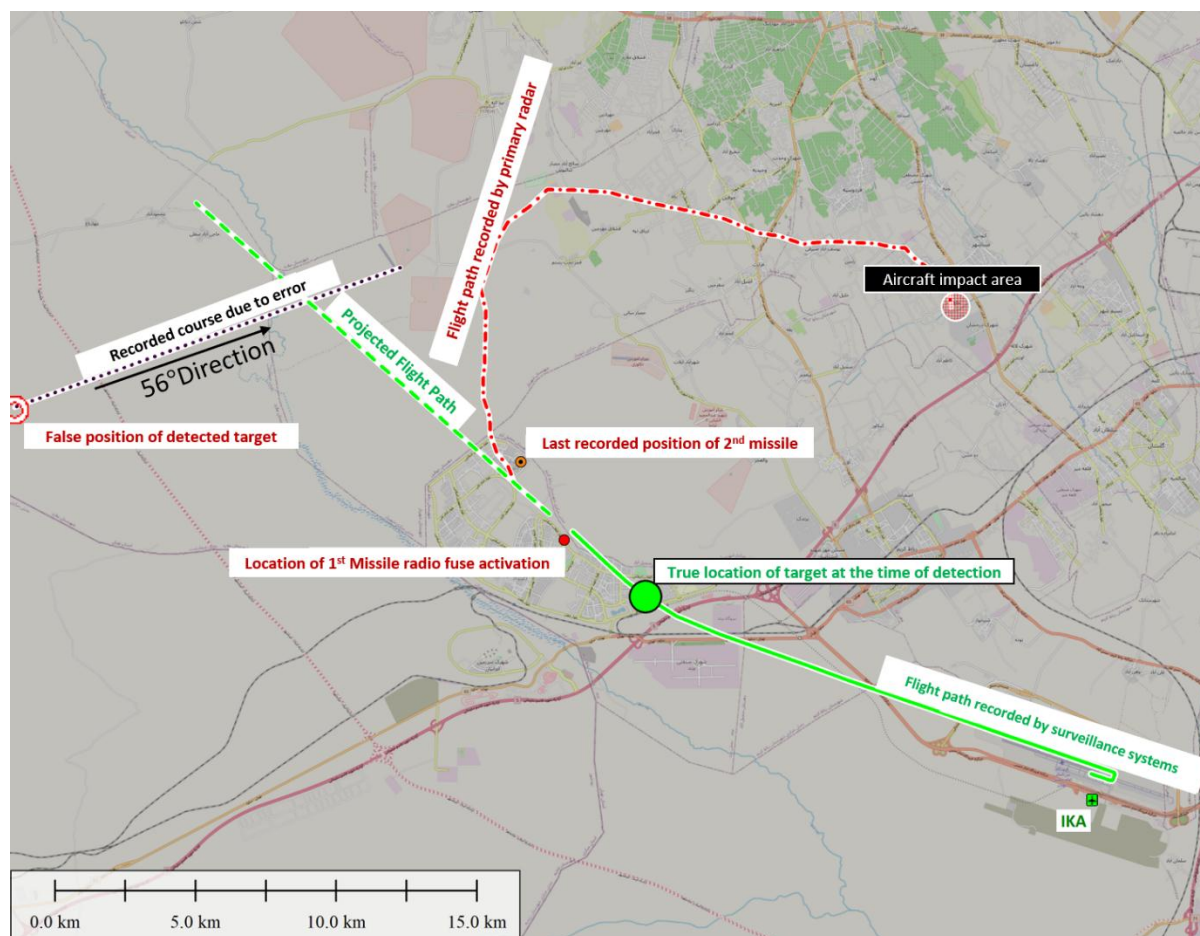
A complete overview of the information, as well as the events on the PS752 flight path are depicted in Figure 7.

Figure 7- Complete overview of available information about the flight route and key events

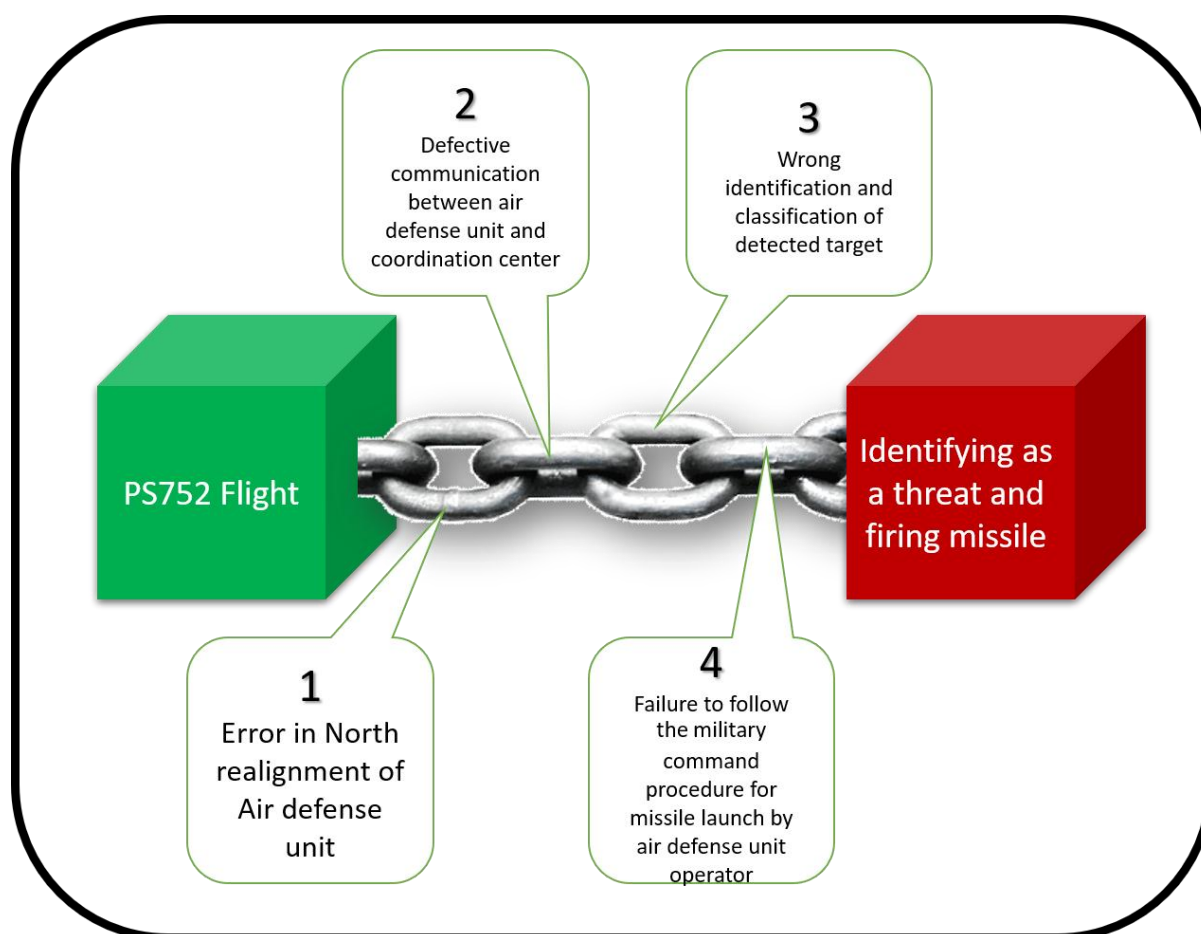
1. The sequence of events clearly shows the occurrence of a chain of events initiated by a human error<sup>8</sup>. Up to this point, some important contributing links in the chain of events have been identified, which have led to targeting the aircraft mistakenly<sup>9</sup>. Figure 8 illustrates the chain of key events identified, that if each had not arisen, the aircraft would not have been targeted. It should be noted that some new links may be found by reading out the flight recorders.

Figure 8- The chain of events leading to targeting the PS752 flight

<sup>9</sup> - At the time of publishing this report, the measures adopted by Iran's military sector focusing on each one of the links in the accident chain indicate that the likelihood of occurrence of a similar event has been reduced to an improbable level. Therefore, the safety level of airspace for commercial flights from the viewpoint of misidentification is now in normal conditions.
