## INCIDENT

<b>Aircraft Type and Registration:</b>	Saab 340B, ES-NSD
<b>No &amp; Type of Engines:</b>	2 General Electric CT7-9B turboprop engines
<b>Year of Manufacture:</b>	1989
<b>Date &amp; Time (UTC):</b>	30 August 2019 at 0645 hrs
<b>Location:</b>	Carlisle Airport, Cumbria
<b>Type of Flight:</b>	Commercial Air Transport (Passenger)
<b>Persons on Board:</b>	Crew - 3                      Passengers - 13
<b>Injuries:</b>	Crew - (None)                Passengers - (None)
<b>Nature of Damage:</b>	None reported
<b>Commander's Licence:</b>	Airline Transport Pilot's Licence
<b>Commander's Age:</b>	50 years
<b>Commander's Flying Experience:</b>	7,300 hours (of which 6,100 were on type) Last 90 days - 130 hours Last 28 days - 46 hours
<b>Information Source:</b>	Aircraft Accident Report Form submitted by the pilot and further AAIB enquiries

## Synopsis

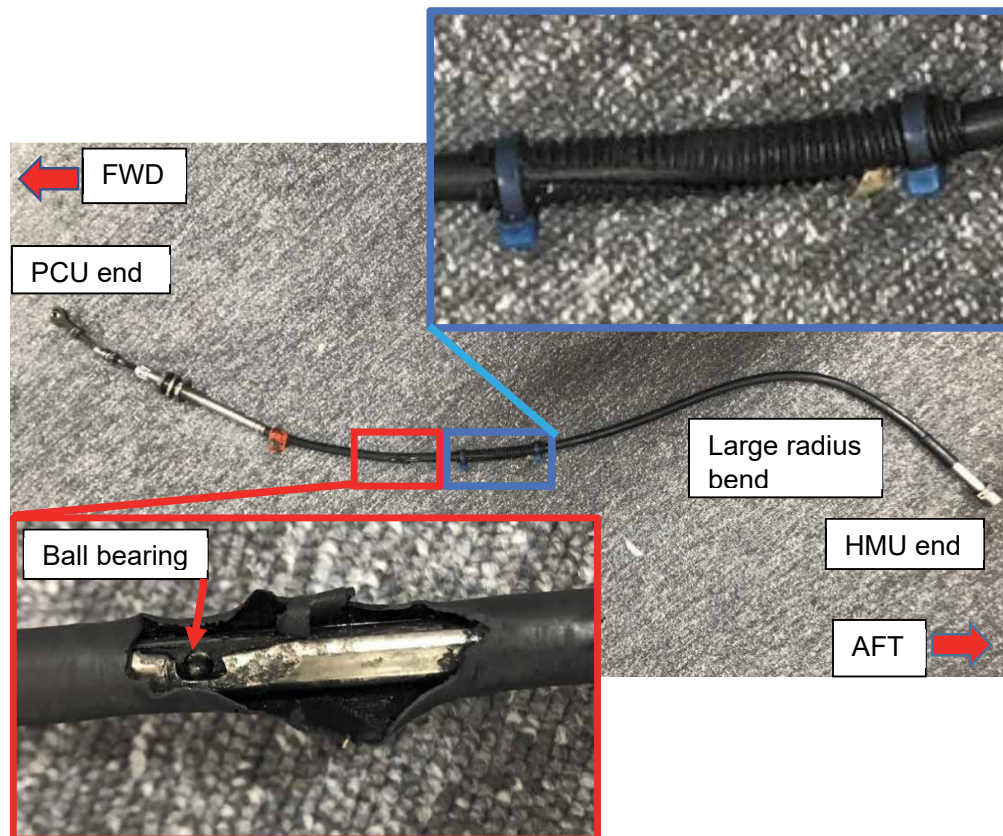
**Figure 2**

There were no photographs of the damaged condition control cable prior to it being removed from the engine but Figure 2 shows the cable after it was removed from the engine. The operator noted that a short section of plastic tubing secured by cable-ties, had been fitted adjacent to the area of visible damage.

ES-NSD left engine condition control cable, insets show damage and chafing protection

The cable from ES-NSD was not examined, but the aircraft manufacturer reviewed the photographs of the damaged condition control cable provided by the operator. It assessed that the large holes in the outer flexible stainless steel casing and vinyl covering were consistent with chafing damage. The ball guide and outer race on the affected side appeared to be damaged, such that the ball bearings were exposed. As far as could be determined from the photographs, the centre race appeared undamaged. The manufacturer noted that chafing protection, although fitted, was not in the correct position and would not have protected the cable from chafing against the accessory gearbox. The correct location is approximately coincident with the area of damage shown in Figure 2. Figure 5 also shows the correct location of chafing protection on a condition cable installed on the engine of another aircraft.

SB 340-76-027 described the precise location in which the chafing protection should be added to condition control cable to prevent chafing against the accessory gearbox. The chafing protection on the condition control cable from ES-NSD was installed at an incorrect location, and was adjacent to, rather than coincident with, the area where chafing damage was most likely to occur. It was not established why the chafing protection was installed in this location but there are several possible explanations: the position of the chafing protection may have been measured from an incorrect datum, for example the end of the rigid metal cable sleeve shown in Figure 5; if the cable-ties were not sufficiently tight, the chafing protection may have slipped from its original position; or, it may have been installed without reference to SB 340-76-027. Following this incident, the operator requested instructions from the manufacturer to perform SB 340-76-027 on all of its Saab 340s and introduced inspections of the cable in its maintenance programme.

The operator conducted a fleet inspection of the condition lever cables for signs of chafing; no anomalies were noted. It also created a periodic inspection of the cables in its maintenance programme.

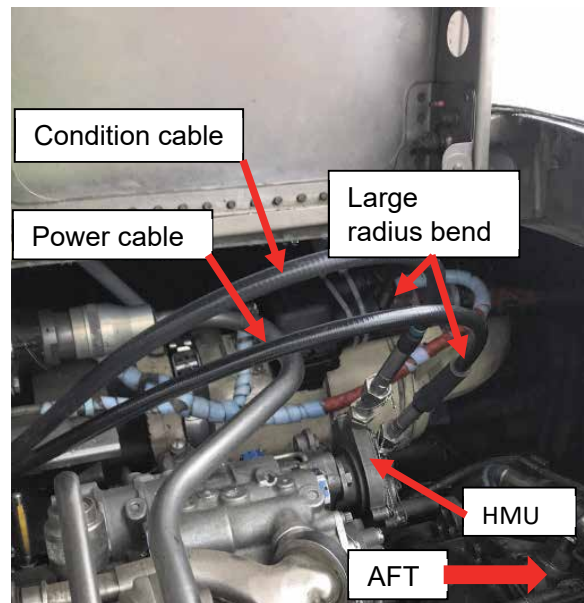
**Figure 3**

The operator initially indicated that the cable appeared to have failed due to chafing against the accessory gearbox and attributed this to the large radius bend at the opposite end of the cable, near the HMU (Figure 3). It subsequently suggested that the cable had broken in the bend near the HMU.

Bend in engine control cables near HMU  
(taken after replacement of condition control cable)

In addition to the visible damage, the operator suggested that the cable had broken in the large bend near the HMU gearbox. The cable was not physically examined but it was considered possible that the cable had also suffered an internal failure at this point, which was not externally visible in the photographs provided. But the manufacturer considered that the substantial chafing damage evident in the photographs would have been sufficient to cause problems with cable operation and could have accounted for the lack of response from the condition lever during the incident.

It was not established if SB-340-76-044 had been embodied on ES-NSD but it is likely that if the standoff bracket had been in its original (pre-SB) position, it would have been visible on the left edge of Figure 3. Therefore, it was considered likely that SB-340-76-044 had been embodied.

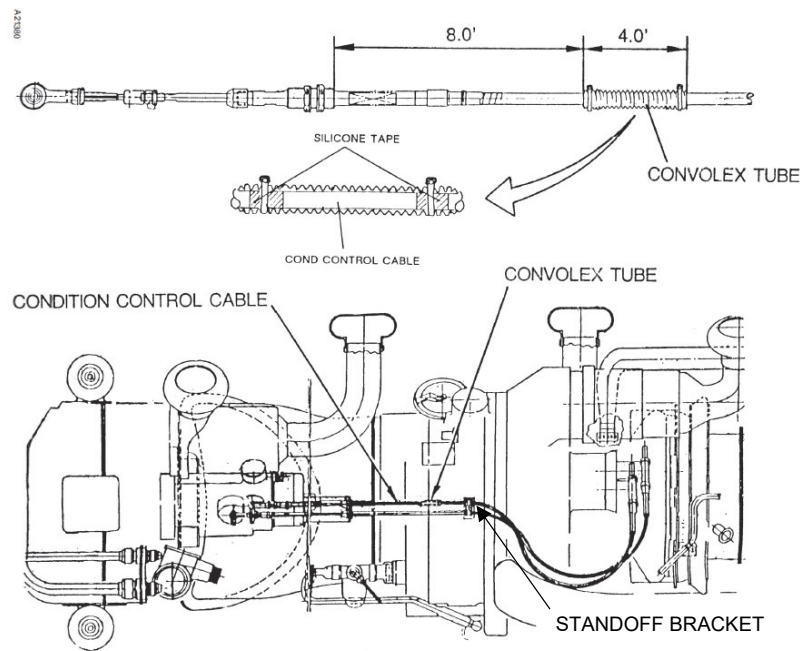
**Figure 4**

SB 340-76-027 Revision 01 '*Engine controls – powerplant – chafing protection of engine control cables*' was issued on 12 November 1988. It described attaching silicon tape and a 4-inch long section of plastic convolex tubing at a specified location on the HMU-PCU section of the condition control cable, to prevent chafing of the cable on the accessory gearbox. Compliance with the SB was described as 'recommended'. Figure 4, taken from SB 340-76-027 shows the location in which the convolex tube should be installed.

Location of anti-chafing protection on condition control cable from SB 340-76-027

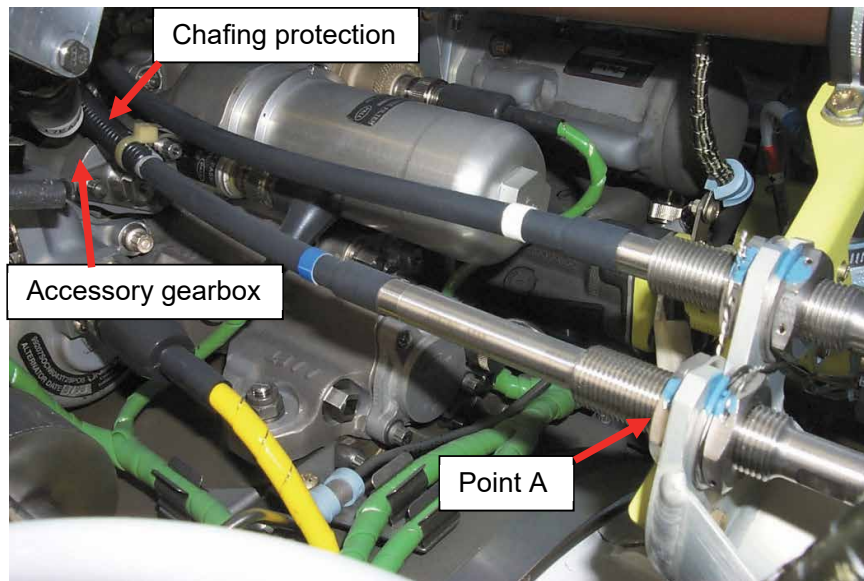
**Figure 5**

Correct location of chafing protection on condition control cable (view looking aft)

Point A in Figure 5 corresponds approximately to the datum shown in SB 340-76-027 (Figure 4); the chafing protection should be installed 8 inches from this point.
