Final Report RL 2017:04e

**Accident at Ängsö, Västmanland County,
on 22 January 2016 involving the
aeroplane SE-LVR of the model Diamond
DA42, operated by Airways
Flygutbildning Svenska AB.**

Reference no. L-06/16

21 March 2017

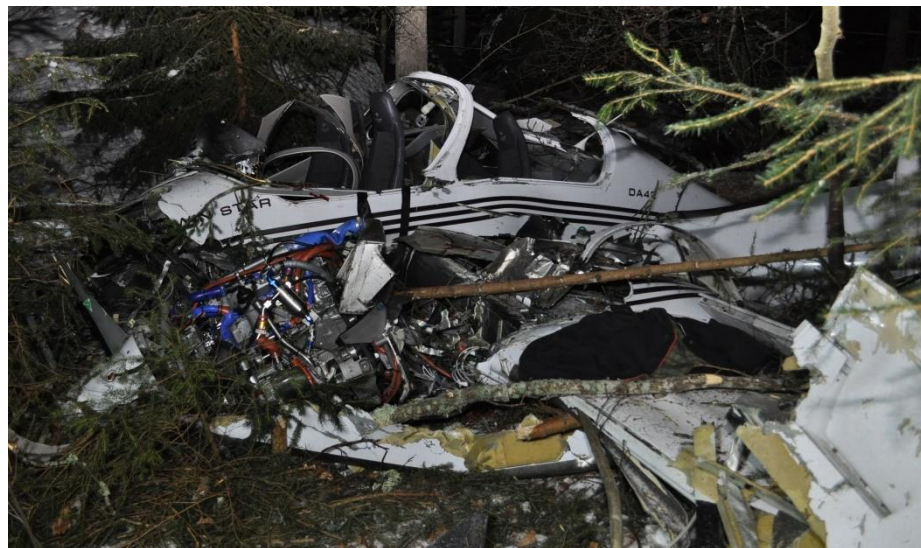
At approx. 2,000 feet, the aeroplane entered the underlying cloud layer and a number of seconds later, impacted into an area of woodland. During the initial sequence of events, the aircraft hit the surrounding trees while rotating. Parts of the wings were found in the trees at the accident site at a height of up to approx. 10 metres. The aeroplane then twisted itself round a Scots pine that penetrated the fuselage and which the plane then rotated around on its way towards the final point of impact. At the impact, the remaining parts of the aeroplane were completely destroyed (see Figure 3), but no fire broke out.

Figure 3. The wrecked aircraft. Photo: Mälardalens Brand- och Räddningsförbund.

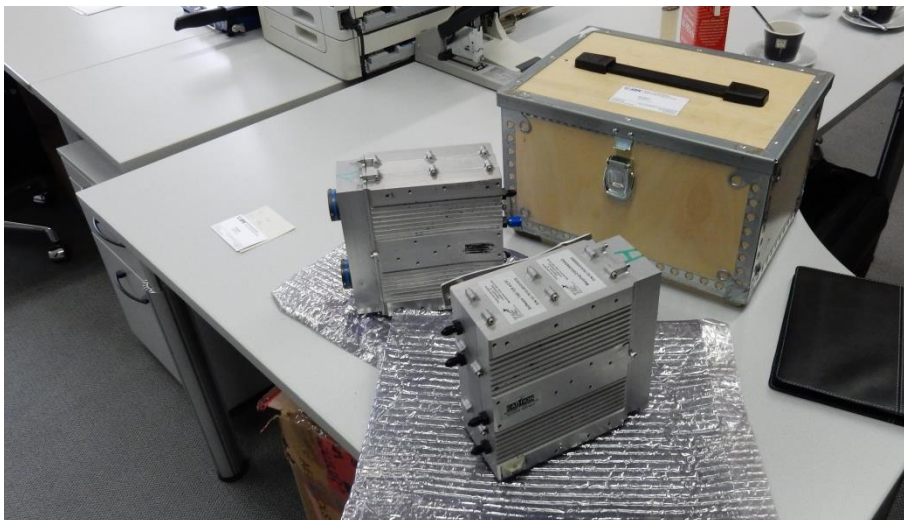
Once the units had been removed from the wreckage, they were transported to the engine manufacturer's laboratory in Hamburg (see Figure 4). In the presence of representatives of SHK, the units were connected and the memory function could be evaluated. The damage that occurred during the accident had not affected the units' recording functions. All parameters could be read out for analysis.

Figure 4. Examination of the FADEC units in Hamburg.

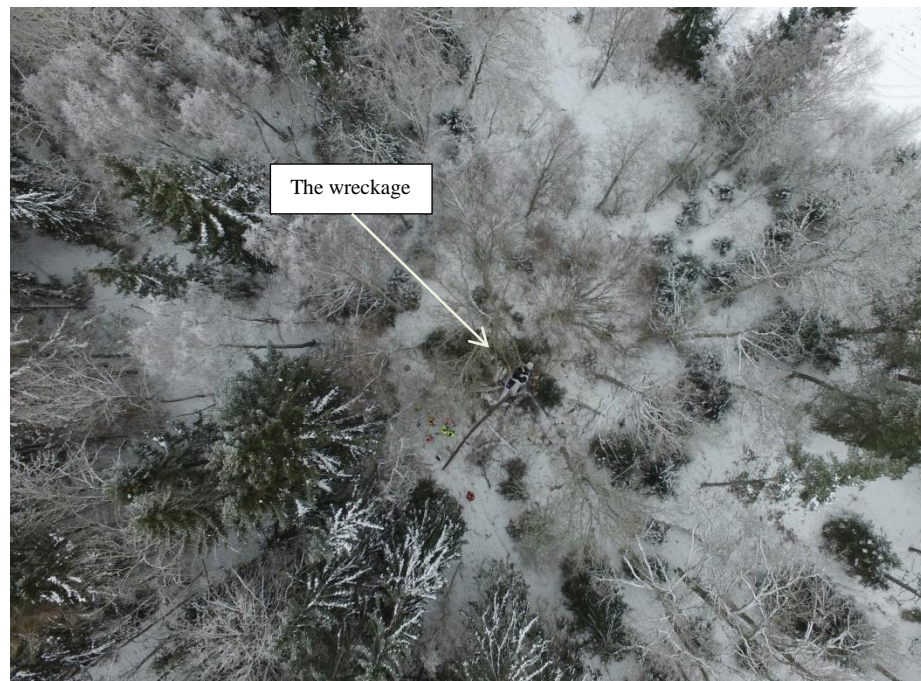
The accident occurred in an area of woodland approx. 300 metres north-east of Ängsö Castle (see Figure 9). The woodland consists of mixture of trees of varied size. The site of the impact consisted largely of a small open area surrounded by tall trees of various species.

Figure 10. The accident site in the woods.

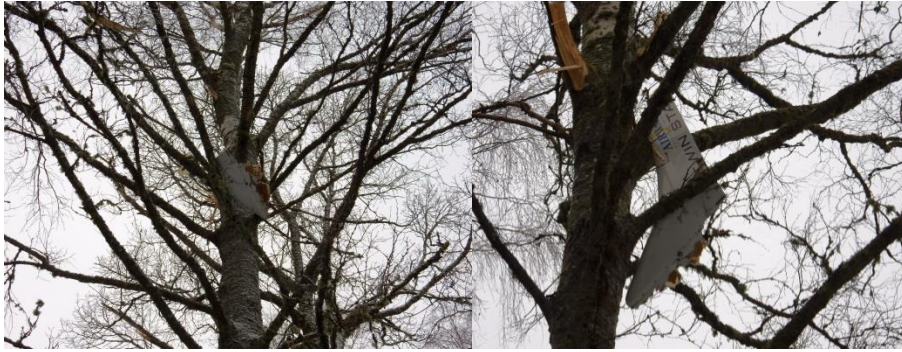
The aeroplane went down in the woods while rotating to the left. Many large pieces of the aeroplane were found in the surrounding trees at heights of up to 10 metres (see Figures 11 and 12). The aeroplane began breaking up when it made contact with the trees. There were a large number of pieces of wreckage spread out on the ground underneath, probably originating from the rotational impacts.

Figures 11 and 12. Parts of the aeroplane, sections of the fuselage and left winglet.

Both wings were found alongside the fuselage, but had come off their attachments. The wings were bent into various angles and broken in a large number of places. Part of the left wing – the outermost part that is angled upwards (winglet) – was found in a tree at a height of approx. 10 metres. A certain quantity of aviation fuel remained in the wing tanks and it was possible for decontamination personnel to pump this out.

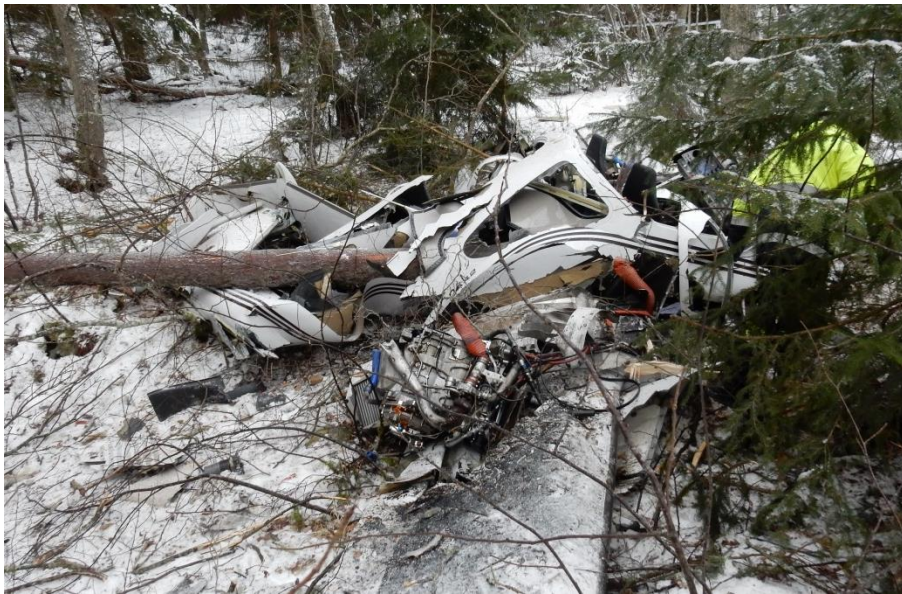
During the initial stage of the impact phase, the aeroplane has also hit a Scots pine in such a way that the trunk penetrated the fuselage (see Figure 13). The aeroplane has then – probably while rotating more slowly – slid down the tree trunk. During the final impact, the tree trunk has broken close to the roots and was found in the place where the right back seat had been.

Figure 13. The wrecked aircraft.

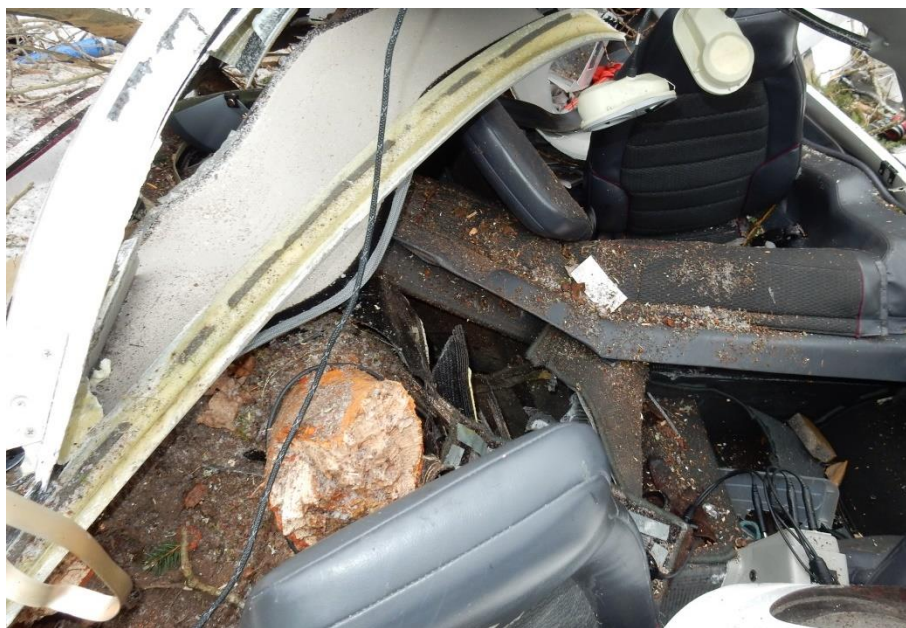
Figure 14. The Scots pine trunk in the right back seat.

The two people in the aeroplane's front seats remained in the aeroplane at impact. SHK has not found it to be meaningful to attempt to calculate the forces of impact due to the special circumstances in the final stage of the sequence of events. The forward speed was probably close to zero, but the vertical forces, combined with the nose-down attitude that has been established at the time of the impact, resulted in the nose section – with the instrument panel and pedal gear – largely being forced into the cabin and causing severe injuries to the crew.

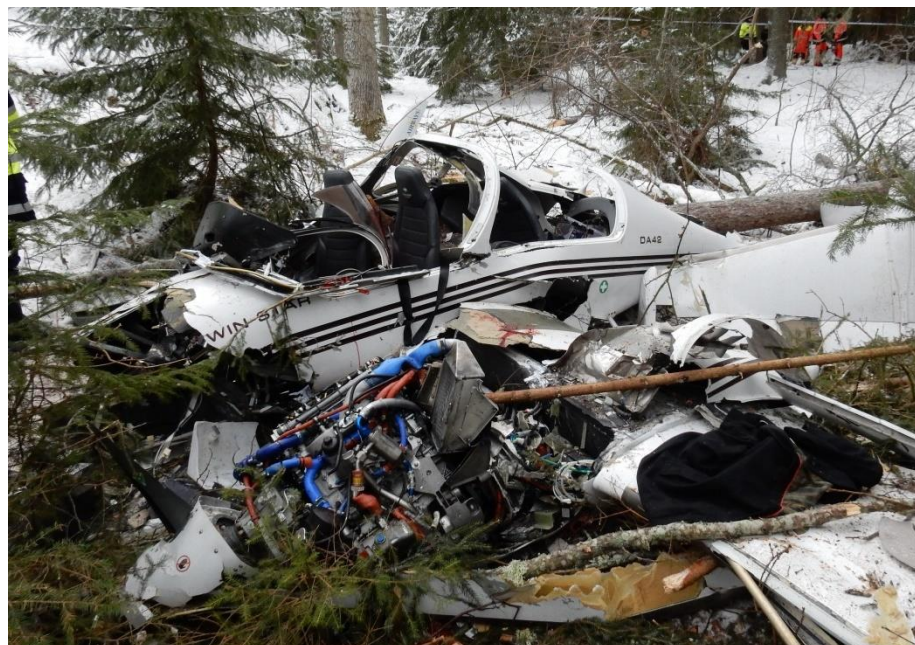
The rotation decreased and rate of descent was further reduced when the aeroplane hit the trees. The aeroplane’s wing tips hit the surrounding trees, further reducing the energy of the movement. At this point, the aeroplane also hit a Scots pine that was broken in such a way that the trunk penetrated the fuselage. In the final stage of the sequence of events – when the aeroplane twisted itself around the trunk – the passenger in the back seat was thrown out of the aeroplane. With a significantly reduced rate of descent and rotation, the remains of the aeroplane hit the ground with a slight nose-down attitude and minimal forward speed (see Figure 16).

Figure 16. The wrecked aircraft.
