Final Report RS 2014:01e

Serious accident at sea on 15 October 2012 involving the vessel Liva Greta at Nockeby Bridge in the County of Stockholm, Sweden.

Diary No: S-165/12
2014-03-12

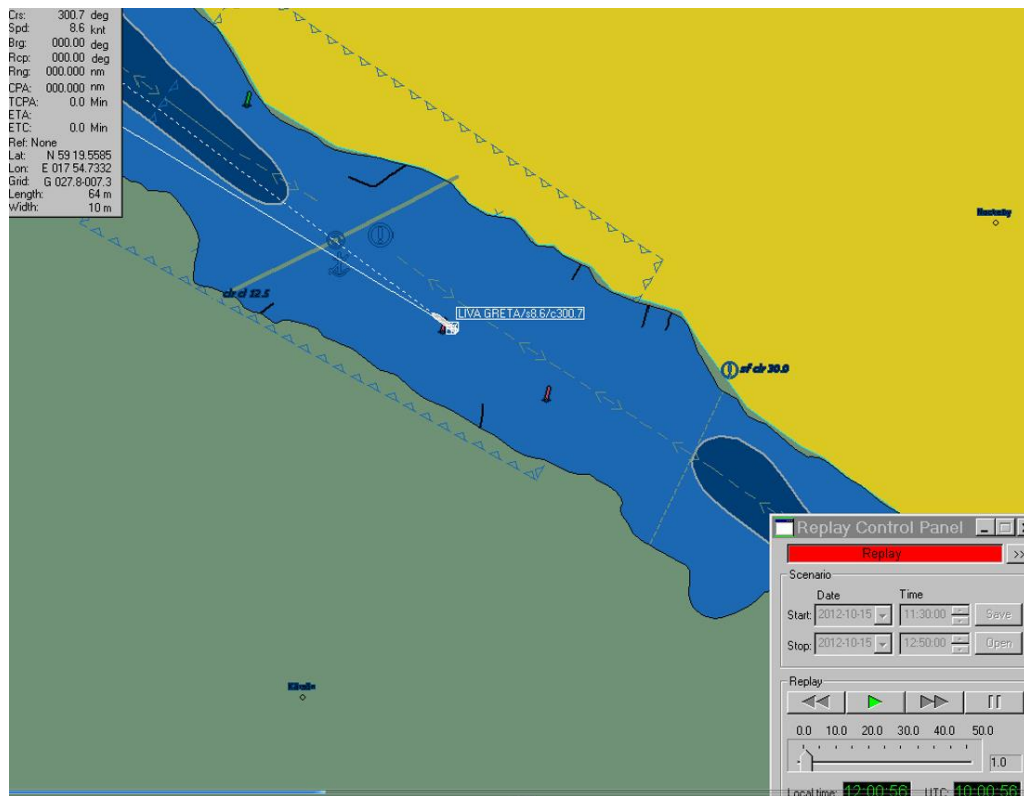
Fig. 3. AIS recorded when passing the second red spar buoy.
© Sjöfartsverket No: 10-01518.

A general speed limit of 5 knots begins to apply at a distance of some 4 cable lengths (about 750 m) from the bridge. M/S Liva Greta held a steady course of 301° and a speed of 8.6 knots until the second buoy had been passed about 1 cable length from the bridge, when the vessel began to reduce speed and change course to starboard (see Fig 3).

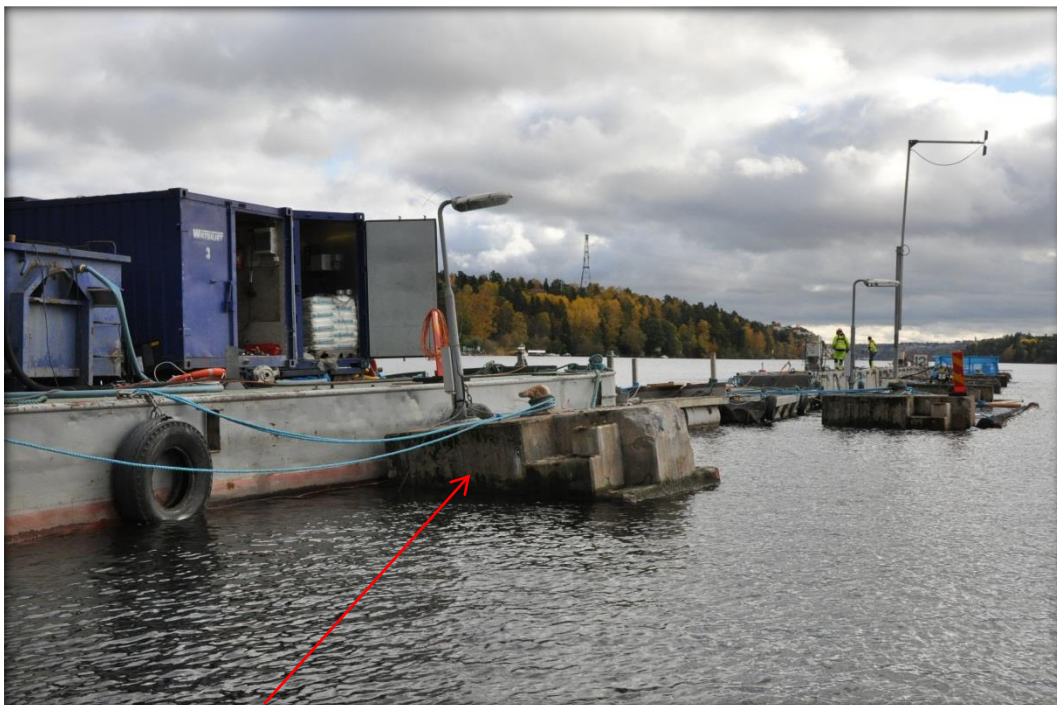
Fig. 4. Fouled dolphin, which was shifted approximately 1.5 m out of position.

Damage to two dolphins, one of which had to be replaced by a new structure, whereas the other one was only cracked and could be repaired.

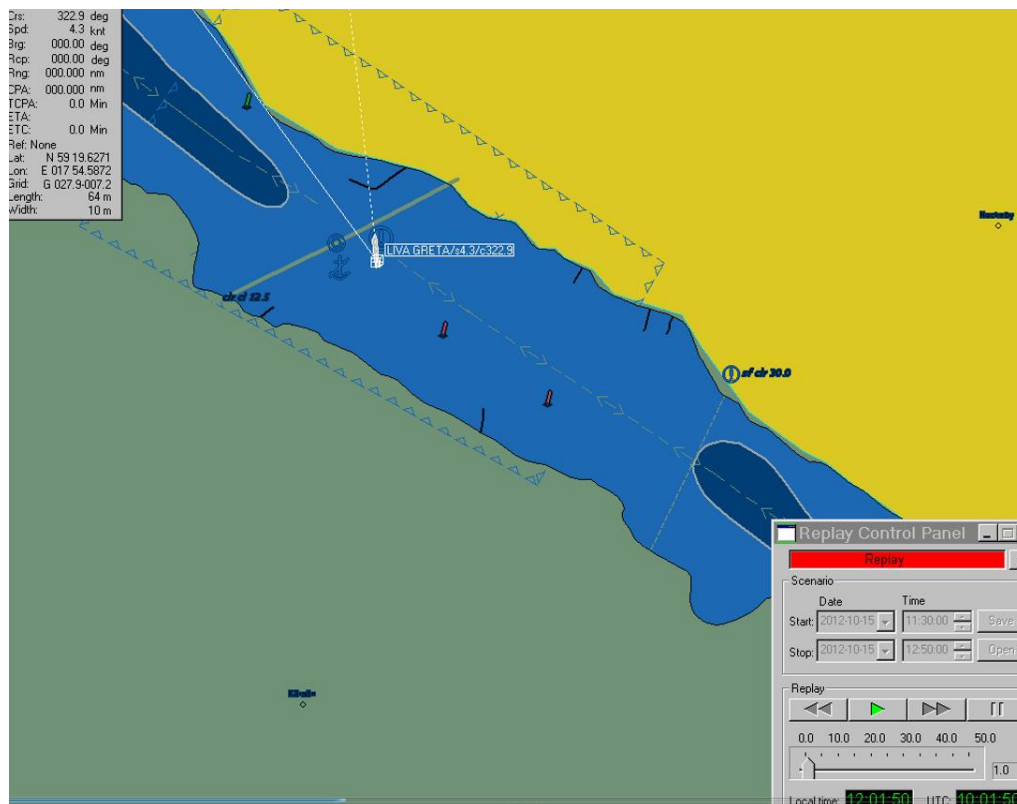
The vessel continued to reduce speed and change course to starboard until the collision occurred. The stern of the vessel collided first with a dolphin on one side of the channel, after which she continued over to the other side of the channel where she collided bow-on with another dolphin (see Fig. 4). The speed of the vessel at the time of the collision was just over 4 knots, which meant that it was a serious collision (see Fig. 5).

Fig. 5. AIS recording at the time of the collision.
© Sjöfartsverket No: 10-01518.

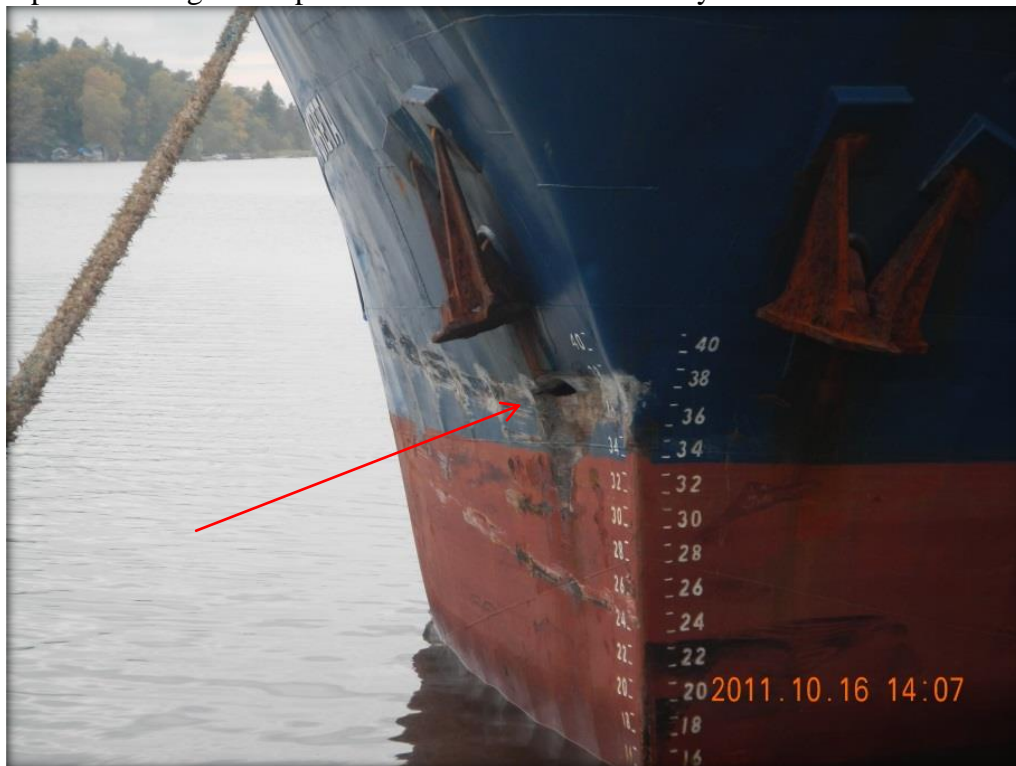
The damage to the vessel was limited to a hole in the forepeak above the water line immediately beneath the starboard anchor (see Fig. 6). The damage was repaired during the stopover at the harbour in Hässelby.

Fig. 6. Damage to the Liva Greta.

When the required turning speed was not obtained, the engine were thrown into full astern in order to avoid colliding with the dolphin bow on. In similar situations, when the engine is running full astern, the turn is accelerated and takes place in a partially uncontrolled manner – in this case to starboard owing to the direction of propeller rotation. In this case, the stern section turned and collided with the southern dolphin, which caused cracking in the dolphin structure. After this, the vessel continued towards the northern dolphin where the starboard bow hit the dolphin and the vessel was holed just below the starboard anchor.
